**Ministry of Business,
Innovation & Employment**

Review of the Maui Pipeline Outage of October 2011

October 2012

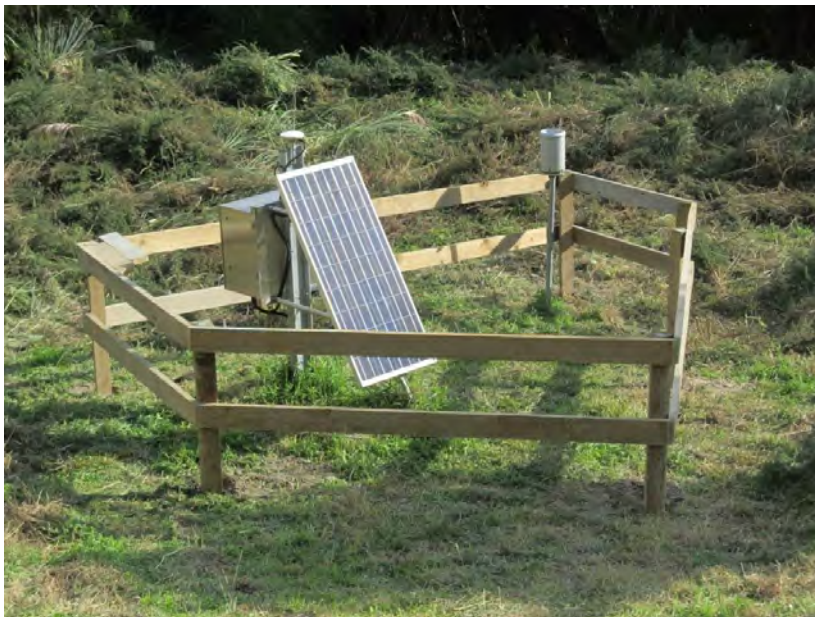
Figure 2: Example of site monitoring equipment (source: Vector Gas)

Figure 2 above shows a monitoring beam with a GPS antenna on top and an automatic rain gauge in the background. The data from this monitor enables monitoring of any movement of the slip. A new fence has been installed due to the recent introduction of stock and horses by the landowner.

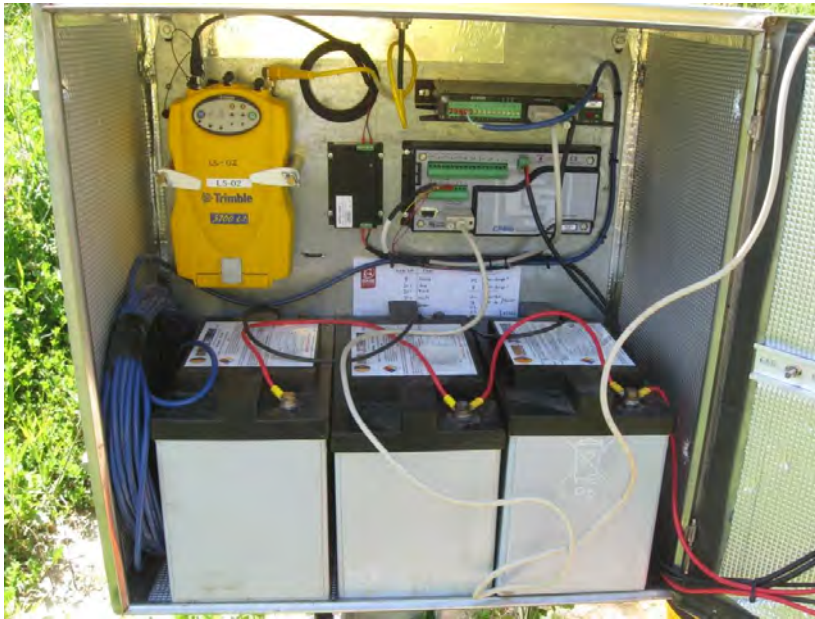
Figure 3: Example of data collection hardware point (source: Vector Gas)

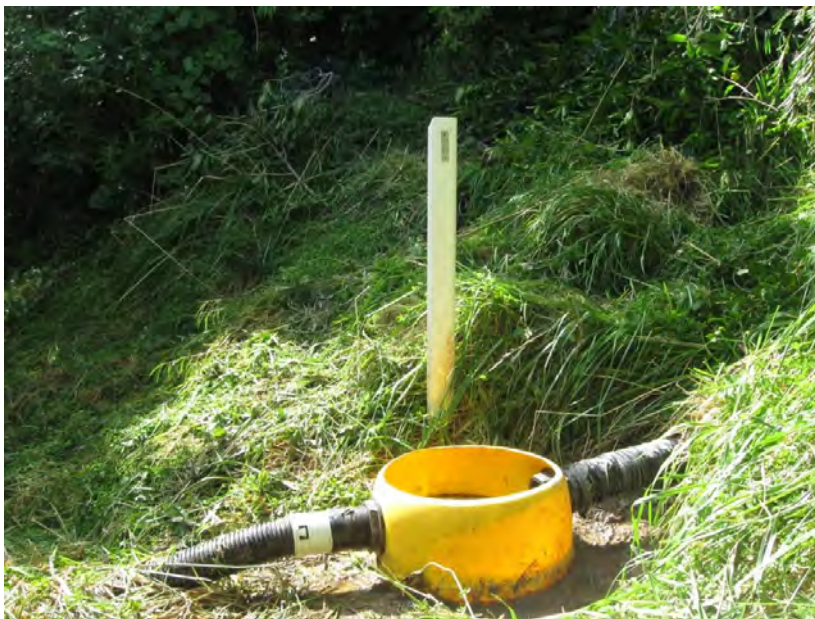
Figure 4: Interception pot for snapshot measuring of drain water flow rate (source: Vector Gas)
