ADDENDUM:

**Investigation into the performance of
Statistics House in the 14 November 2016
Kaikōura Earthquake**

June 2018

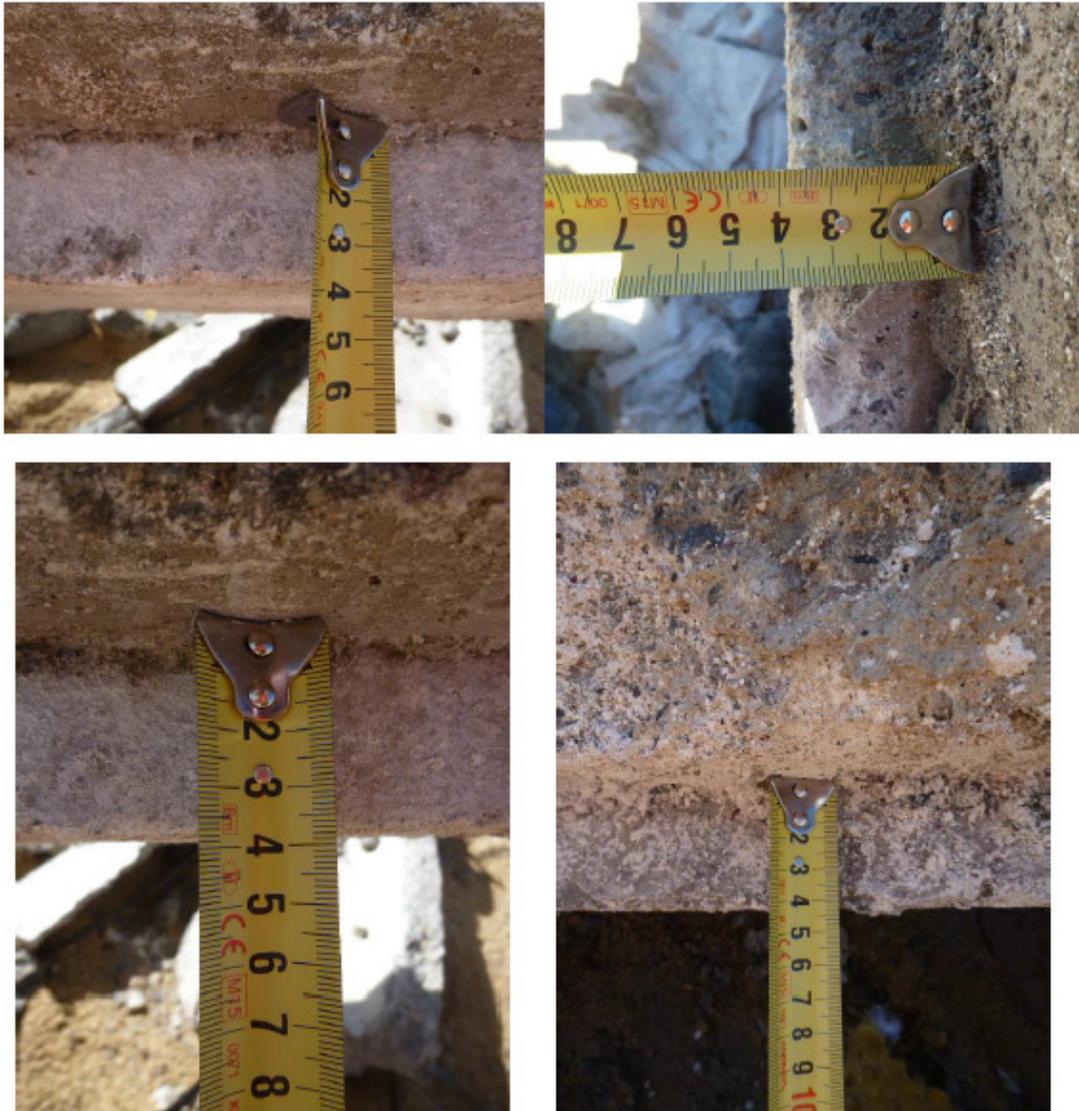
Given the findings during the demolition, in particular the very limited seating identified to the double tee floor units very similar to those that failed, we would consider that the limited seating identified on site may materially impact on the findings contained within this report, and therefore the recommendations that have come out of it.

For your information below are a limited number of photographs which are indicative of what appears to be the limited seating shelf present on the beams which provided support to a number of the double tee units. We would note we have further photographs and site reports should these be required.

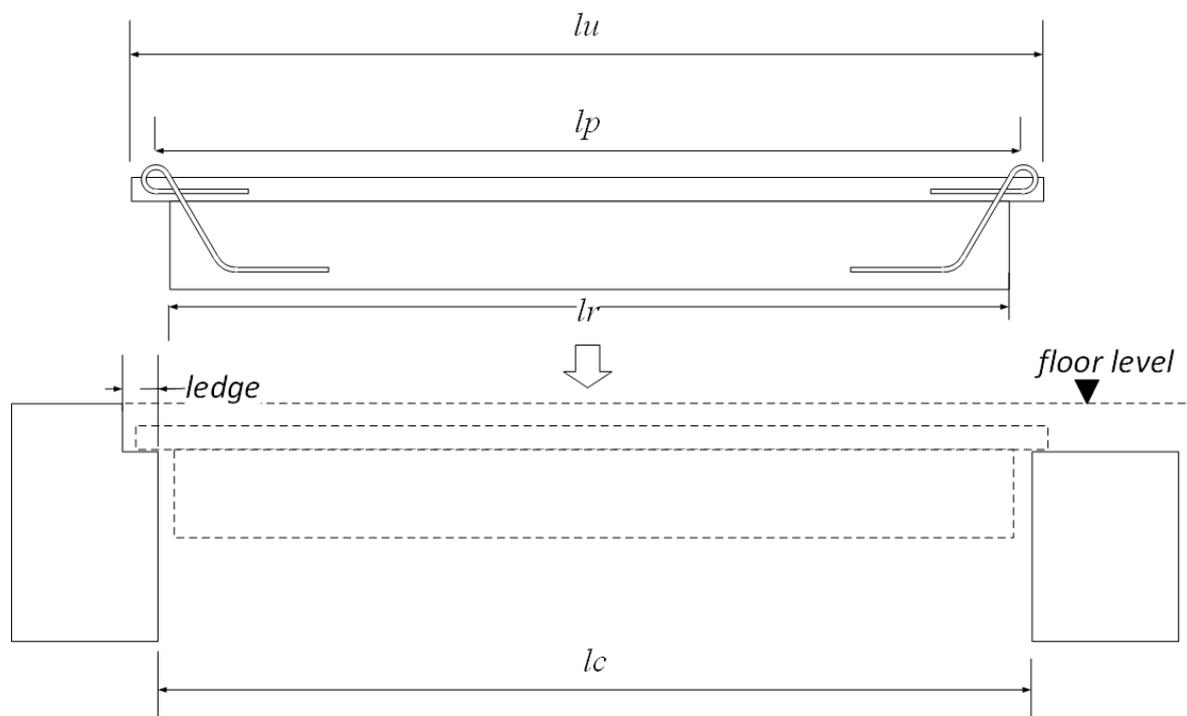
Figure 1: Precast tolerances for Statistics House (not to scale)

There are a number of variable dimensions that may impact on the fit of the units and therefore the available seating. Refer to Figure 1.

- length of the unit
- available width of the precast beam ledges
- erection and casting in of the supporting beams
- actual location of the double tee within the gap between the supporting beams.

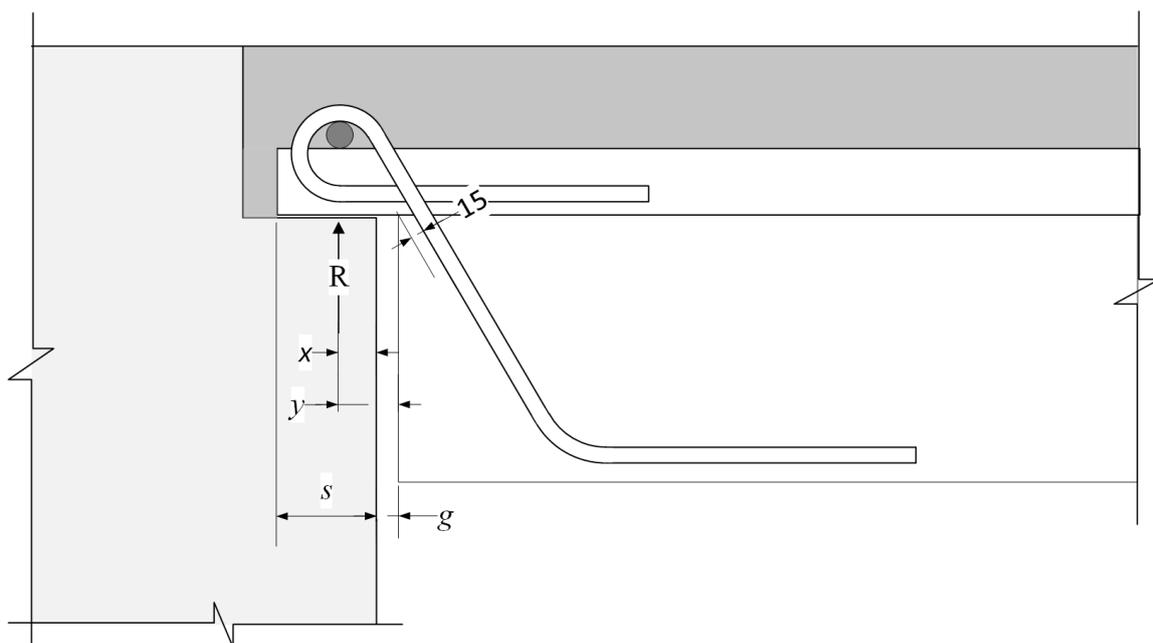
Figure 2: Detail of loop bar at support

Finally, the nature of the support itself should be considered. With a flange-supported double tee, the primary supporting element is the nib of the double tee, reinforced by the loop bar hanger. The location of the loop bar is determined by the requirement for cover to the angled leg of the loop bar from the throat of the double tee (where the rib intersects the flange); in this case, it is a minimum of 15mm (the minimum cover allowed under NZS3101 for 60MPa concrete in an interior environment). Given the centre of the reaction R from the weight of the units must intersect at the centre of the loop bar, the critical dimension that determines this location is the gap between the end of the rib and the supporting beam. This is illustrated in more detail in Figure 2.

With the geometry of the loop bar and the cover requirement taken into account, the distance, y , from the reaction R at the centre of the loop to the end of the rib is approximately 35mm. (If an inclination of the reaction of say 15 degrees from vertical is assumed, this moves the reaction to approximately 48mm from the end of the rib).

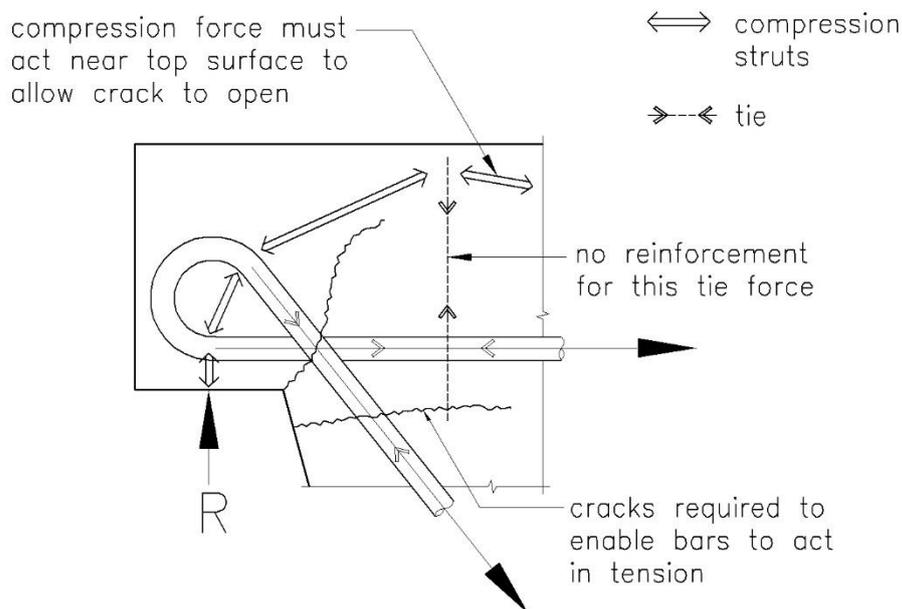
Figure 3: Strut and tie analysis of flange-supported double-tee (from Figure 5, SESOC Journal)

After viewing videos provided by the demolition contractors and demolition engineers the Panel discussed the demolition failure mechanism with both parties. The Panel’s opinion is that the failure observed during demolition is likely to have followed one of the forms of failure proposed by the Structural Engineering Society of New Zealand (SESOC) study of 2009⁵. In this case the sudden overloading from the impact of material falling from above would have resulted in immediate failure at the loop bar as indicated in Figure 3. The tensile force generated across the unreinforced construction joint would have caused failure of the concrete in tension, leading to the loop bar bending up and the floor units subsequently falling. The damaged state of the building after the earthquake, including the presence of beam elongation, may have contributed to the eventual failure of the units during demolition.

Therefore the mechanism of failure during the Kaikōura earthquake and during demolition cannot be directly compared.

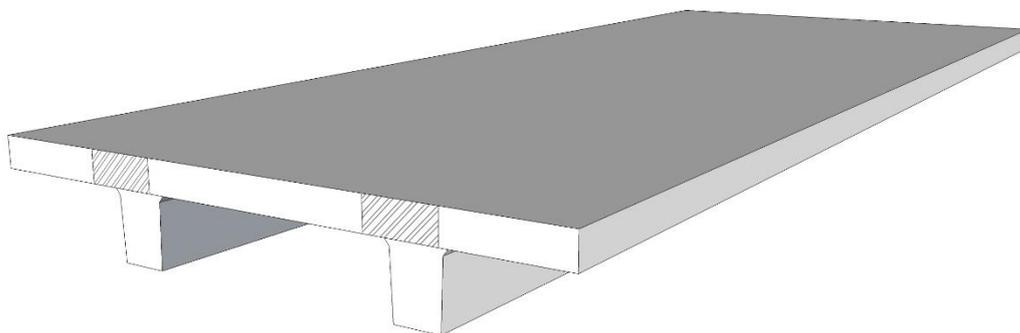
Figure 4 Points of support for double-tee floor unit

With the accumulation of debris on the floor (which was not possible to sweep clear over the majority of units) and the significant shock loading, the entire support mechanism was likely to be overwhelmed. This is probably exacerbated in the case of flange-supported double tees by the fact that the entire support mechanism for a double tee is concentrated at two points at each end of the units, as illustrated in the hatched areas of Figure 4 below, where the loop bar hangers are located.

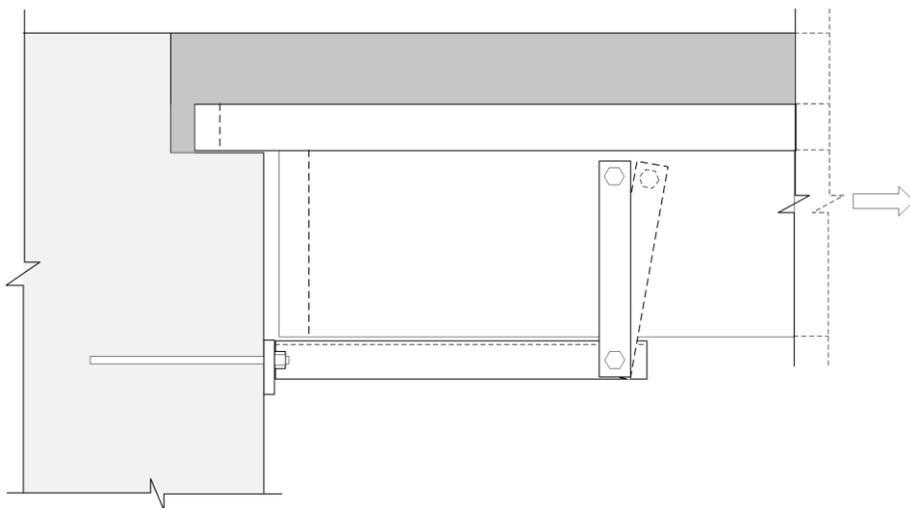
Figure 5: Retrofit detail used at Statistic House

This is a distinctly different case to demolition loading, where the double tees either had the outer support beam physically removed or were failing at the ends under the shock loading of debris falling from above. As the bracket was physically attached to both the double tees and the support beams a failure had to occur in either the fixings or the bracket itself, as the bracket was forced into tension. There is not sufficient evidence to draw any conclusions on the precise mode of failure, but it is likely that the instantaneous overload was much greater than the bracket was designed for.

In reviewing the detail and the information presented, the Panel has no adverse comment on the likely performance of this bracket under the loading conditions for which it was originally designed. The Panel would not necessarily have expected to see the brackets remaining fixed to the beams following demolition, nor for the brackets to have had sufficient capacity to prevent failure of the floor under the cumulative weight of debris and shock loading.
