FORSYTH BARR

FORSYTH BARR BUILDING STAIRS
SITE EXAMINATION AND MATERIALS TESTS
FOR DEPARTMENT OF BUILDING AND HOUSING
17TH SEPTEMBER 2011

REPORT PREPARED FOR:
DEPARTMENT OF BUILDING AND HOUSING

DR CLARK HYLAND

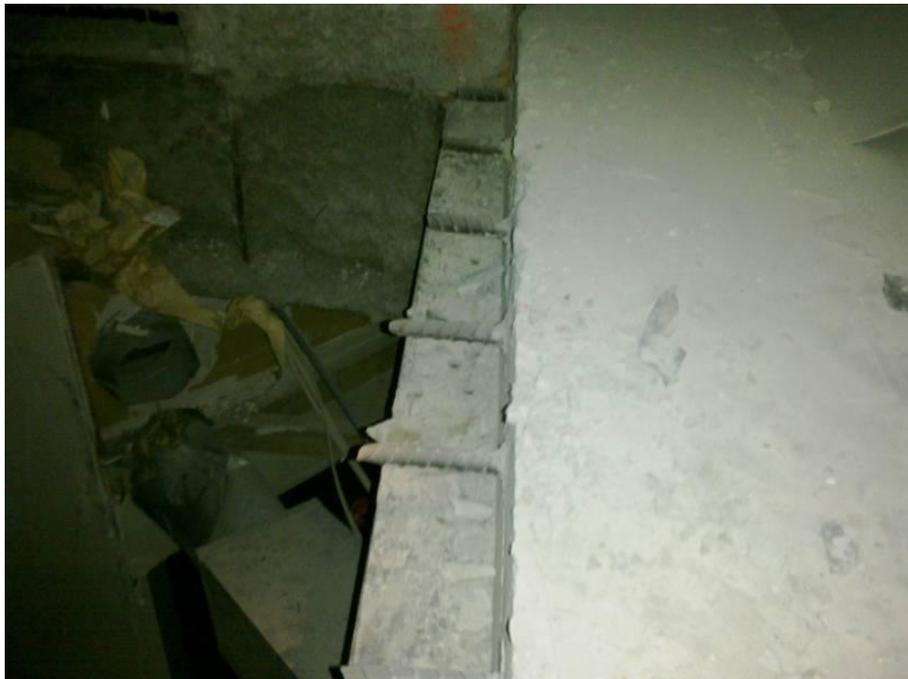
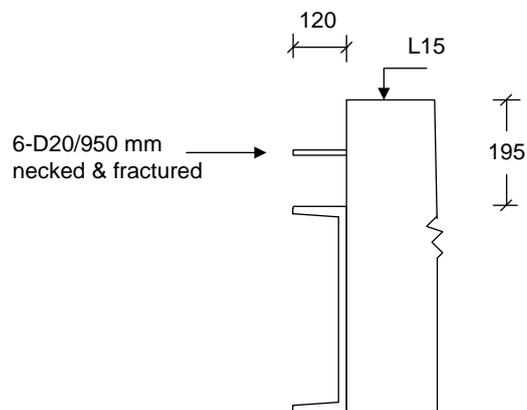
The fractured D20 reinforcing steel at the top supports of the stair flights from which the stair flights had broken away was visible (Figure 1).

Figure 1 - Southwest L15 to L14 stair upper landing with fractured D20 reinforcing steel above 381x102 mm RSC steel channel support

- f. At the upper supports from which stairs had fallen, the necked and fractured ends of six D20 reinforcing steel bars protruded 120 mm out of the concrete beams, just past the tip of the supporting 102

mm wide flange of the supporting 381 × 102 RSC steel channel. The steel channel had not suffered any obvious damage (Figure 1).

Necked and fractured reinforcing bars are left with 110 mm stick out from the upper, similar to what was seen on other upper landing supports (Figure 1).

The stair flight had fallen away and six D20 bars spaced evenly over 950 mm were exposed that had necked and fractured 120 mm from the edge of the concrete slab above the edge of the 102 mm wide top flange of the 381x102 mm RSC steel channel supporting it.

The top flange of the RSC steel channel appeared to be undamaged (Figure 1).

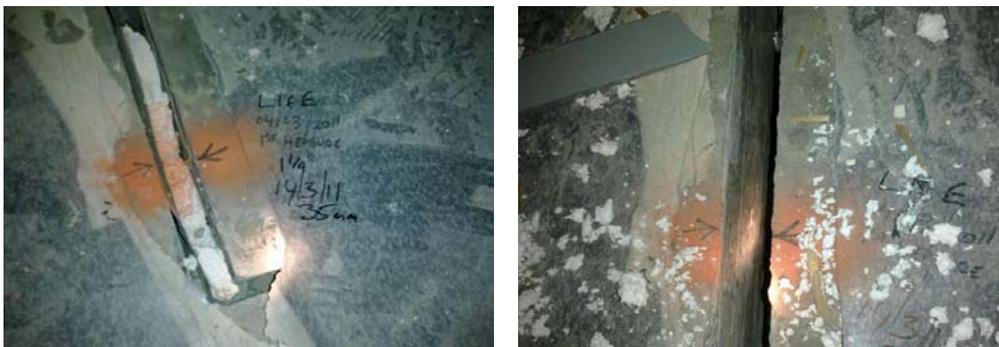
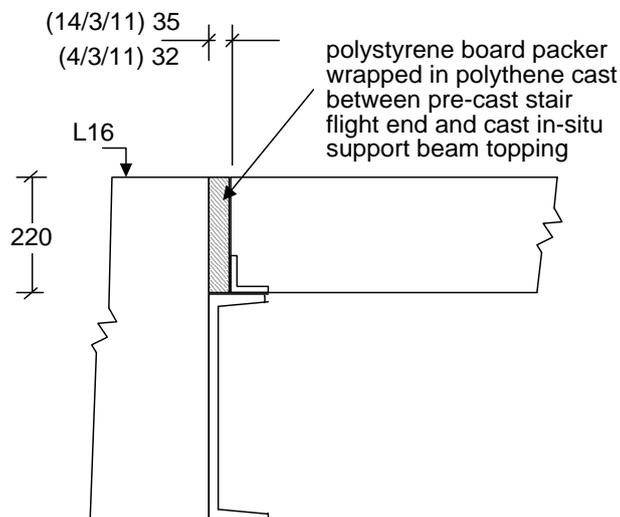
During the Stairwell Examination a 30 mm polystyrene construction packer was found in the gap in one of the remaining stair flights. In that instance it had not been subsequently removed to provide the specified gap shown in the Drawings (Figure 2).

Figure 2 - Level 16 Northeast Exit Level 16 to Level 17 Stair Flight lower landing and support: (photos from left to right): (a) Polythene wrapped polystyrene packer in seismic gap; (b) seismic gap with packer removed during Stairwell Examination showing in-situ casting marks on support beam topping from packer wrapping.

A polythene wrapped polystyrene construction packer was found in this seismic gap. The packer was removed during the Stairwell Examination revealing casting marks on the support slab which was evidence that it had been installed during the original construction of the stairs.

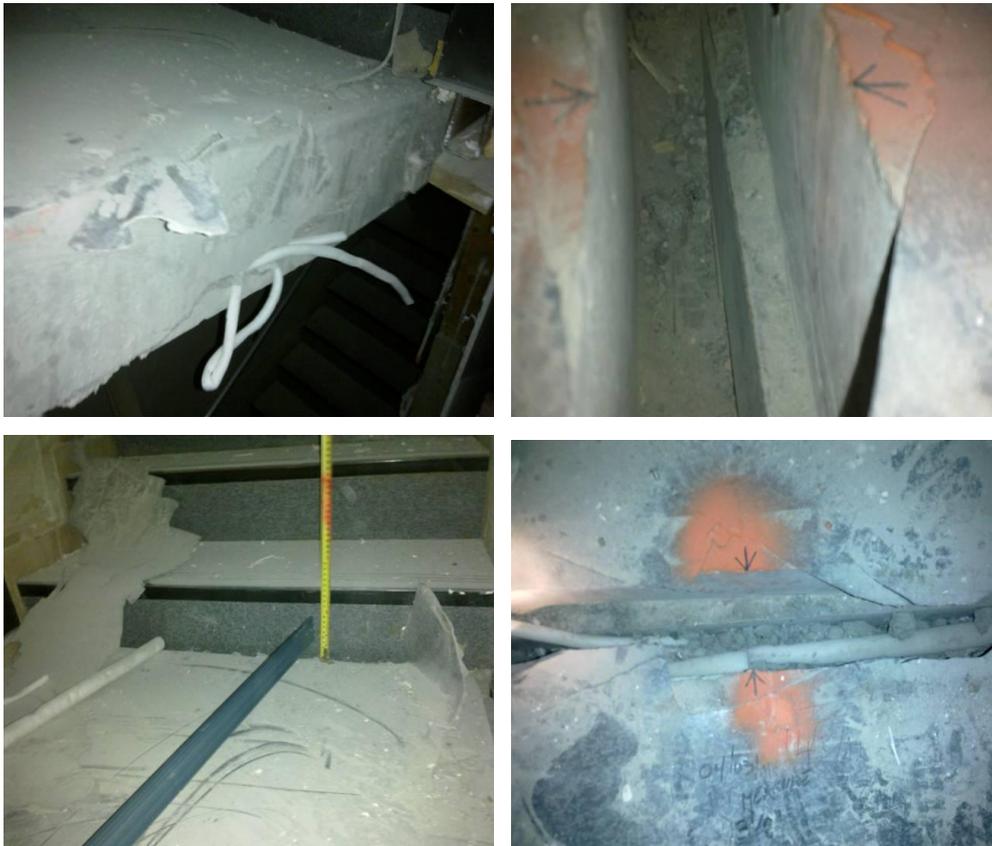
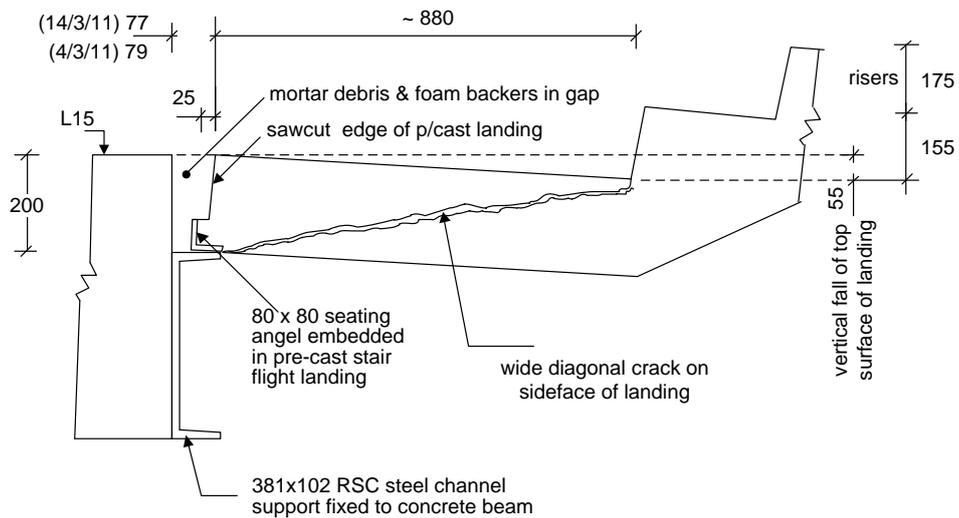
Figure 3 - Level 15 Southwest Exit L15 to 16 stair lower landing and support: (photos clockwise from top left): (a) Diagonal crack in the side face of the stair flight landing with expanded foam tube caught in it; (b) Seismic gap with debris removed showing saw-cut end and ledge at seating angle; (c) Seismic gap measurement with debris; (d) Vertical slumping of the landing at the first riser

- e. The Level 15 to 16 stair flight observed at the Level 15 Southwest Exit had visibly slumped downwards 55 mm at the junction of the lower landing to the first riser (Figure 3). At Level 16 Southwest Exit the lower landing of the Level 16 to 17 stair flight had dropped 25 mm at the junction of the landing with the first riser (Figure 4).

A large wide diagonal crack had formed on the side face of the stair landing. A piece of expanded foam material had been caught in it.

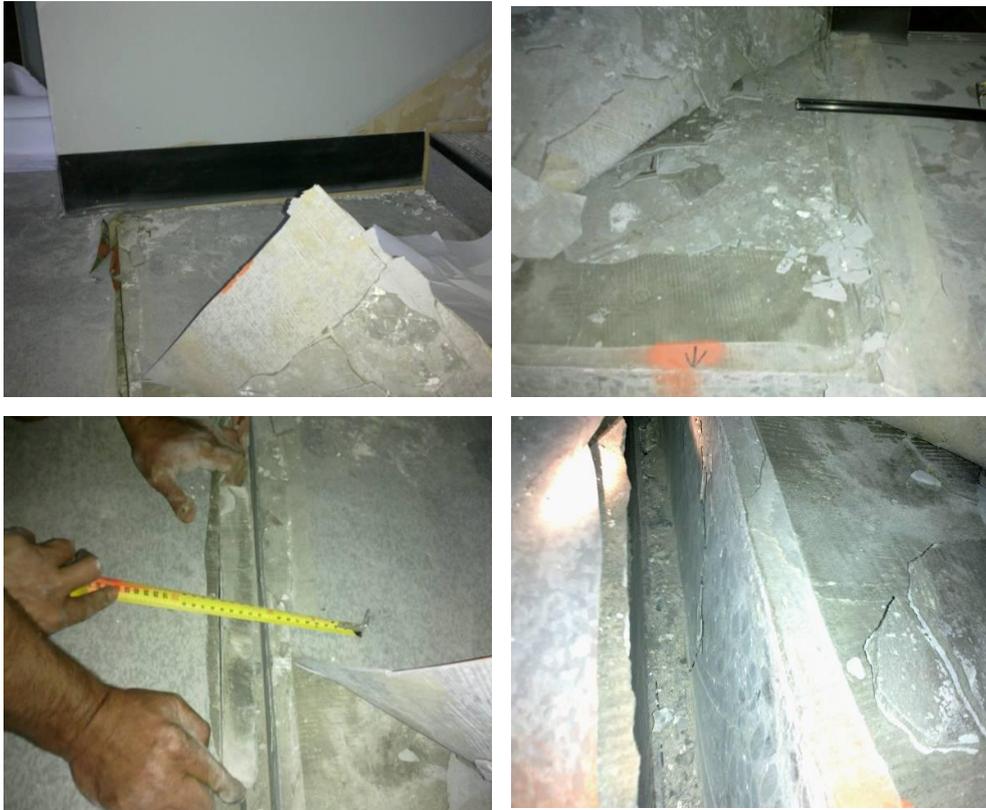
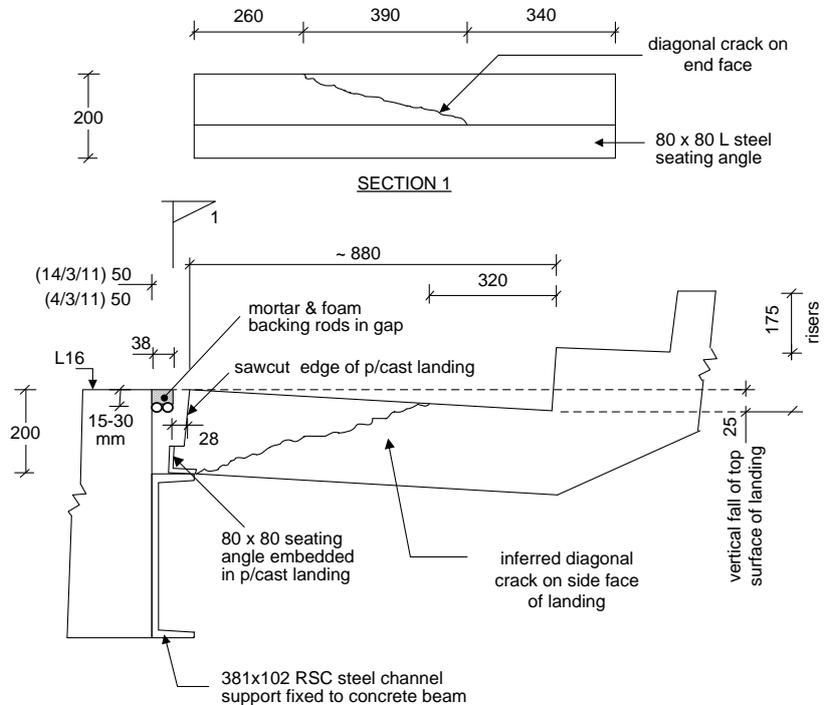
It was also found that the seismic gaps had also been compromised in a number of instances by the installation of a rigid mortar strip up to 30 mm thick seated on expanded foam rods, rather than being filled with flexible sealant as specified in the Drawings (Figure 4).

For an average measured strip thickness of 22 mm the mortar strip would have been able to restrict movement induced actions of up to a maximum of 435 kN while it remained in place (Figure 4).

Figure 4 - Level 16 Southwest Exit Level 16 to 17 Stair Flight lower landing and support: (clockwise photos from top left): (a) 25 mm drop in landing at first riser; (b) diagonal crack along top face of landing; (c) Adjoining diagonal crack in sawn face of precast landing; (d) 38 mm wide mortar remnant held back in original location.

The lower landing had a diagonal crack on the top surface that linked to a matching one on the end face. It is therefore surmised that a corresponding diagonal crack occurred on the side face. But this was obscured by the upper Level 16 to 15 stair flight landing which was still in place (Figure 4).

Mortar remnants up to 30 mm thick and 38 mm wide were found that had been supported by two expanded foam rods over part of the seismic gap. Mortar debris was also found in the gap.

Compressive strength testing of the mortar strip by Opus International Consultants Ltd Christchurch Laboratory, ("Opus Laboratories Christchurch") found it to have an average compressive strength of 20.4 MPa.

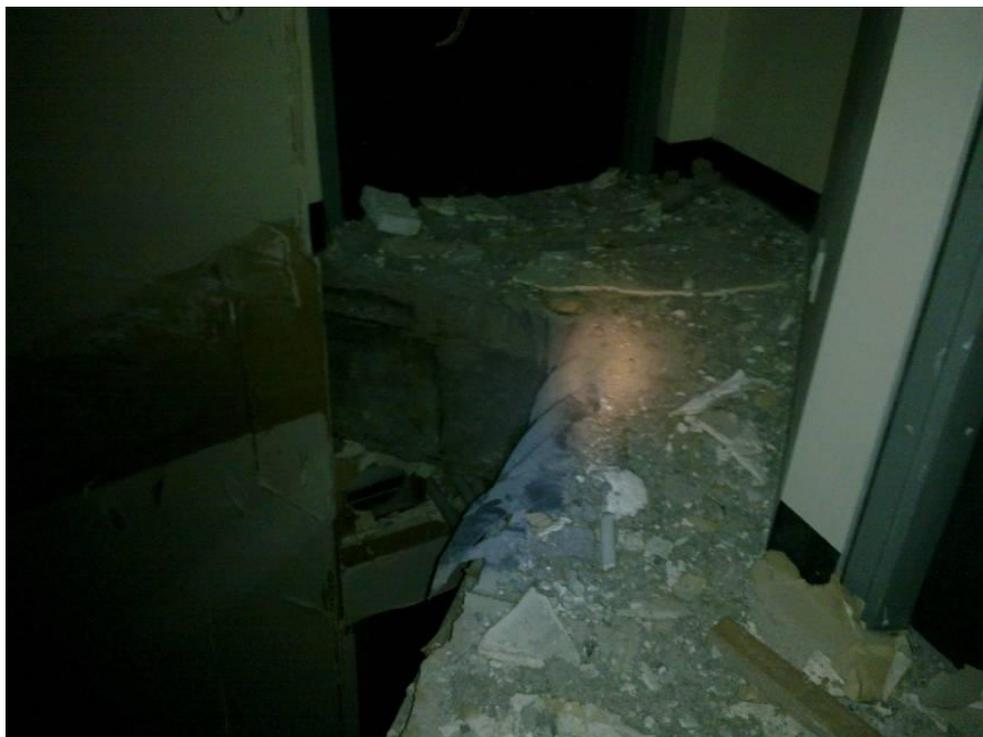
It is likely that this stair collapsed after it was hit by stairs falling from above judging by the tearing pattern in the lino (Figure 6).

Figure 6 - Level 9 Southwest Exit L9 to L8 Stair Flight upper support with fractured D20 reinforcing and lino that appears to have been torn by stairs falling from above

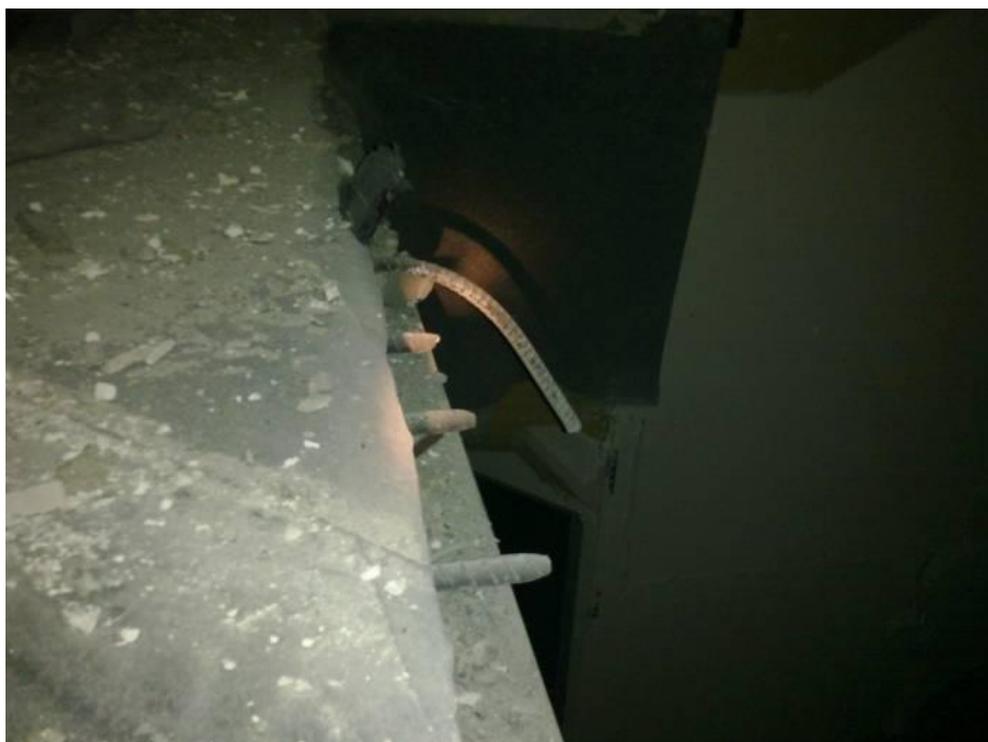
One bar had de-bonded from the precast stair whereas the other five D20 bars have necked and fractured in a similar manner to other landing supports. The remaining D20 bar stubs extend 120 mm out from the supporting concrete beam face (Figure 1).

The stair flight had fallen away. The 381 x 102 RSC support channel appeared to be undamaged.

Figure 7 -Level 12 Northeast Exit L12 to L11 stair flight upper support with one de-bonded bar and five fractured D20 bars extending out from the support beam. The 381 x 102 RSC steel channel is undamaged and continues over to the L12 to L13 lower support.

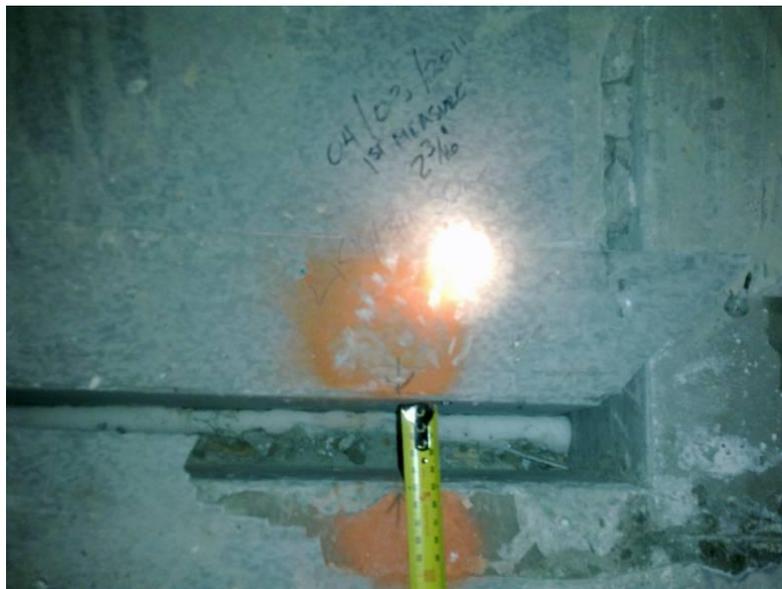
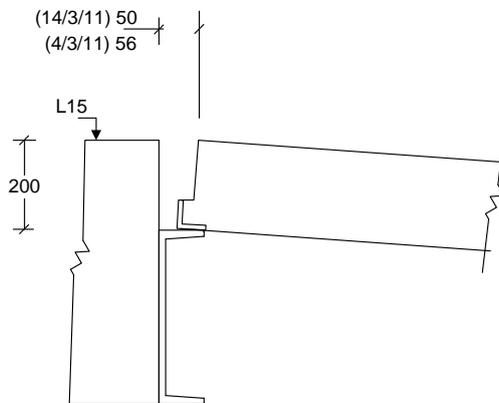
Figure 8 - Level 15 Northeast Exit Level 15 to 16 Stair Flight lower landing seismic gap

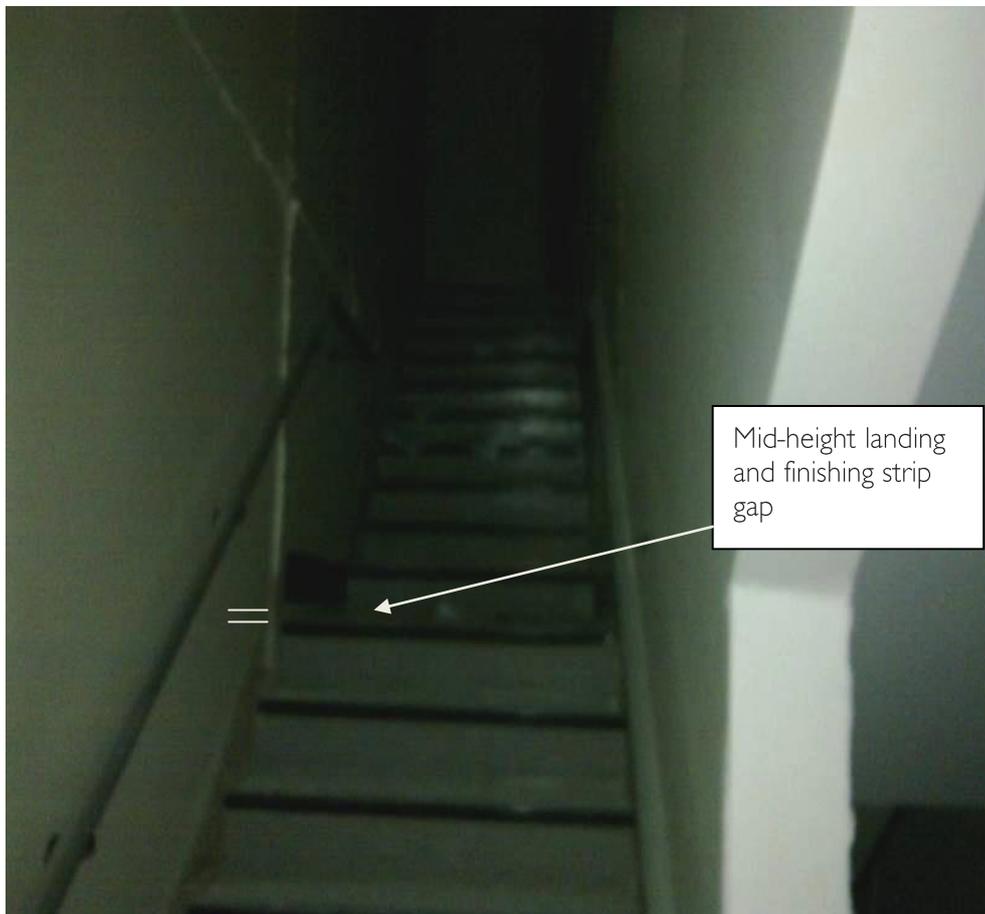
Figure 9 - Level 15 Northeast Exit Level 15 to 16 Stair Flight showing vertical displacement at mid-height landing relative to black finishing strip.

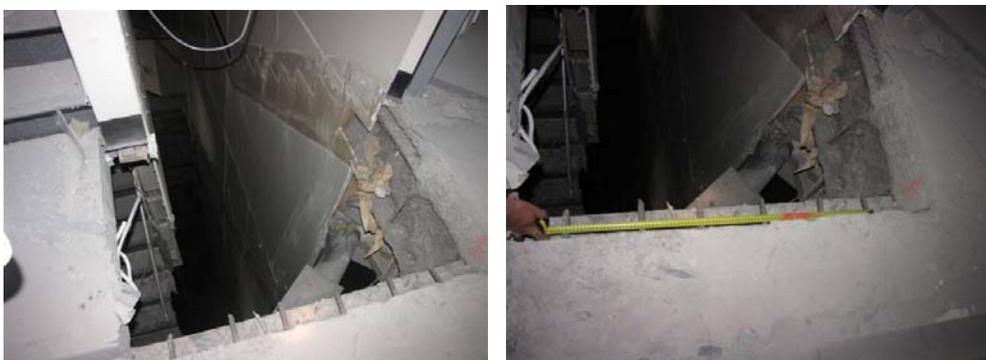
There is a void where the stair flight had fallen away (Figure 10).

Figure 10 - Level 15 Southwest Exit: (photos from left): (a) Remaining Level 15 Southwest Exit L15 to L16 stair flight lower landing with the remaining Level 14 Southwest Exit L14 to L15 Stair Flight able to be seen directly below. All flights below and including the Level 15 Southwest Exit Level 15 to 14 stair flight have fallen away; (b) Fractured reinforcing remnants at upper support of the Level 15 Southwest Exit L15 to L14 flight which has fallen away.

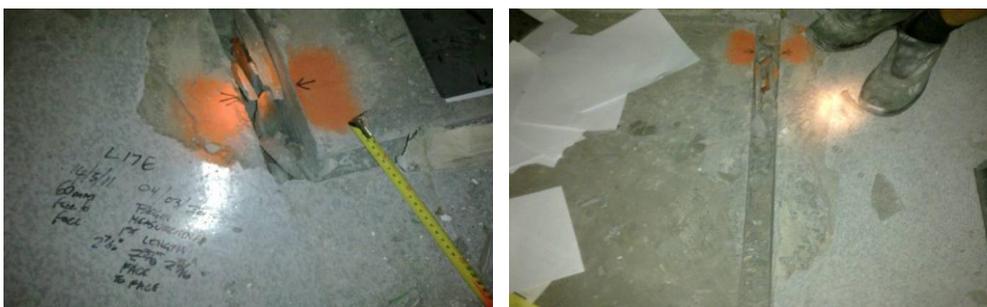
- h. The gap at the top of these saw-cut landings had been filled with up to 30 mm thick of mortar on expandable foam backing rods (Figure 4 and Figure 11). This mortar strip was found by testing to have an average compressive strength of 20.4 MPa. This compromised the ability of the stairs to slide and was evidently strong enough to transmit compressive actions sufficient to cause damage to the landings. Mortar debris was also found in the gaps of some saw-cut landings.

Figure 11 - Level 17 Northeast Exit (left to right) (a) Level 17 to L18 stair flight seismic gap measurement where a portion of the mortar strip had been removed previously by other parties; L17 to L16 stair flight in foreground. (b) Extent of remaining mortar filling of seismic joint of L17 to L18 stair flight.

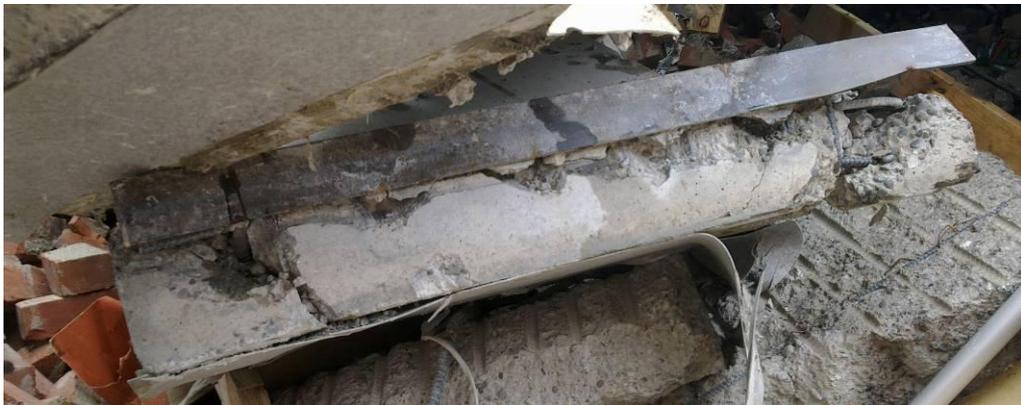
Necked and fractured reinforcing steel at the precast stair upper landings corresponding to that found in the stairwell supports was observed in a number of the stair remnants (Figure 15).

Figure 15 - Upper landing reinforcing steel fractures matching those seen in the stairwell supports. The steel seating angle to the underside and end of the stair flight landing is visible at the top

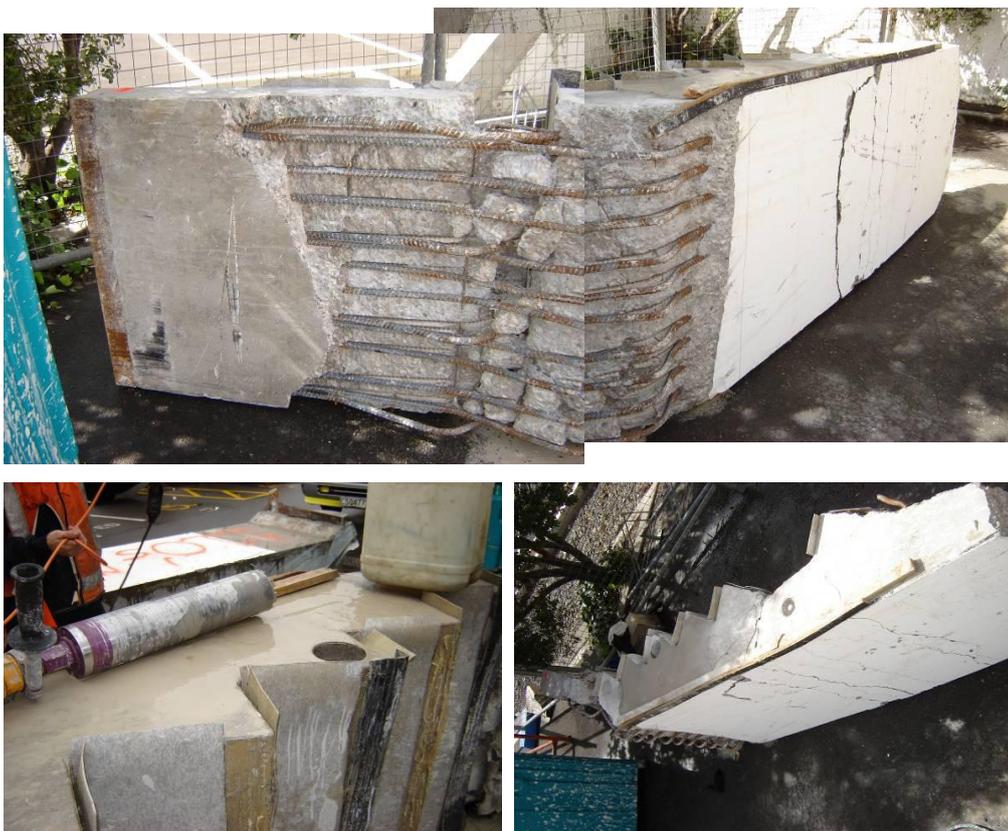
A. UNIT 1

Figure 16 - Unit 1 (clockwise from top): (a) Flexural damage at underside of lower landing; (b) Flexural cracks in underside above lower landing; (c) Concrete core test location in tread.

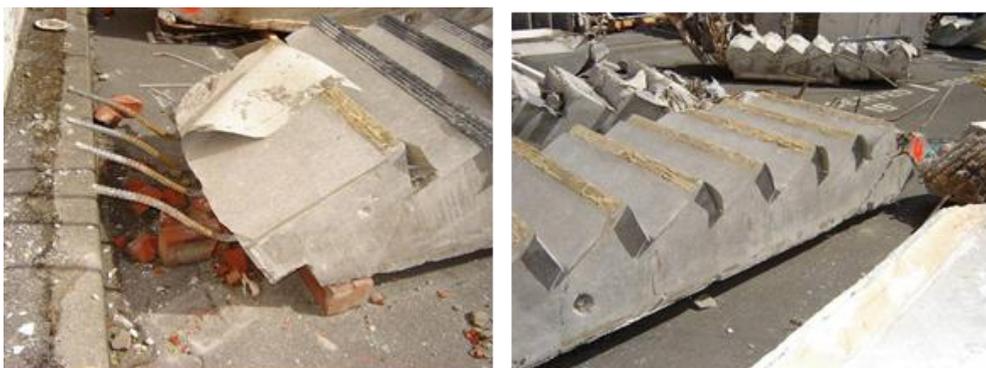
D. UNIT 4

Figure 19 - Unit 4 (left to right): (a) De-bonded top landing bars (possibly from Level 2); (b) Cracks across stair throat at toes of risers.

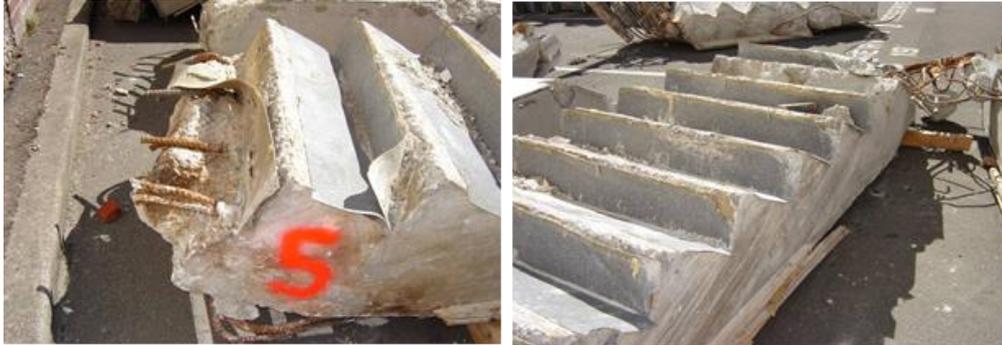
E. UNIT 5

Figure 20 - Unit 5 (Clockwise from top left): (a) Gas cut rebar at mid-height landing; (b) Damaged upper landing.

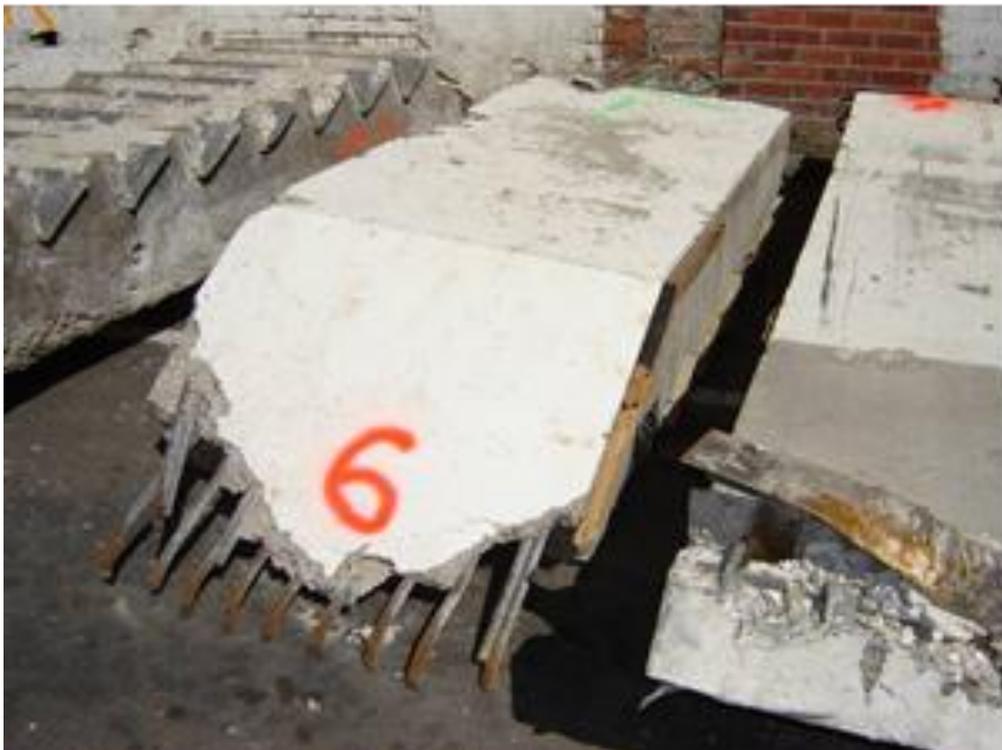
F. UNIT 6

Figure 21 - Unit 6 broken up and gas cut landing. 30 to 50 mm cover to ten D20 reinforcing at underside of lower landing; Unit 7 upper landing to the right.

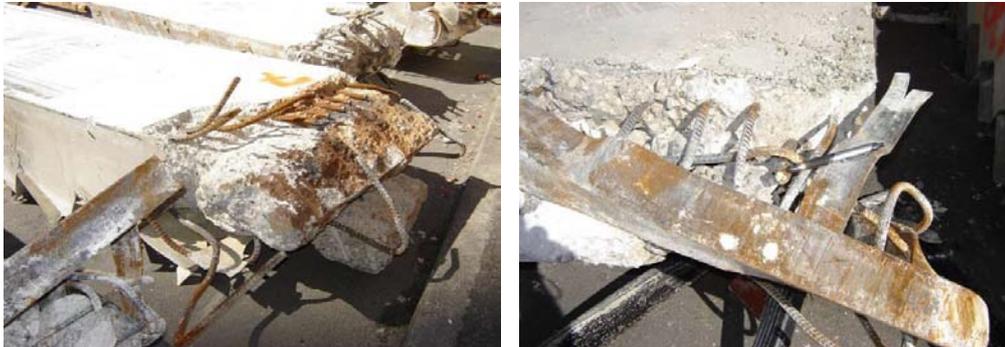
G. UNIT 7

Figure 22 - Unit 7 (left to right): (a) Gas cut mid-height landing bars. Cracks across throat at toe of risers; (b) Damaged upper landing steel seating angle.

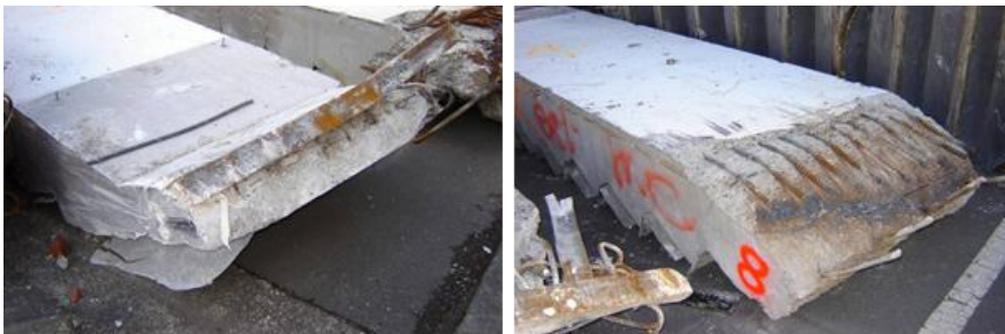
H. UNIT 8

Figure 23 - Unit 8 (left to right): (a) 300 mm long upper landing with 45 degree shear crack and damaged seating angle. Fractured D20 bar remnants in end face; (b) Gas cut mid-height landing b.

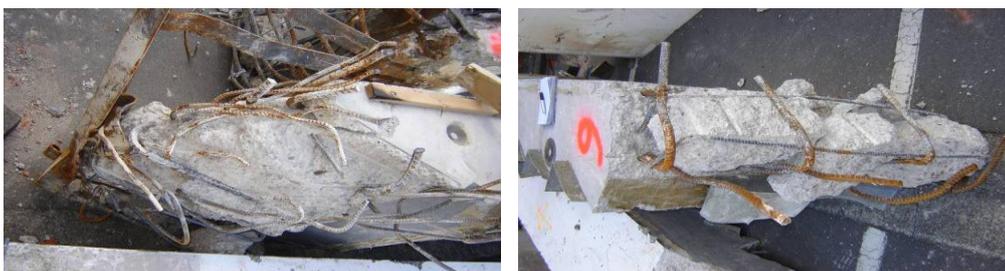
I. UNIT 9

Figure 24 - Unit 9 (Left to right): (a) Damaged upper landing; (b) Damaged mid-height landing with crushed concrete and de-bonded reinforcing.

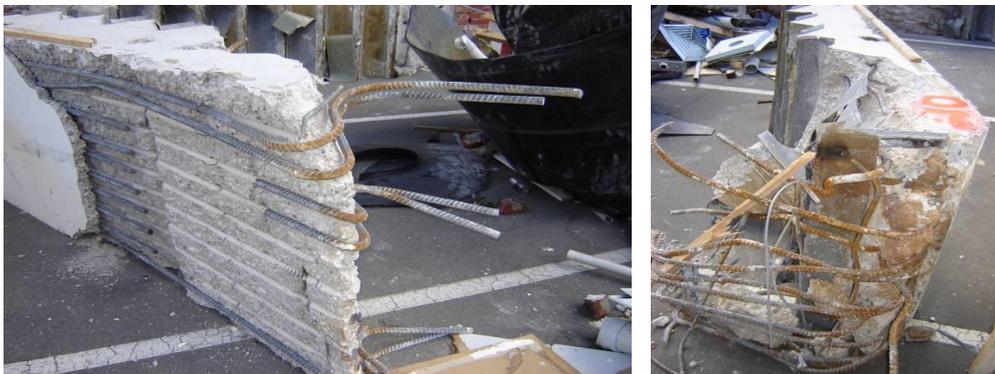
J. UNIT 10

Figure 25 - Unit 10 (left to right): (a) Underside near mid-height landing where D20 reinforcing steel samples were extracted for testing; (b) Damaged lower landing.

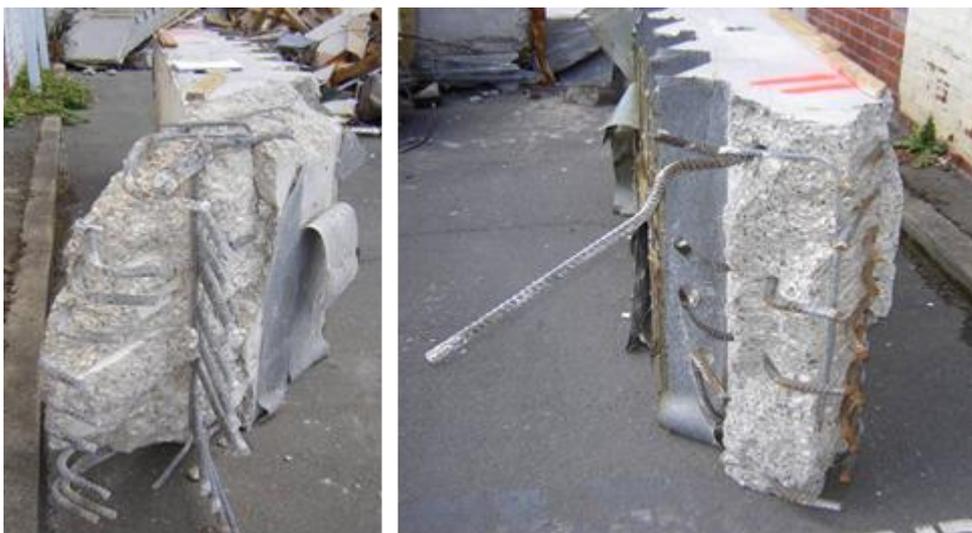
K. UNIT 11

Figure 26 - Unit 11 (left to right): (a) Damaged mid-height landing with hooked bottom bars (bars not gas cut); (b) Bottom rebar gas cut at lower landing junction to first riser.

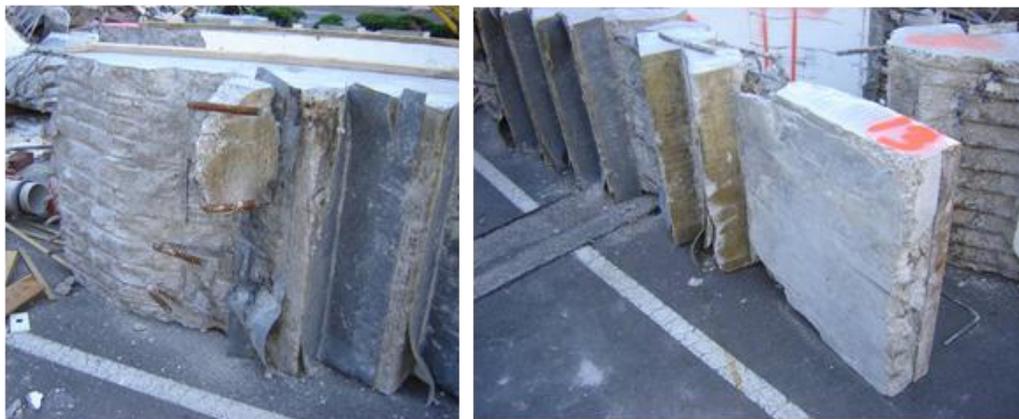
M. UNIT 13

Figure 28 - Unit 13 (left to right): (a) Mid-height landing; (b) Lower landing 600-700 mm long with flexural damage at first riser

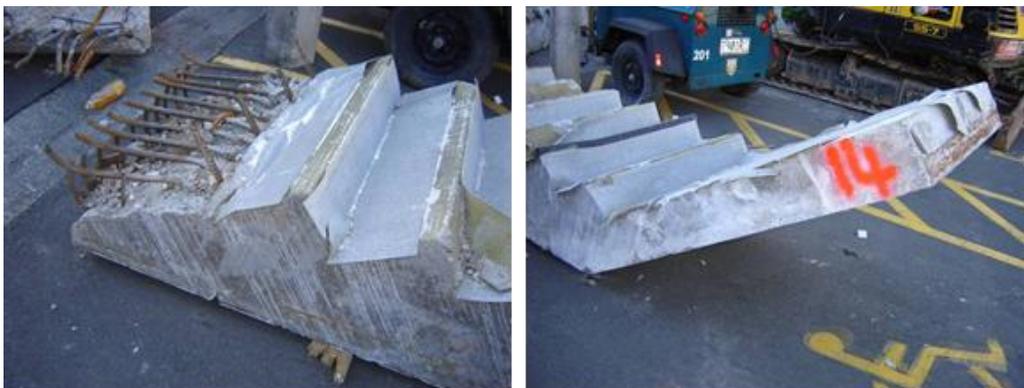
N. UNIT 14

Figure 29 - Unit 14 (Left to right): (a) Mid-height landing bars gas cut; (b) Lower landing intact.

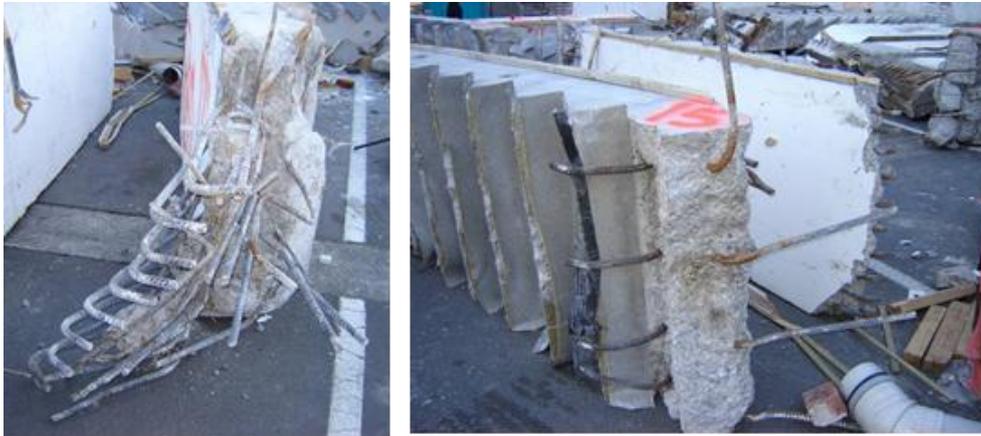
O. UNIT 15

Figure 30 - Unit 15 (Left to right): (a) Damaged mid-height landing with hooked bottom bars; (b) Gas cut bars at lower landing which has broken away near first riser.

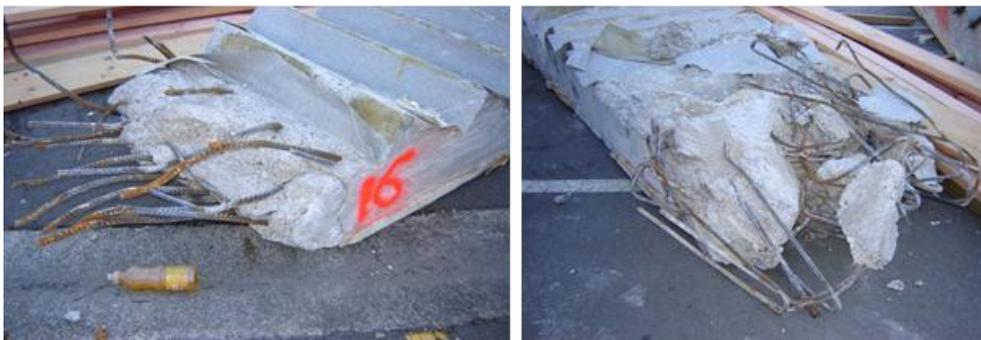
P. UNIT 16

Figure 31 - Unit 16 (left to right): (a) Mid-height landing bars gas cut; (b) Damaged upper landing.

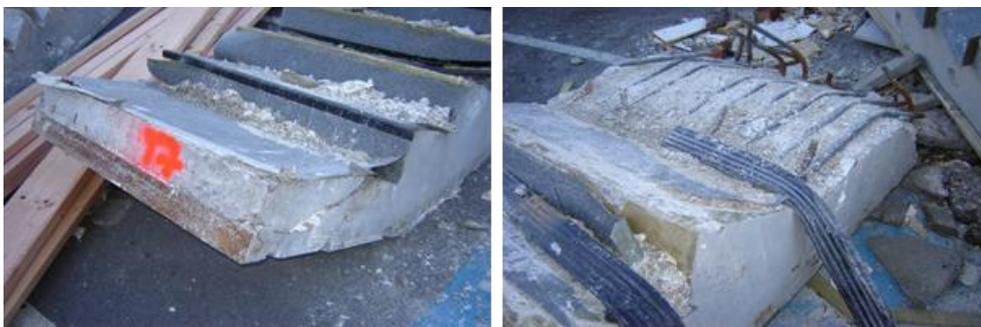
Q. UNIT 17

Figure 32 - Unit 17 (Left to right): (a) Lower landing with compression support lateral impact shear cracking and saw cut end; (b) Mid-height landing ten D20 bottom bars bent and developed to underside of second riser below landing exposed, four D20 top bar stubs visible.

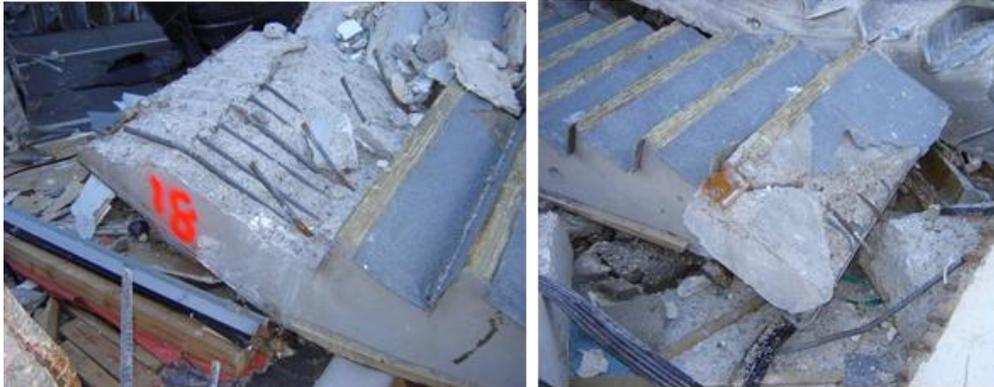
R. UNIT 18

Figure 33 - Unit 18 (Left to right): (a) Gas cut bars at mid-height landing. No construction joint apparent in side face indicating stair was precast as one unit; (b) Cut support bars at upper landing.
