CTV BUILDING

CTV BUILDING COLLAPSE INVESTIGATION
FOR DEPARTMENT OF BUILDING AND HOUSING
25TH JANUARY 2012

Report Issue Date: 27 January 2012

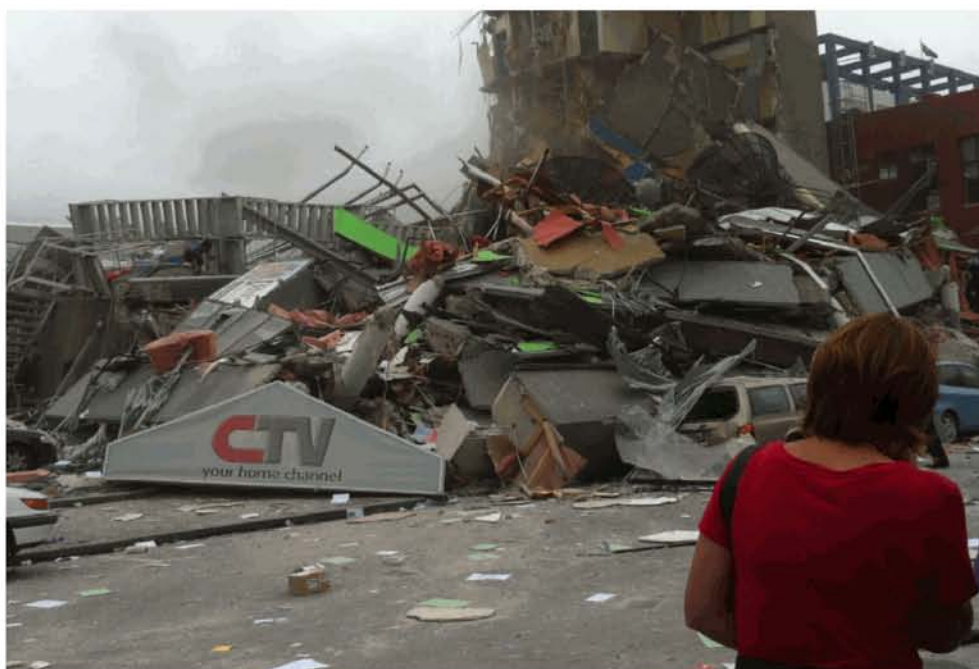
Figure 1 - The CTV Building seen from the corner of Cashel and Madras Streets immediately after the collapse, and prior to debris being shifted and removed. The escape stair on the collapsed South Wall can be seen laying on top of the rubble. Fractured Line F columns and precast concrete Spandrel Panels have fallen onto cars parked in Madras Street. A portion of floor slab from in front of the lift doors at Level 5 hangs precariously from the North Core in the distance (MSN).

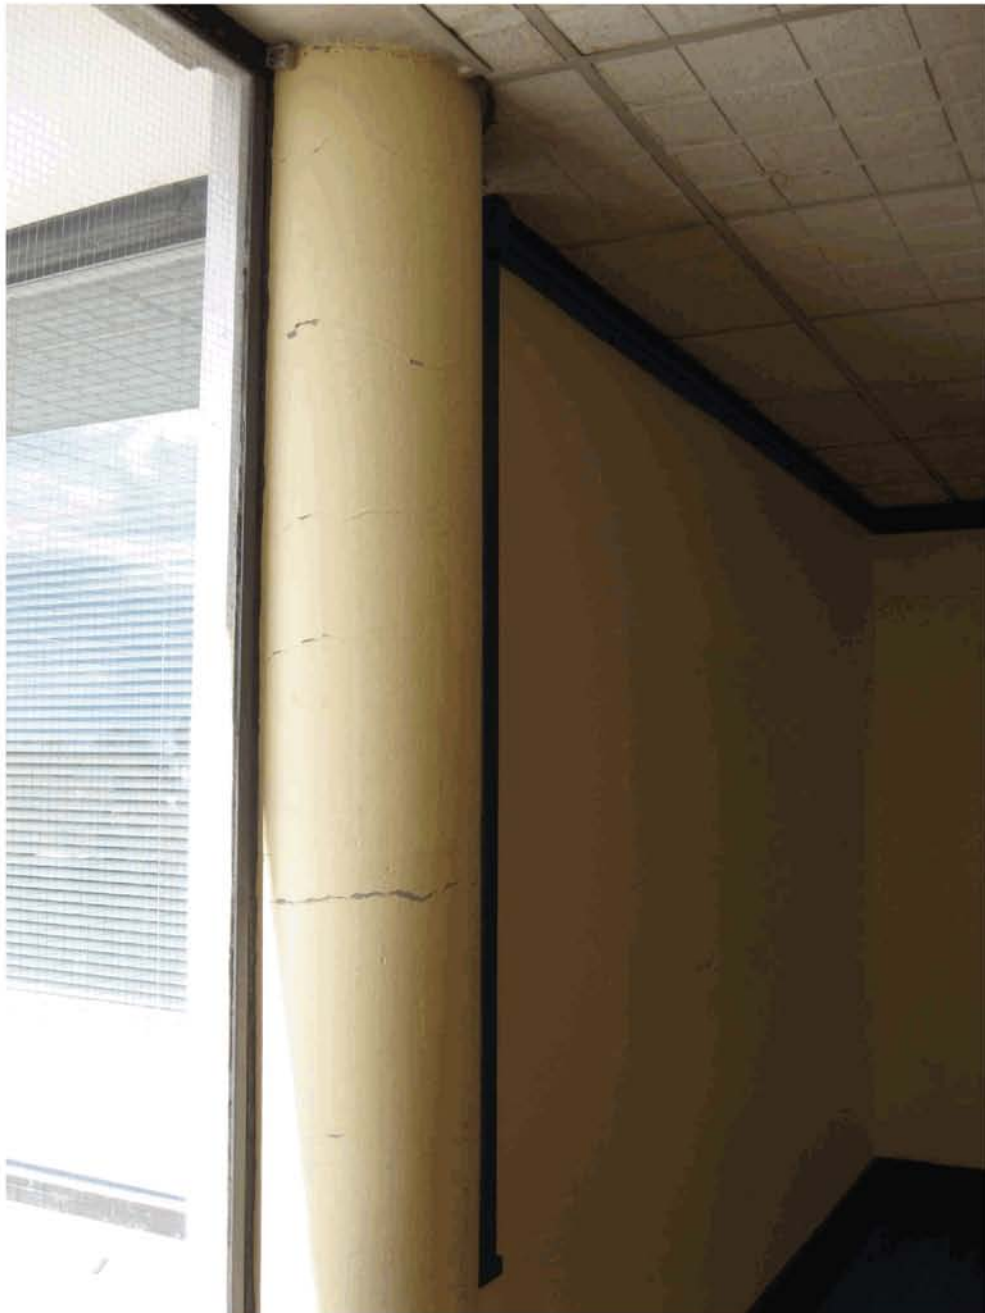
The cracking to the Level 6 columns may have been an indication of interaction of the columns with the Spandrel Panels in the September Earthquake.

Figure 22 - Level 6 400mm diameter columns Column 4 D/E outside lift with horizontal cracking.

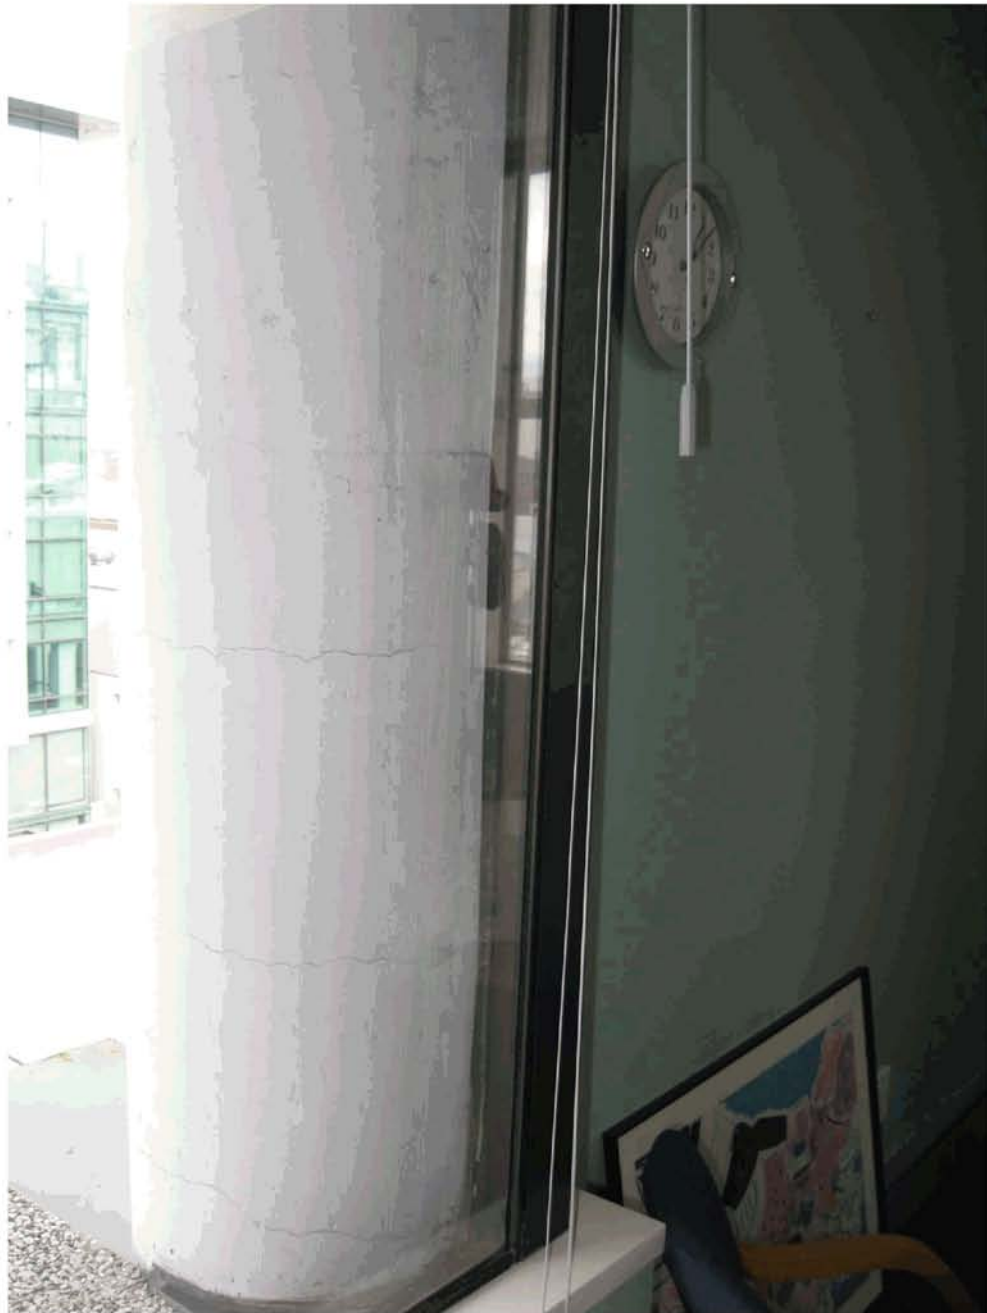
Figure 23 - Level 6 400mm diameter Column on Line I/A-B with horizontal cracking.

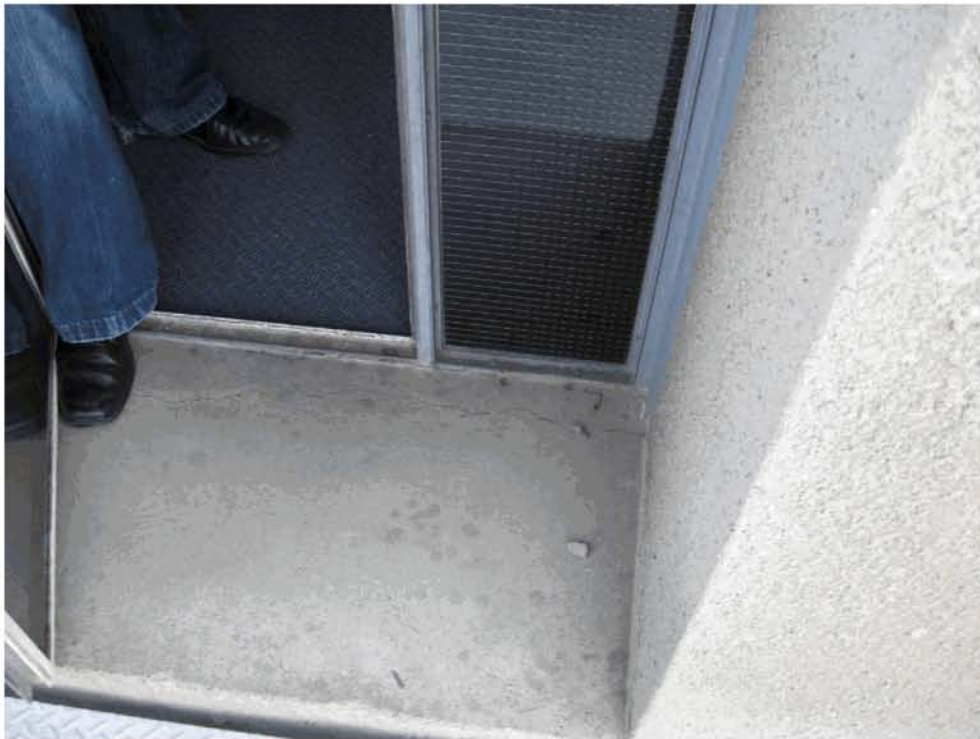
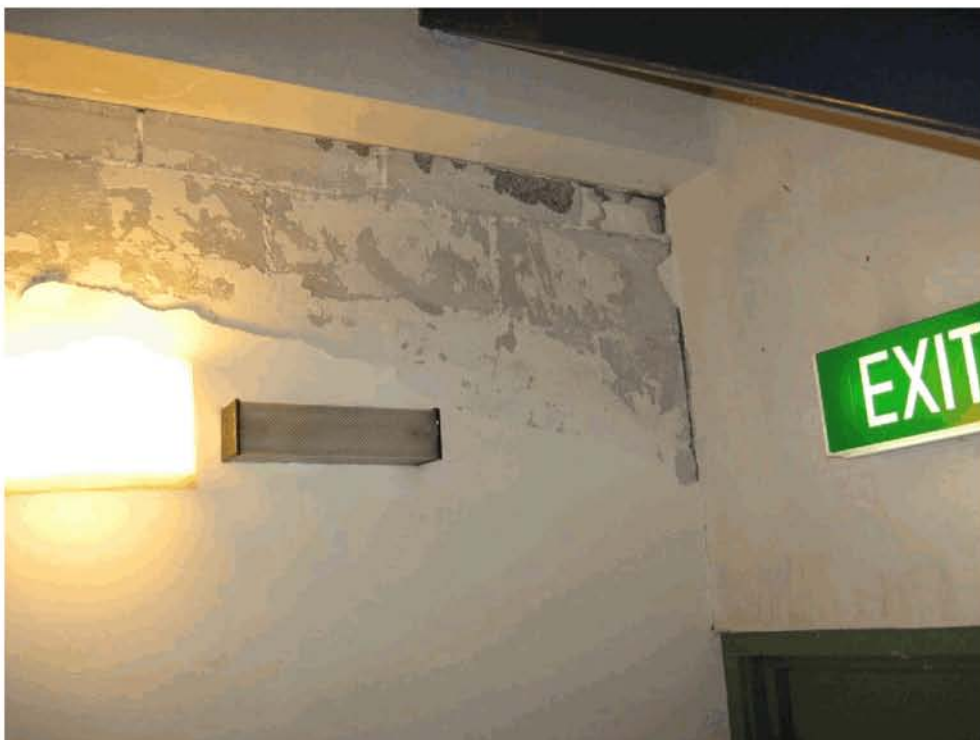
Figure 24 - (Top to bottom) (a) Fine cracking in floor at junction with South Wall; (b) Spalling of plaster finishes on internal masonry in-fill wall on Line 4 in front of stair well.

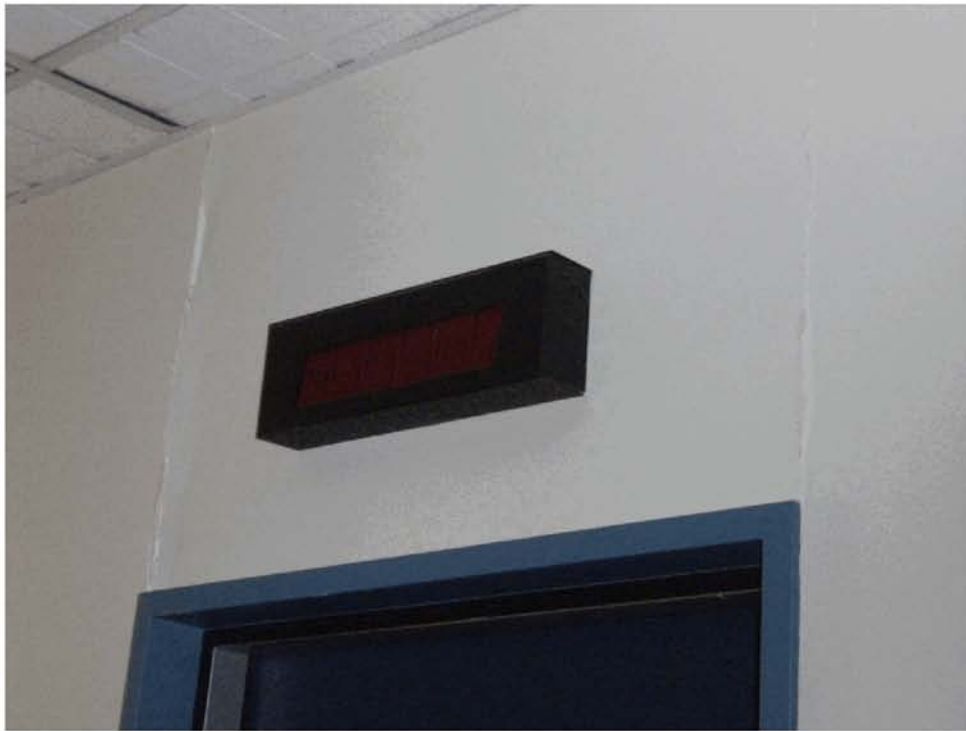
Figure 25 - Damage to wall Linings after 4 September 2010 Earthquake.

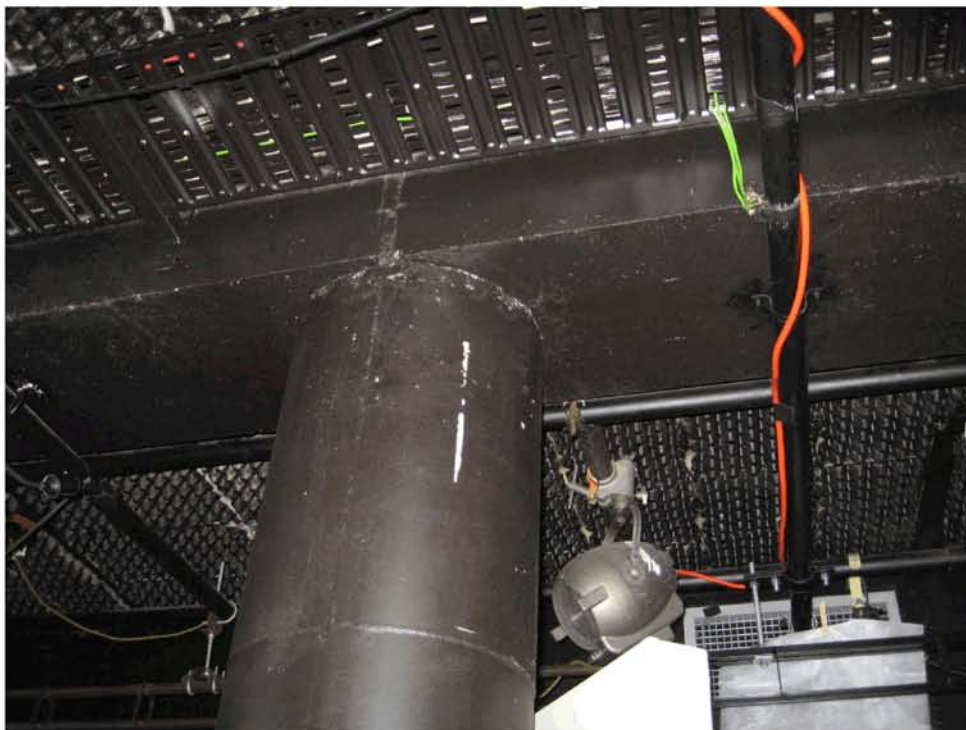
Figure 26 – Internal 400mm diameter column and beam after 4 September 2010 Earthquake. No visible cracking evident. A horizontal circumferential formwork mark can be seen approximately 600 mm down from the underside of the beam indicates it was a Level 1 column which were constructed using extensions to the formwork shutters.

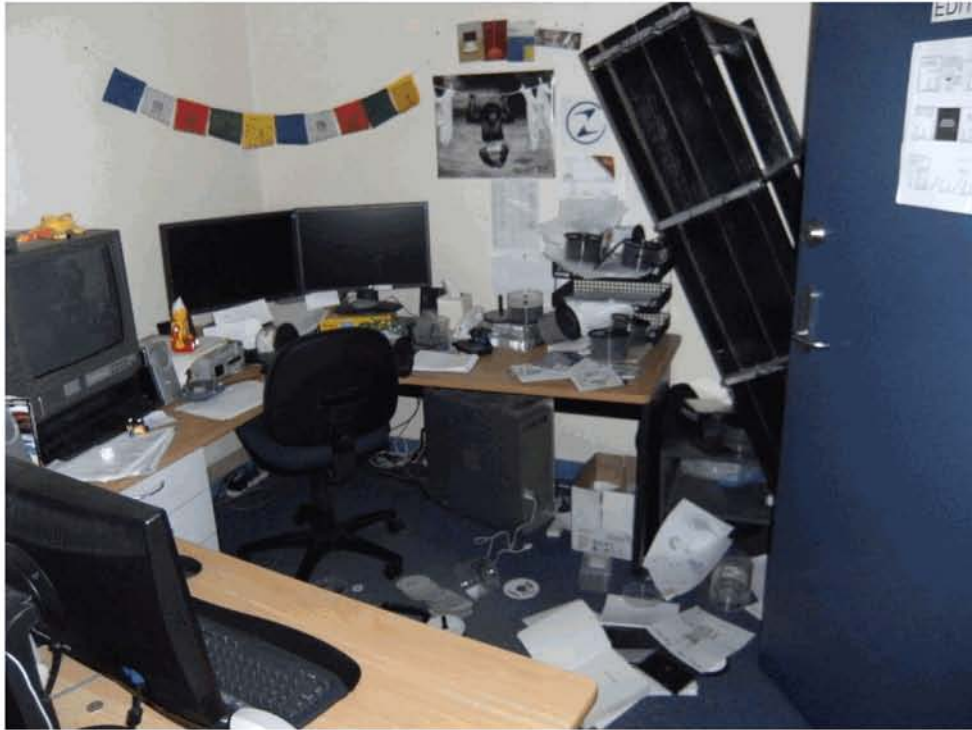
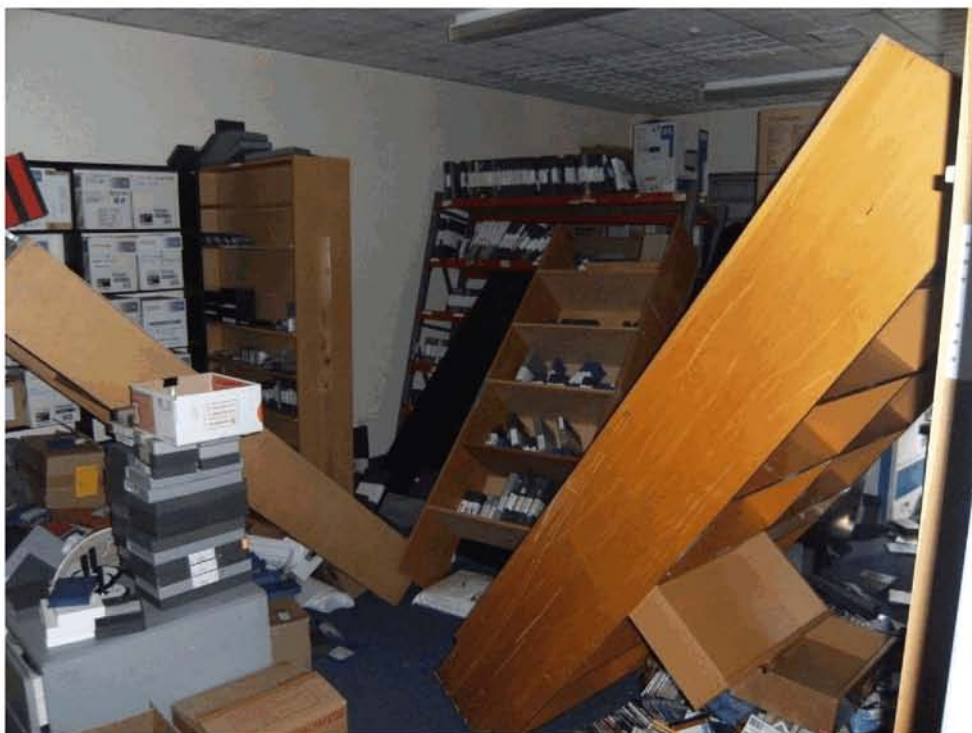
Figure 27 - Damage to office furniture on Level 2 after the 4 September 2010 Earthquake.

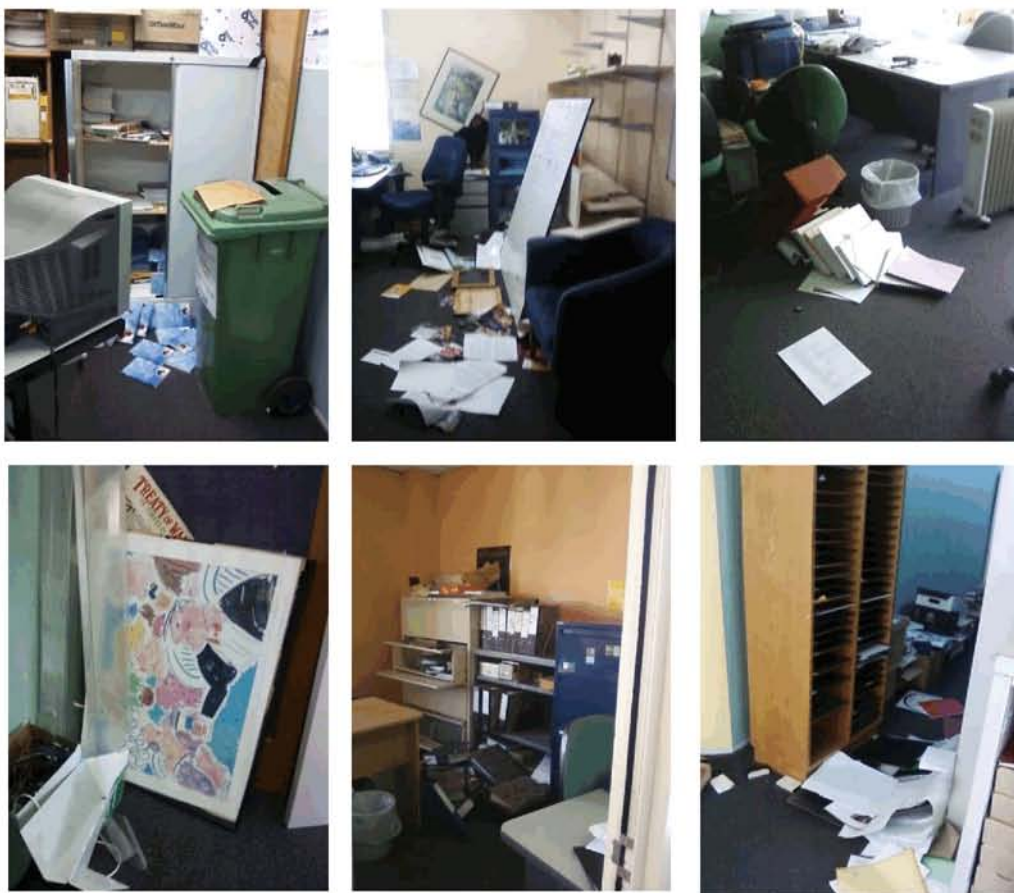
Figure 28 - Damage after 26 December, 2010 Aftershock on Level 6 of CTV Building (clockwise from top left) a) Cabinet door had opened but hadn't fallen over (Line 3/B-C); b) As it was found, except that the filing cabinet had been stood back up (Line 2/A-B); c) Oil heater had been righted. Two filing cabinets had fallen to the floor; (Line 1/B-C) d) The cubby-hole unit had not emptied of papers in the earthquake on 4th September. However in December it had fallen against the corridor wall towards Cashel Street. It had been righted before the photo was taken. (Line 2/B-C) E) The shelves and filing cabinets had gone down, but had been righted before the photo was taken (Line 4/A-B). F) The painting had fallen from the wall. (Line 1/A-B).

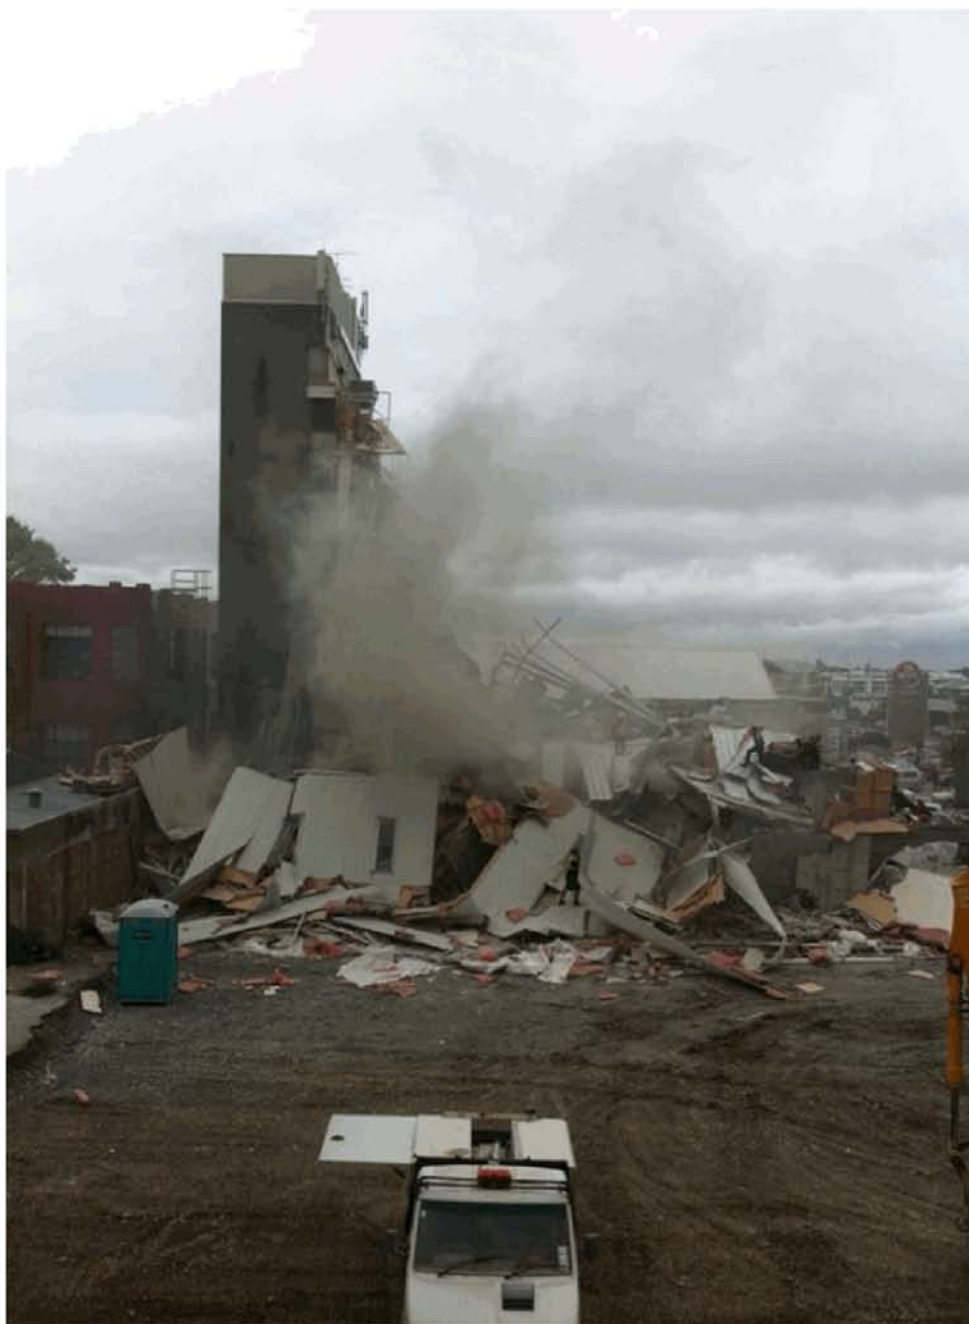
Figure 30 - View of the entire west wall on Line A from Les Mills immediately after collapse before debris removal commenced. No signs of liquefaction can be seen on the adjacent vacant site. Smoke from the fire can be seen beginning to rise. Some of the upper light weight external panels between Levels 4 and 6 have fallen northwards, possibly as a consequence of the South Wall falling north towards them. Large diagonal cracks can be seen in the Level 2 to 3 masonry infill wall at the right hand end that has fallen onto the vacant site. Roof steelwork can be seen in mid-picture.

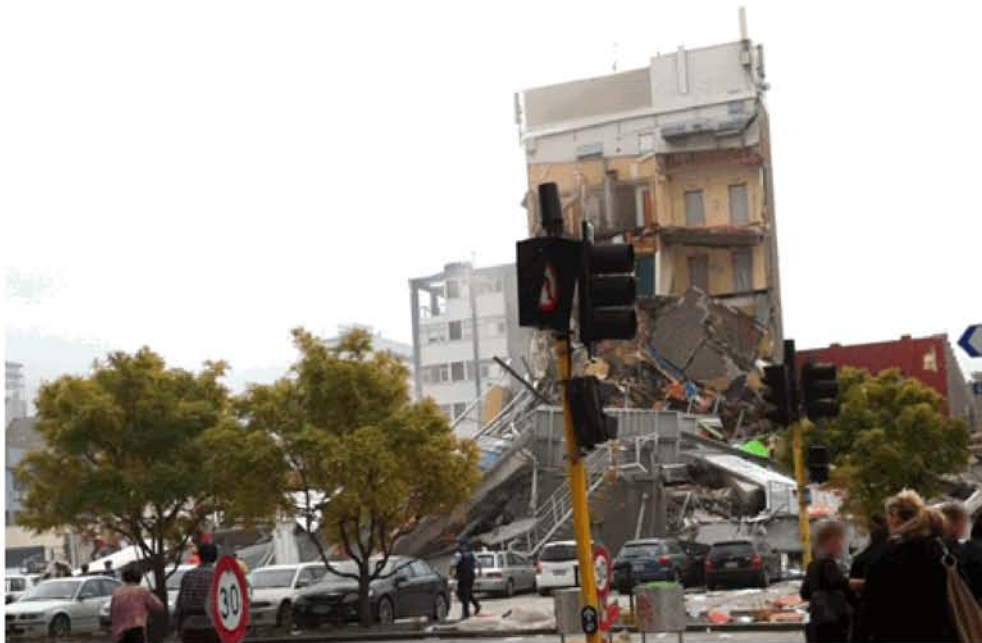
Figure 31 - Cashel St. south face with North Core tower in background immediately after collapse and prior to the fire starting. The cars in the car park on the south face were largely undamaged. The white escape stair that was attached to the South Wall can be seen still attached to the wall as it lay on top of the collapse debris.

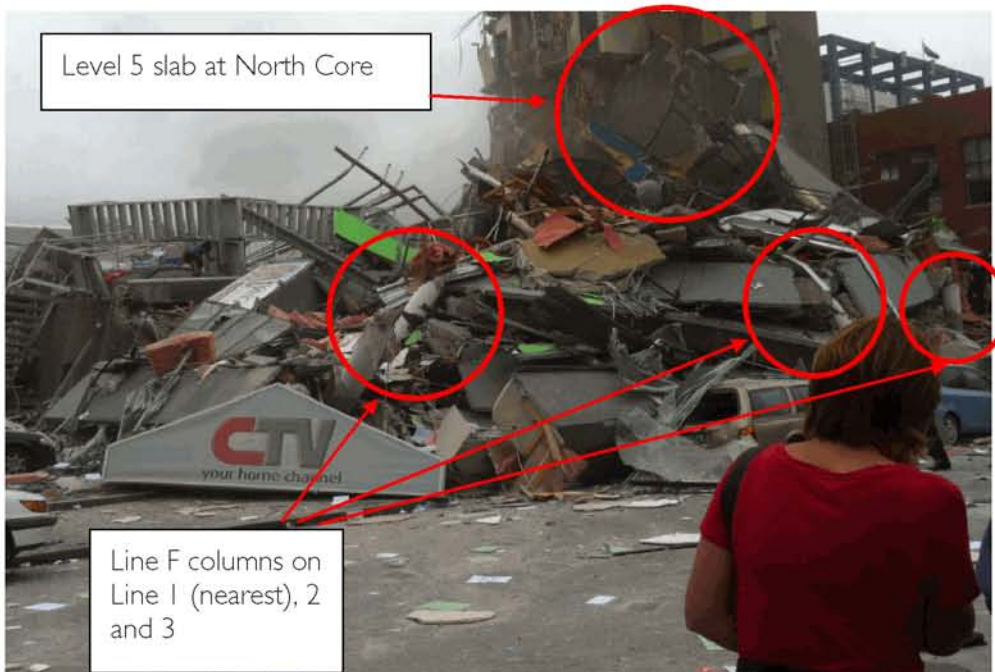
Figure 32 - Corner of Cashel and Madras Streets looking towards North Core. Fractured columns and fallen Spandrel Panels are visible (MSN photo).

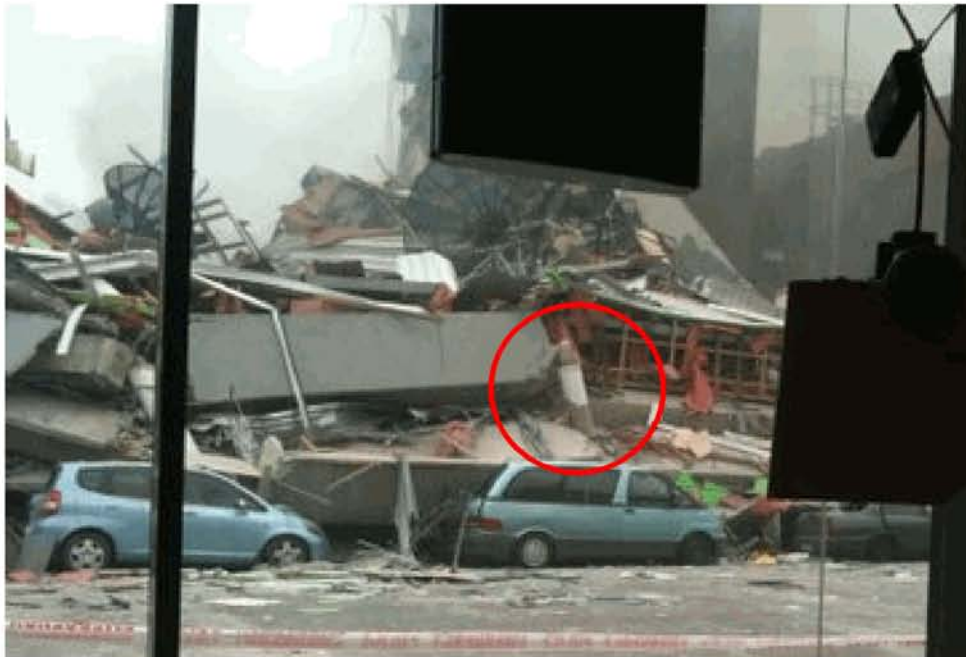
Figure 33 – View looking west across Madras Street. A Line F/3 column is highlighted showing conical fracture in the painted portion, above unpainted portion which had been enclosed by Spandrel Panels.

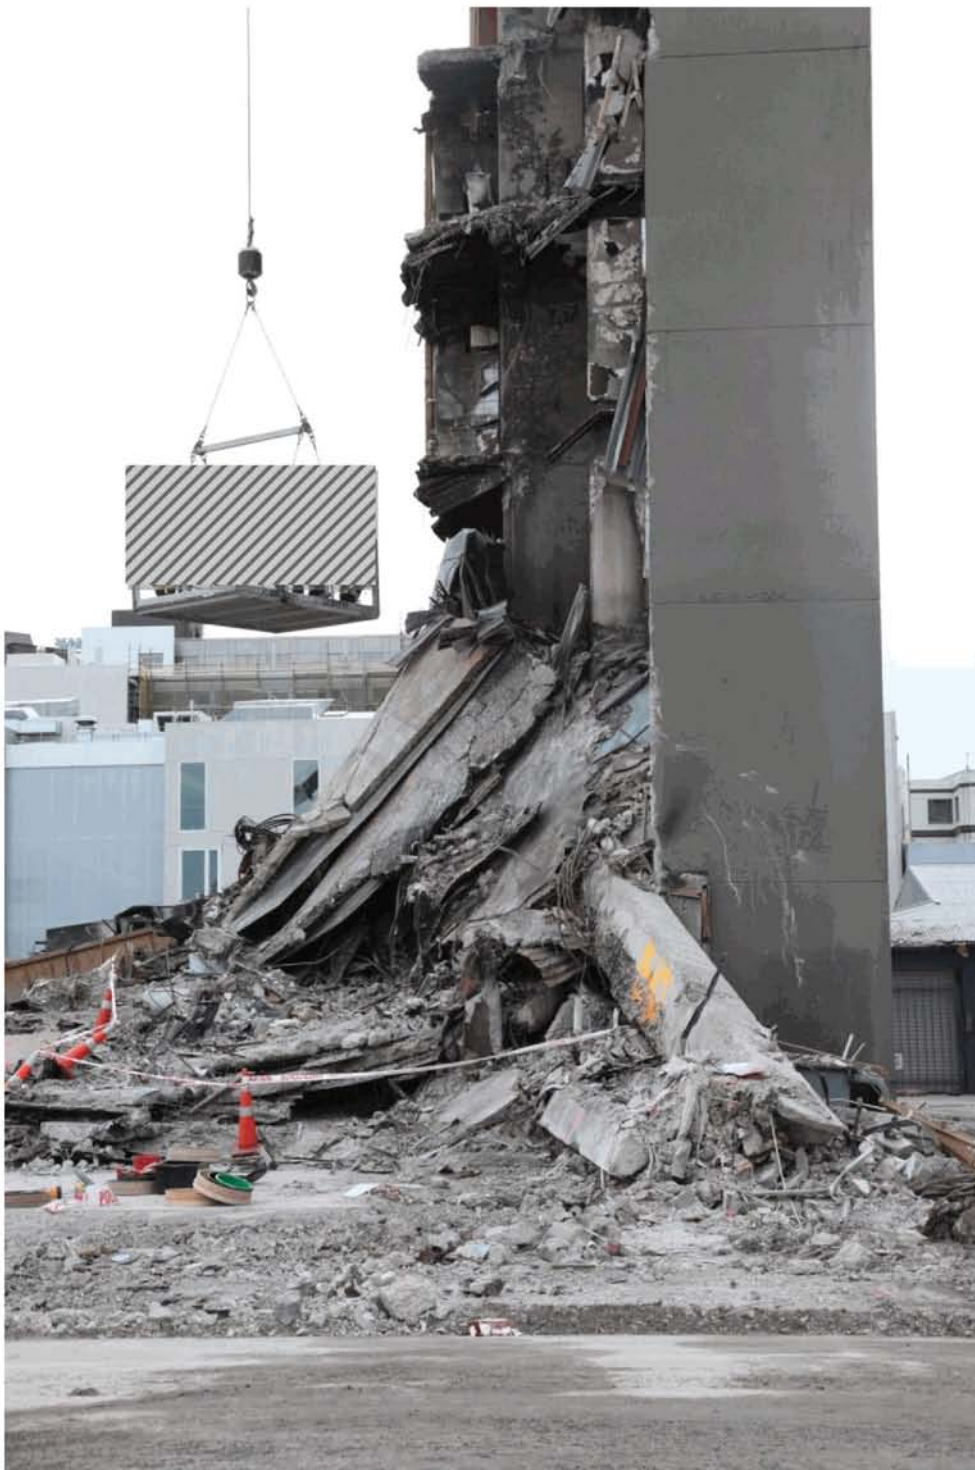
Figure 34 - North Core with Level 4 and 3 slabs laying diagonally against it.

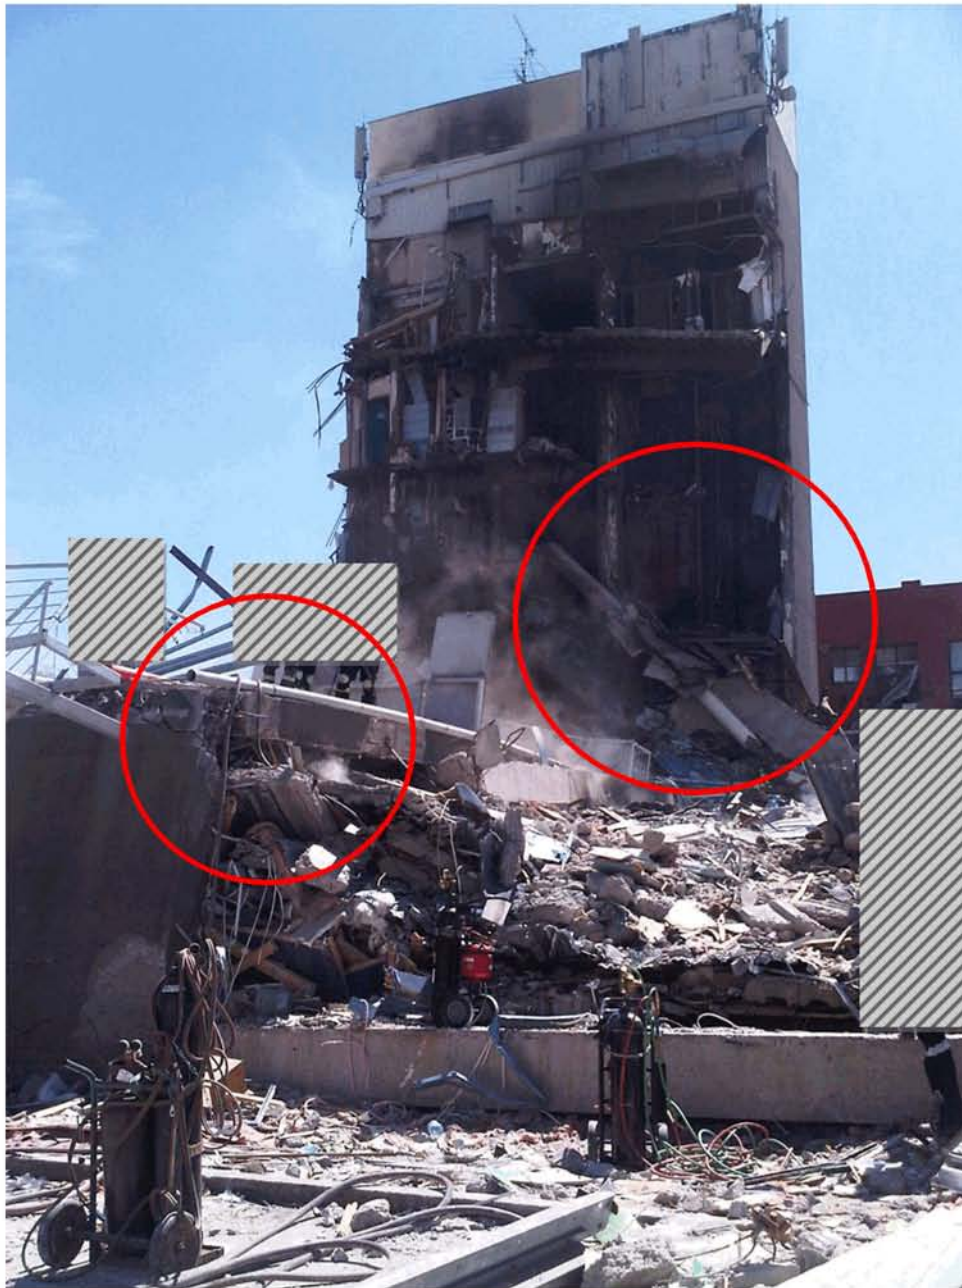
Figure 36 - View from Cashel Street, east side with Line 1 South Wall lying on debris at left; end profile of floor slabs laying on top of each other in foreground; A portion of floor slab highlighted, appears to be still in contact with the South Wall at Level 2 and may have prevented the South Wall breaking over at ground level. The collapsed column on Line 4-D/E at the North Core in the background is also highlighted.

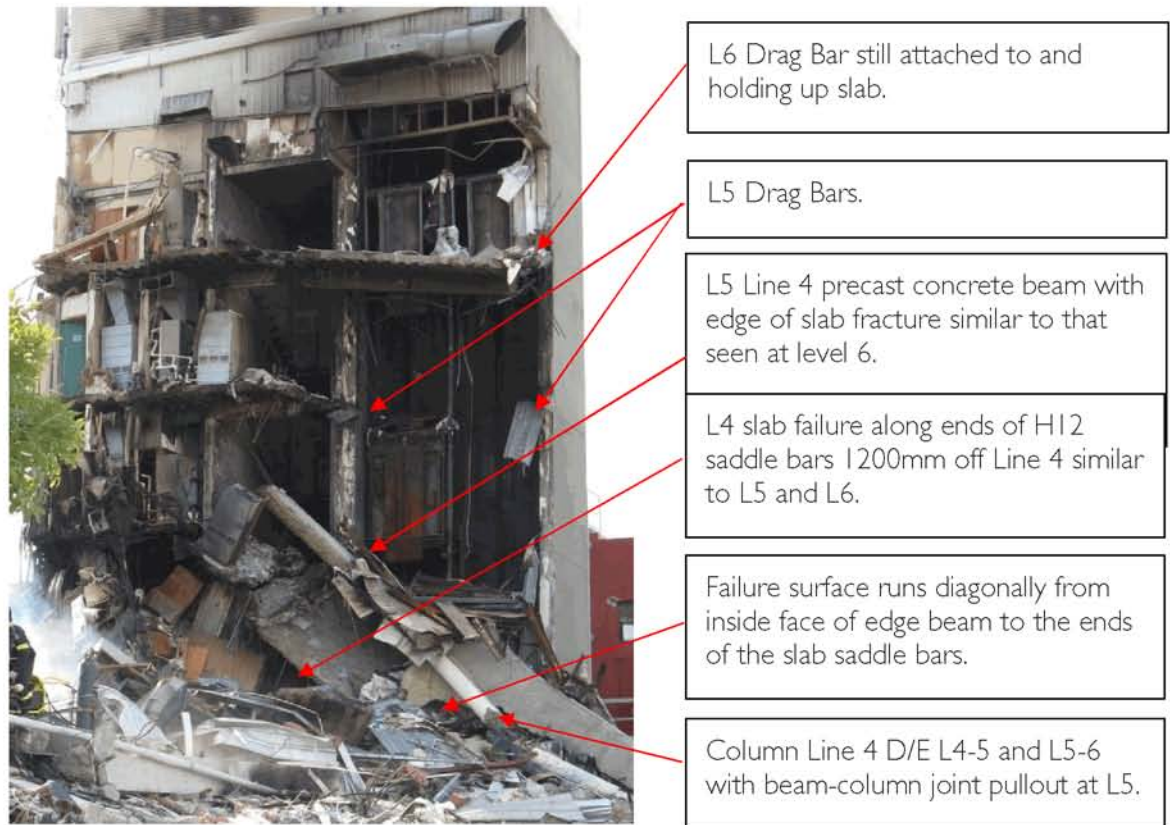
Figure 37 - Failure of slabs adjacent to the North Core.

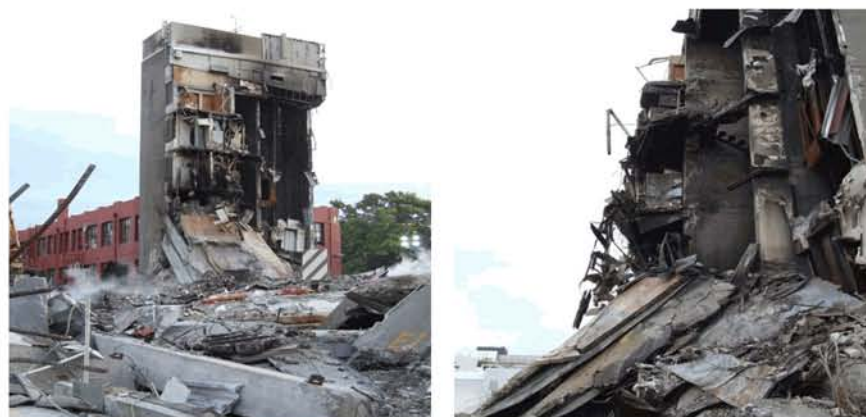
Figure 38 – View of North Core showing Level 4 slab lying diagonally on top of Level 3 slab. This indicates that the Level 3 and 4 slabs lost their vertical support on Line 3 prior to breaking away from the North Core.

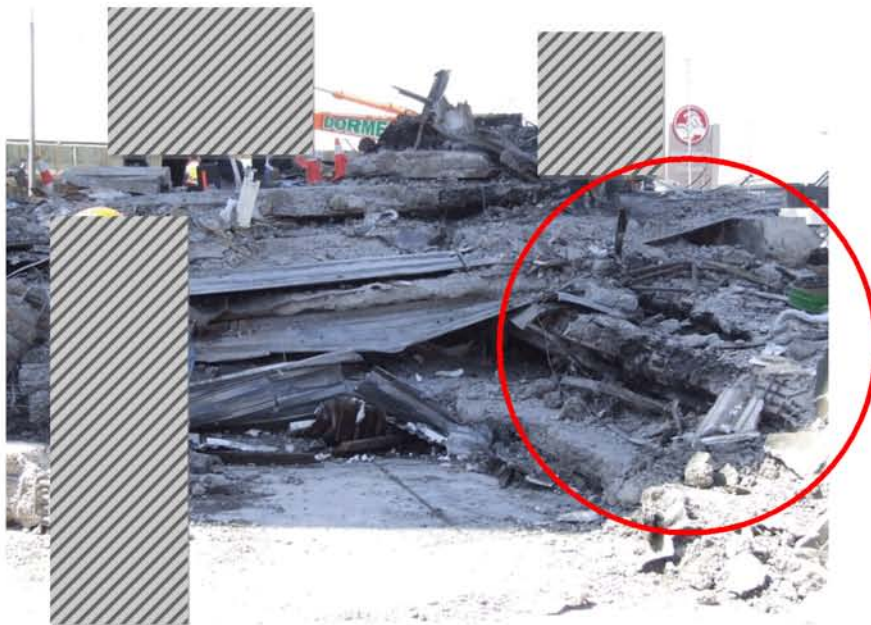
Figure 39 - Line 2 beams highlighted laying rotated northwards. This appears to indicate that the Line 2 columns collapsed prior to the slabs breaking away from the Line 1 South Wall and frame.

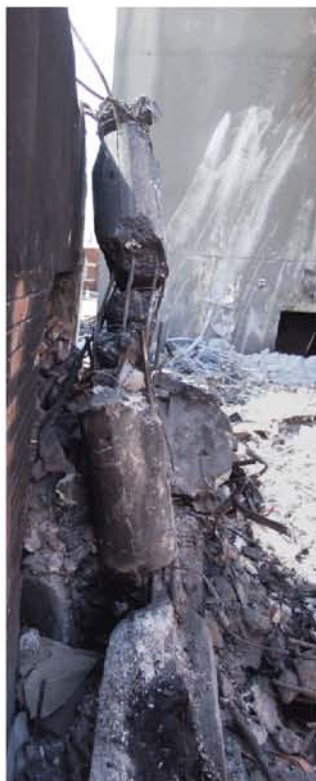
Figure 40 - Line 4 / B column with precast log beam in foreground and shell beam at rear. The column may have broken its back on a precast concrete Spandrel Panel and sustained head damage during the collapse.

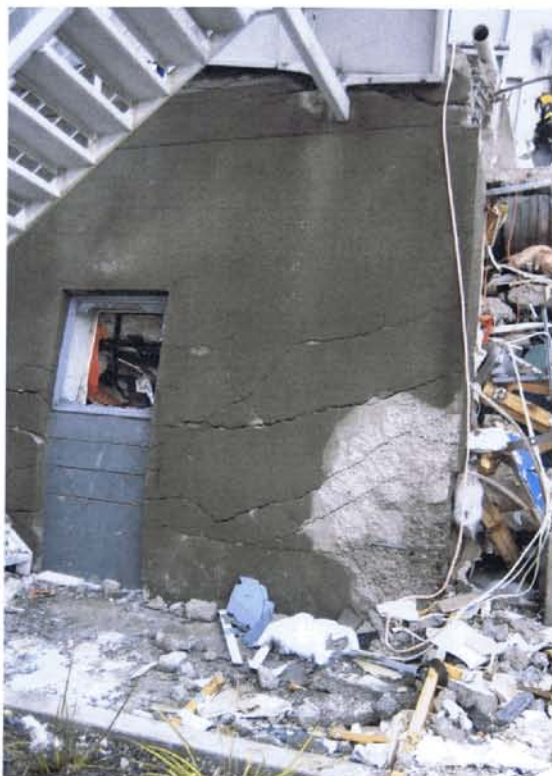
Figure 41 – Angled fan-like flexural cracking on the South Wall in conjunction with spalling on the outside face at the east end. This indicates that the South Wall may have suffered flexural / compressive damage prior to the collapse.

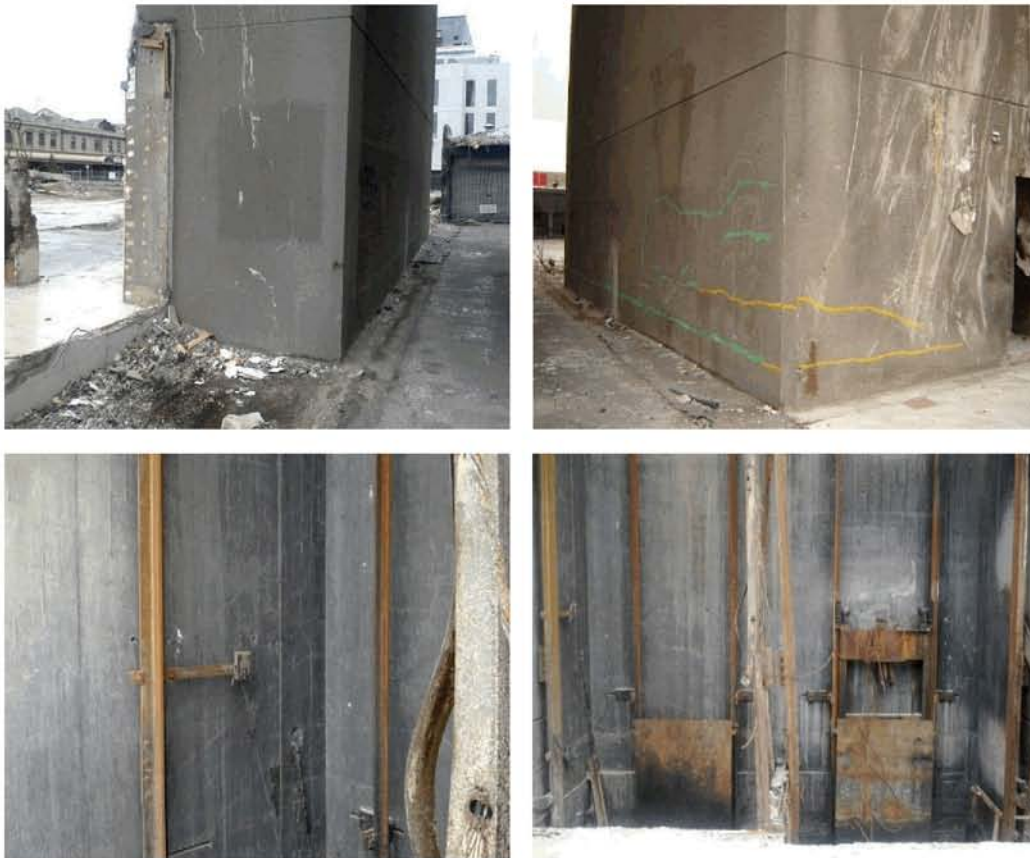
Figure 42 - North Core cracking (clockwise from top left) (a) No obvious cracking on Line D/E wall; (b) Horizontal flexural cracking on west and north west face of Line 5 wall and north end of Line C wall at Line C/5; (c) Fine two-way diagonal cracking on the inside faces of Level 1 to 2 Line 5; (d) and D walls in North Core.

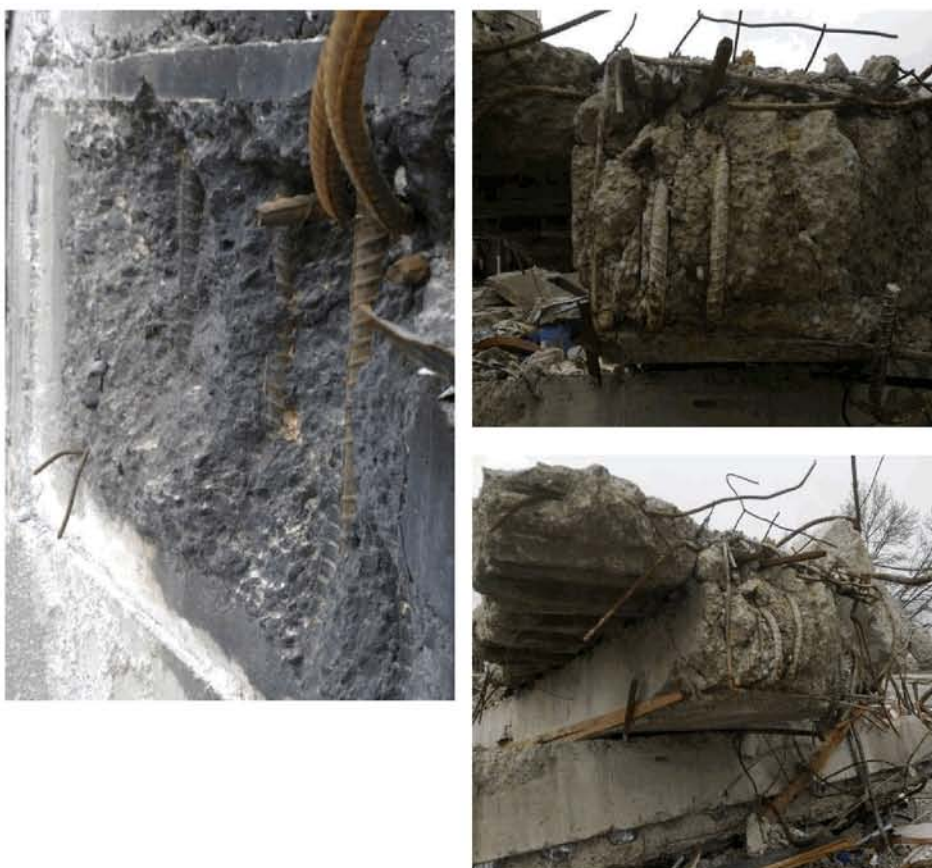
Figure 44 - Precast shell beam (Item E14) from northern face Grid 4, west side of North Core (DENG B23 Dwg S18). (clockwise from top right) (a) to (b) Fractured slab outstand remnant at east end from which slab concrete cores were extracted. The bottom H24 bars from shell beam have been turned back into the concrete infill rather than embedded in shear wall as detailed (DENG Detail 5 Dwg S19). Notice the bar imprint on wall at the connection seen in (c) at Level 4 and at Level 3.
