REMEDIAL TREATMENT OF DIFFICULT TO ACCESS FRAMING TIMBER COMPARISON OF TWO TREATMENT METHODS

Dave Page and Tripti Singh

Date: September 2011

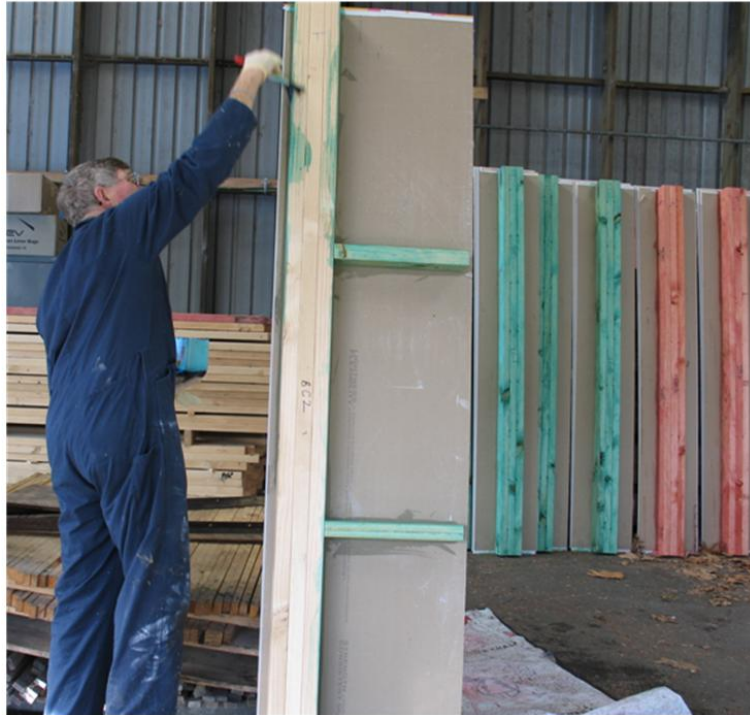
Figure 1 – Brush application of copper naphthenate to brush-on units. ‘Brush on plus injections between the studs’ units stacked for drying are visible to the right background.

Thirty-two multiple stud units were assembled using three 2.4 m lengths of 90 x 45 mm planer gauged MSG 8, kiln dried, radiata pine framing, nailed together with 90 mm galvanised flat head nails. In half of the assemblies, two 400 mm long nogs were nailed to one of the outside studs, 800 mm from each end (Figure 1). Standard 10 mm thick plaster board was fixed to the edge of the central stud and to the nogs in the assemblies with 32 mm long plasterboard screws at 300 mm centres.

The units with nogs were brush coated on all exposed surfaces with preservative solution, eight with the boron formulation and the other eight with copper naphthenate. The units were supported vertically to simulate on-site application. After the first coat of preservative was applied, the units were left to dry for at least 30 minutes before the second coat application. The amount applied to each unit was determined by weighing the preservative before and after each application.

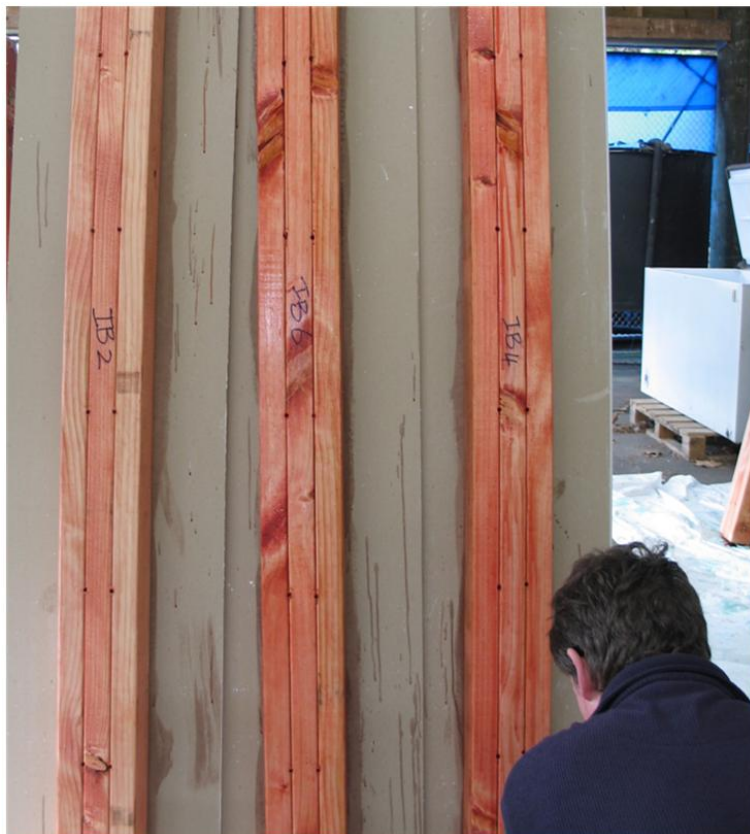
Figure 2 – Brush application of boron to ‘brush on plus injections between the studs’ units. The injection holes are visible between the studs

Holes were drilled at 300 mm intervals along the two interfaces between the studs in the units without nogs (Figure 2). The holes were 6 mm in diameter and 80 mm deep at an angle of approximately 30 degrees to horizontal, sloping downwards so that liquid inserted would run into the unit. The units were brush coated with preservative, following the procedure used for the units with nogs. After the two coat brush-on application was completed approximately 10 ml of preservative was injected in each of the pre-bored holes using a syringe with a long nozzle that fitted tightly into the hole (Figures 3-4). The units were left to dry for at least 30 minutes and then a second 10 ml injection procedure was completed.

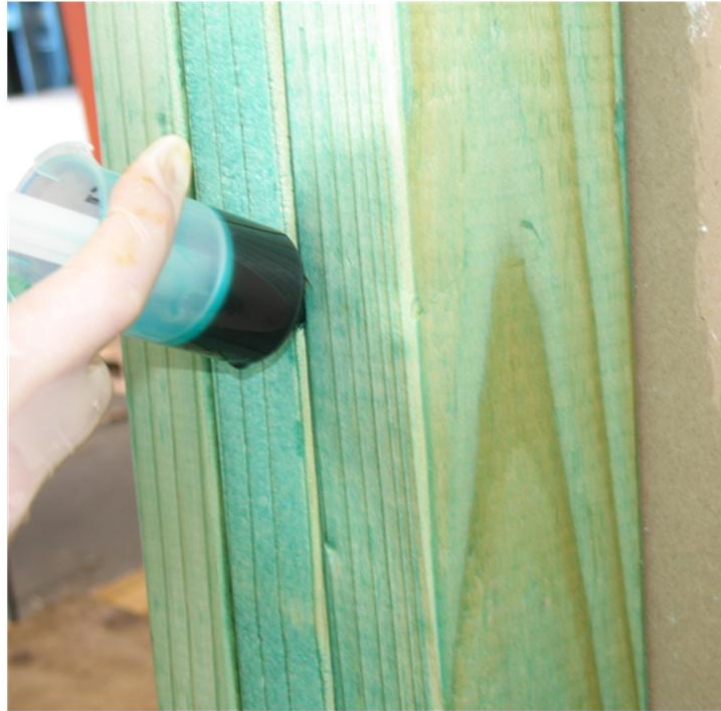
Figure 3 – Injection of copper naphthenate to ‘brush on plus injections between the studs’ units. Injection was done after ‘double coat brush-on’ application using a syringe with a long tapered nozzle.

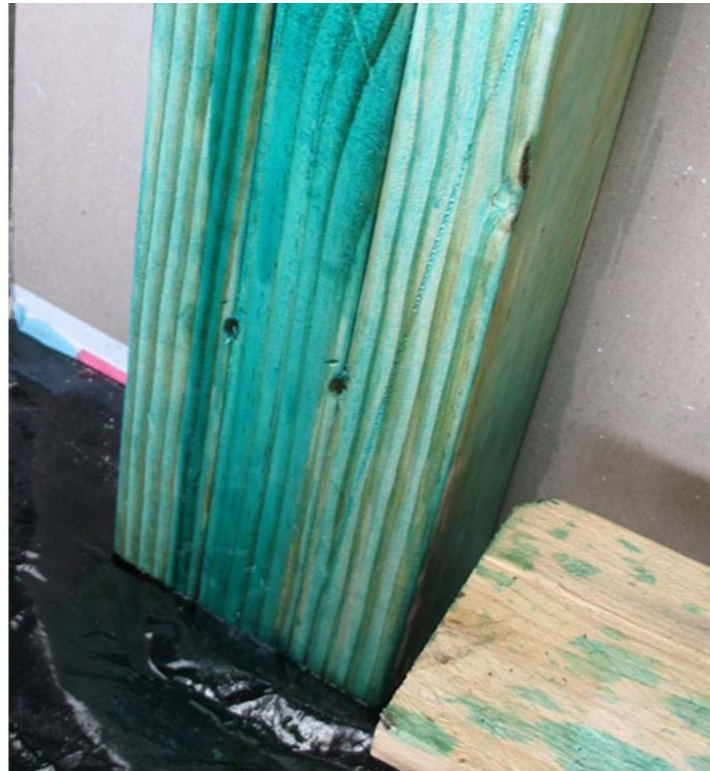
Figure 4 – Injection of copper naphthenate to ‘brush on plus injections between the studs’ units. Preservative tended to run out of the hole and down between the studs to pool on the floor during injection.

The injection holes were less than 3 ml in volume and much of the 10 ml of preservative that was injected at each application either ran down the outside of the studs or came out of gaps between the studs, to the extent that small pools of preservative formed on the ground at the base of the units. The syringes used were not ideal for this purpose and a better application system would be required if this method was to be practicable for on-site remedial treatment of buildings. The viscous nature of the boron preservative also caused some problems with loading the syringes. However, even with the identified practical problems and losses of preservatives using injection method, the analytical results (Table 2, Appendix II) shows the preservative loading in the middle stud significantly increases for both preservatives.

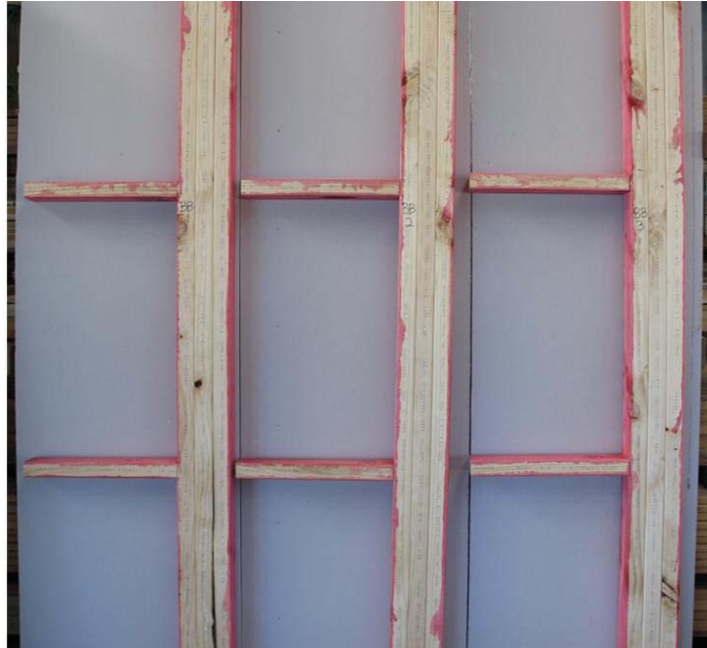
Figure 5 – Boron ‘double coat brush-on’ units with the plaster board removed (showing the edges of studs originally attached to plasterboard) starting with unit BB1 on the left to unit BB3 on the right. Very little preservative had penetrated between the plasterboard and the framing except from the upper face of the nogs. Preservative had not penetrated sufficiently between studs to reach the plasterboard.

When the 'double coat brush-on' units were disassembled preservative spread beyond the area where it was immediately applied was negligible (Figures 5-8). There were occasional small areas where it had penetrated between the framing components and the plaster board or at the two stud interfaces but these were very irregular. The most consistent penetration away from the exposed surfaces appeared to be along the upper section of the interface between the plasterboard and the nogs.

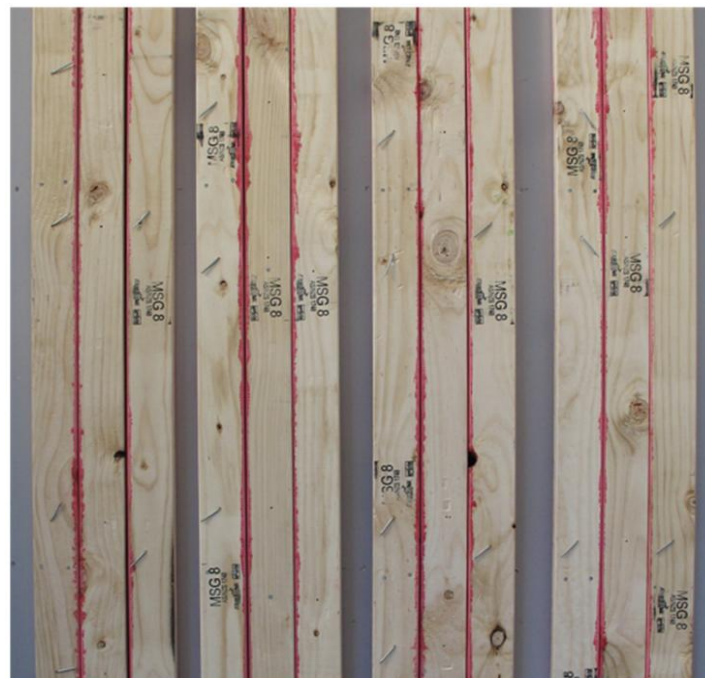
Figure 6 – The concealed faces of ‘double coat brush-on’ boron treated studs (after dismantling), unit BB1 on the left through to unit BB4 on the right. Preservative had only spread a few mm between studs from the edges that it was brushed on to.

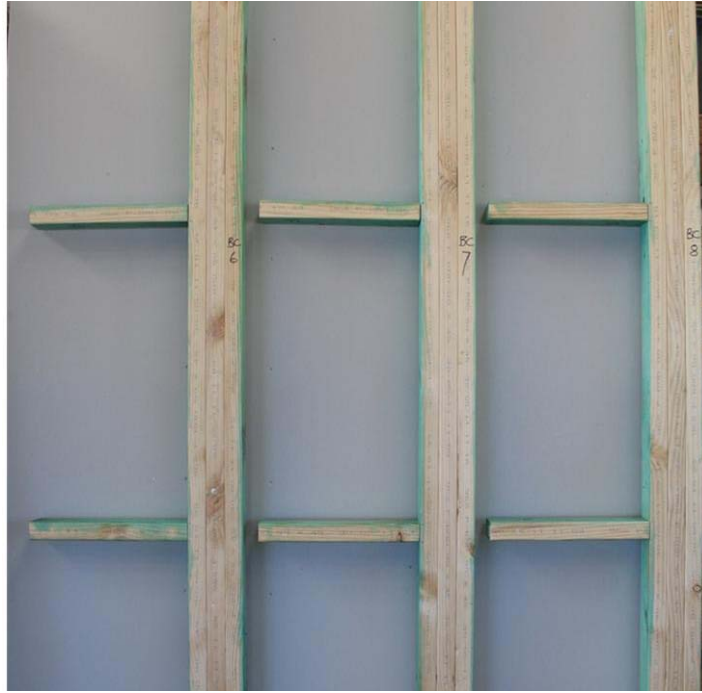
Figure 7 – Copper naphthenate ‘double coat brush-on’ units with the plaster board removed (showing the edges of studs originally attached to plasterboard) starting with unit BC6 on the left through to unit BC8 on the right. Very little preservative had penetrated between the plasterboard and the framing except from the upper face of the nogs. Preservative had not penetrated sufficiently between studs to reach the plasterboard.

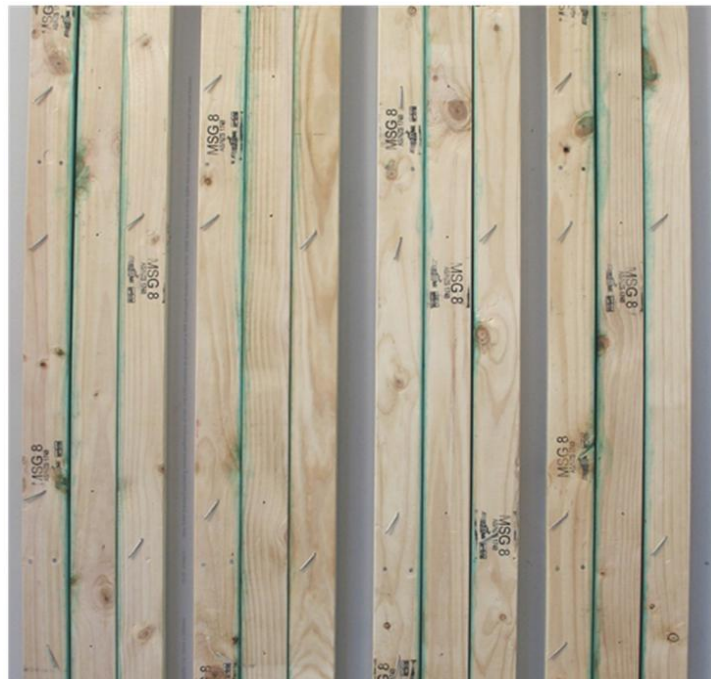
Figure 8 – The concealed faces of ‘double coat brush-on’ copper naphthenate treated studs (after dismantle), unit BC5 on the left through to unit BC8 on the right. Preservative had not spread far from the surfaces that it was brushed on to.

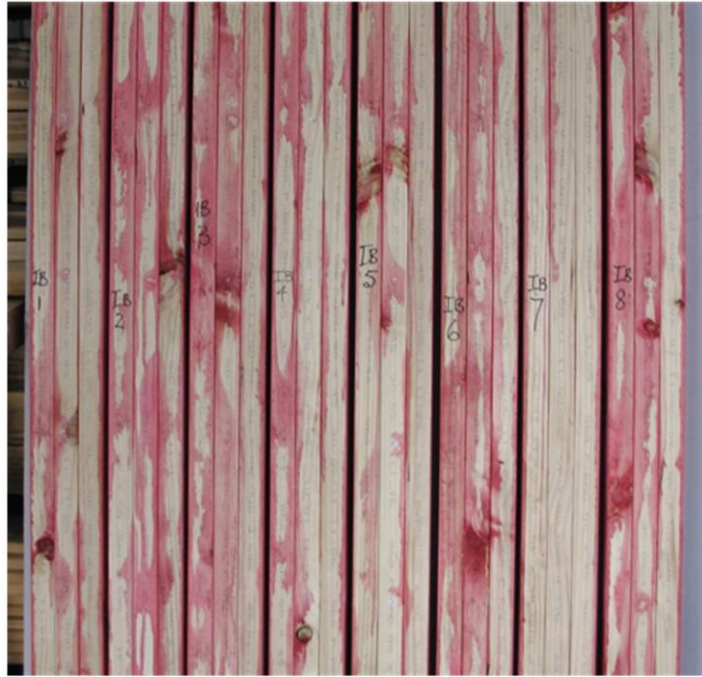
Figure 9 – Boron ‘brush on plus injections between the studs’ units with the plaster board removed (showing the edges of studs originally attached to plasterboard) starting with unit IB1 on the left through to unit IB8 on the right. The preservative had penetrated from the injection holes through to the plasterboard in irregular patches but there was little penetration from the brushed surfaces.

In the disassembled 'double coat brush-on plus injection treatment between studs' units there were large patches of preservative penetration extending out from the holes bored between the studs and limited patchy penetration between the studs and the plasterboard (Figures 9-12). While the injection application did not achieve full cover on the concealed surfaces, particularly at the top of the units, the proportion left untreated was generally less than 50%.

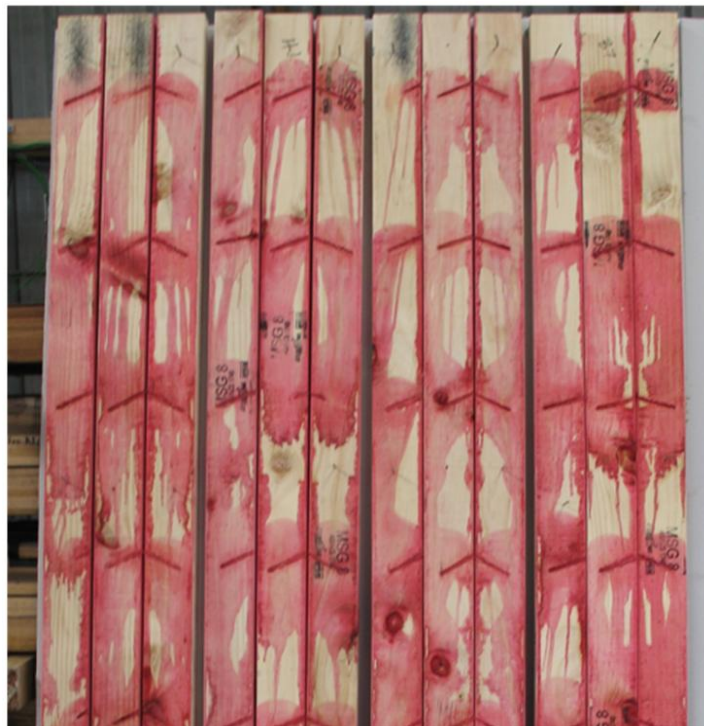
Figure 10 – The concealed faces of ‘brush on plus injections between the studs’ boron treated studs (after dismantle), unit IB1 on the left through to unit IB4 on the right. Preservative had spread out from the injection holes.

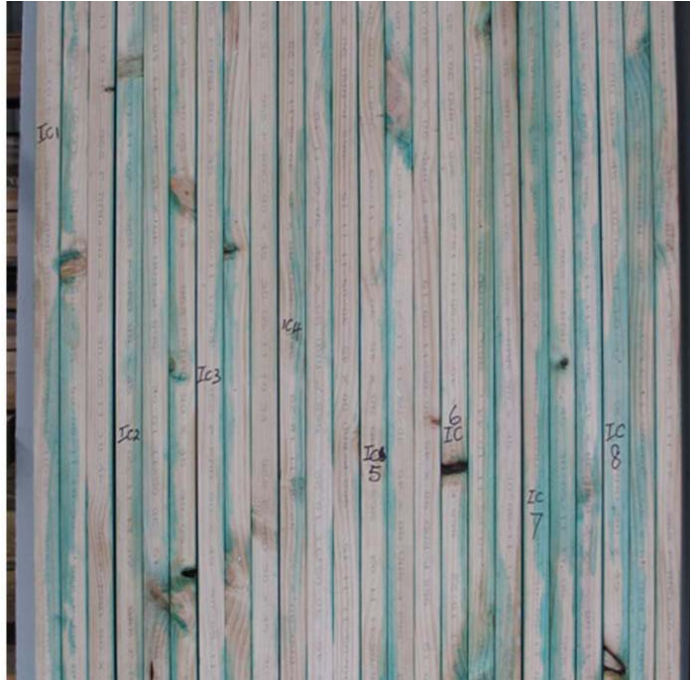
Figure 11 – Copper naphthenate ‘brush on plus injections between the studs’ units with the plaster board removed (showing the edges of studs originally attached to plasterboard), starting with unit IC1 on the left through to unit IC8 on the right. The copper naphthenate has penetrated from the injection holes through to the plasterboard in patches but there was little penetration from the brushed surfaces.

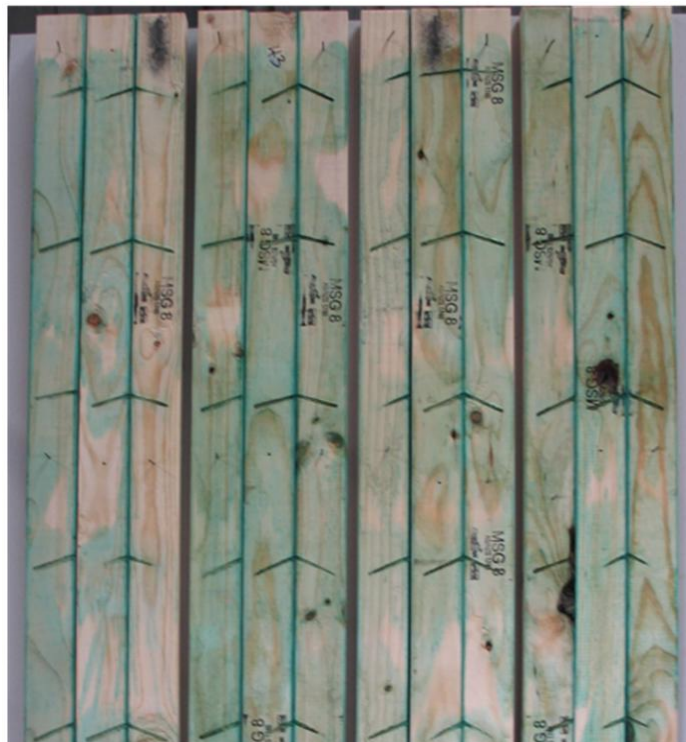
Figure 12 – The concealed faces of ‘brush on plus injections between the studs’ copper naphthenate treated studs (after dismantle), unit IC1 on the left through to unit IC4 on the right. Preservative had spread out from the injection holes.

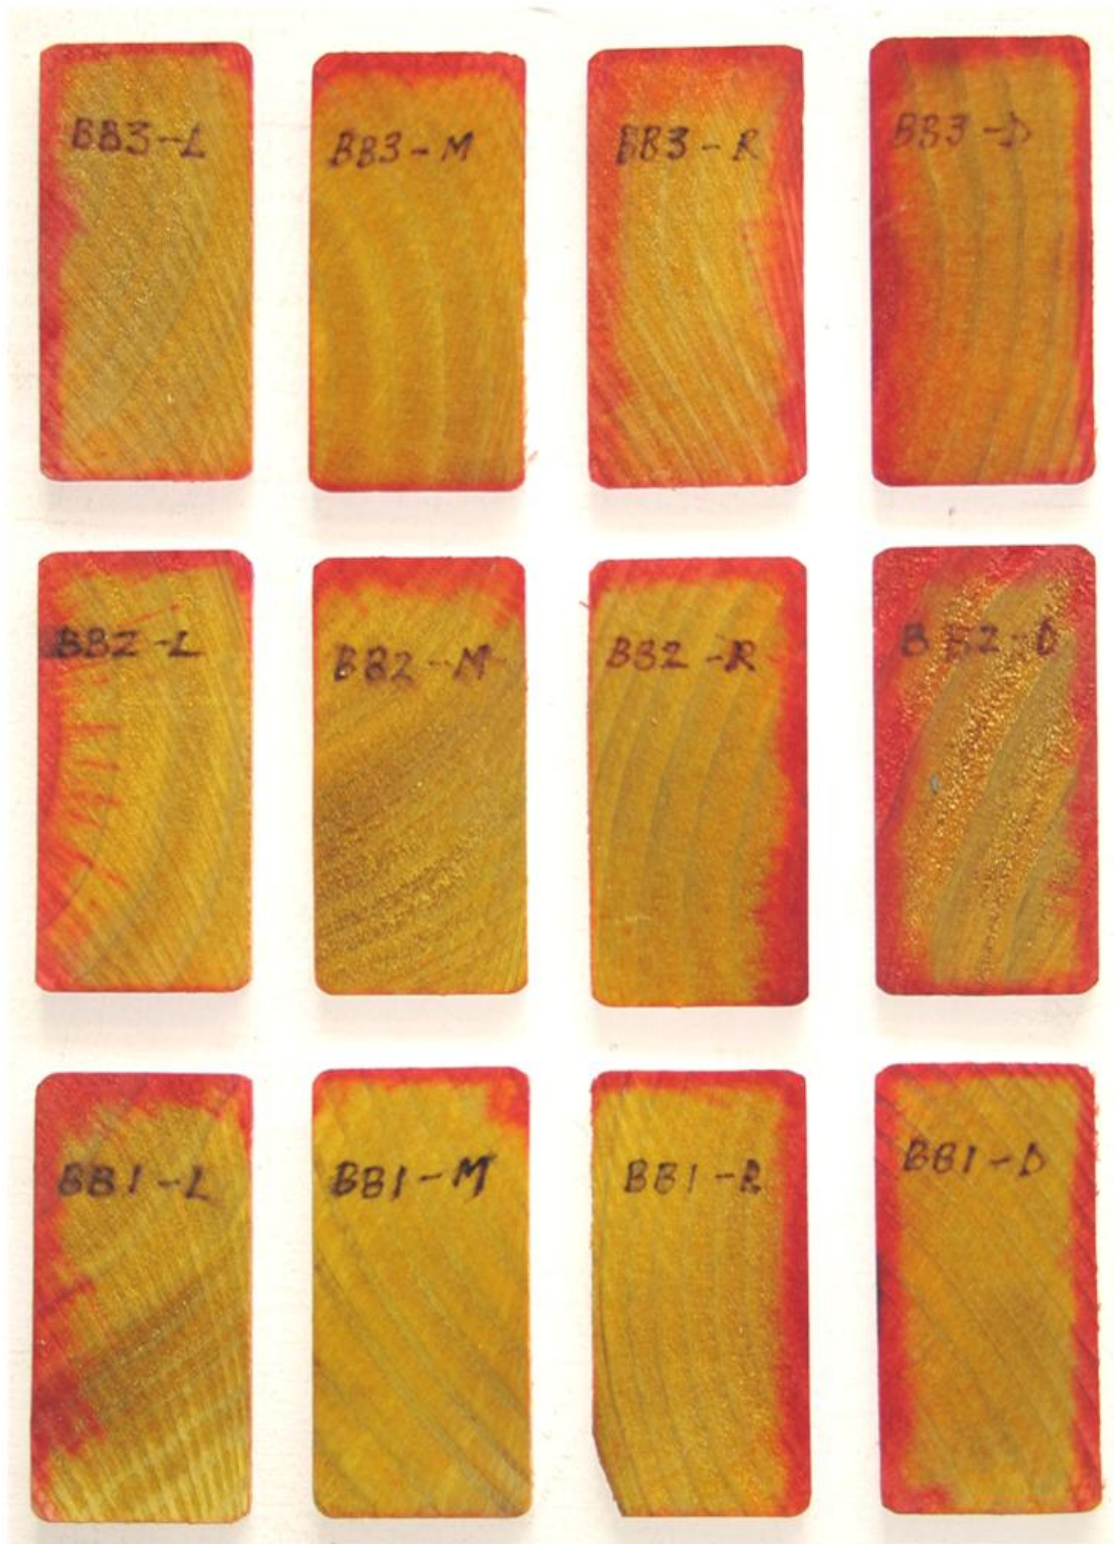
Figure 13 – Penetration of boron in ‘double coat brush-on’ treated units, BB1 at the bottom, through to unit BB3 at the top. Samples, from the left side, are left stud, middle stud, right stud and nog. There was generally 5-10mm penetration only from the surfaces that the preservative was brushed on to.

Preservative penetration into the timber in the 'double coat brush-on' boron treated components seldom exceeded 10 mm and was generally closer to 5 mm from the surface that it was applied to (Figure 13). For the 'double coat brush-on plus injection treatment between studs' treated units patchy penetration was also present from concealed surfaces (Figure 15).

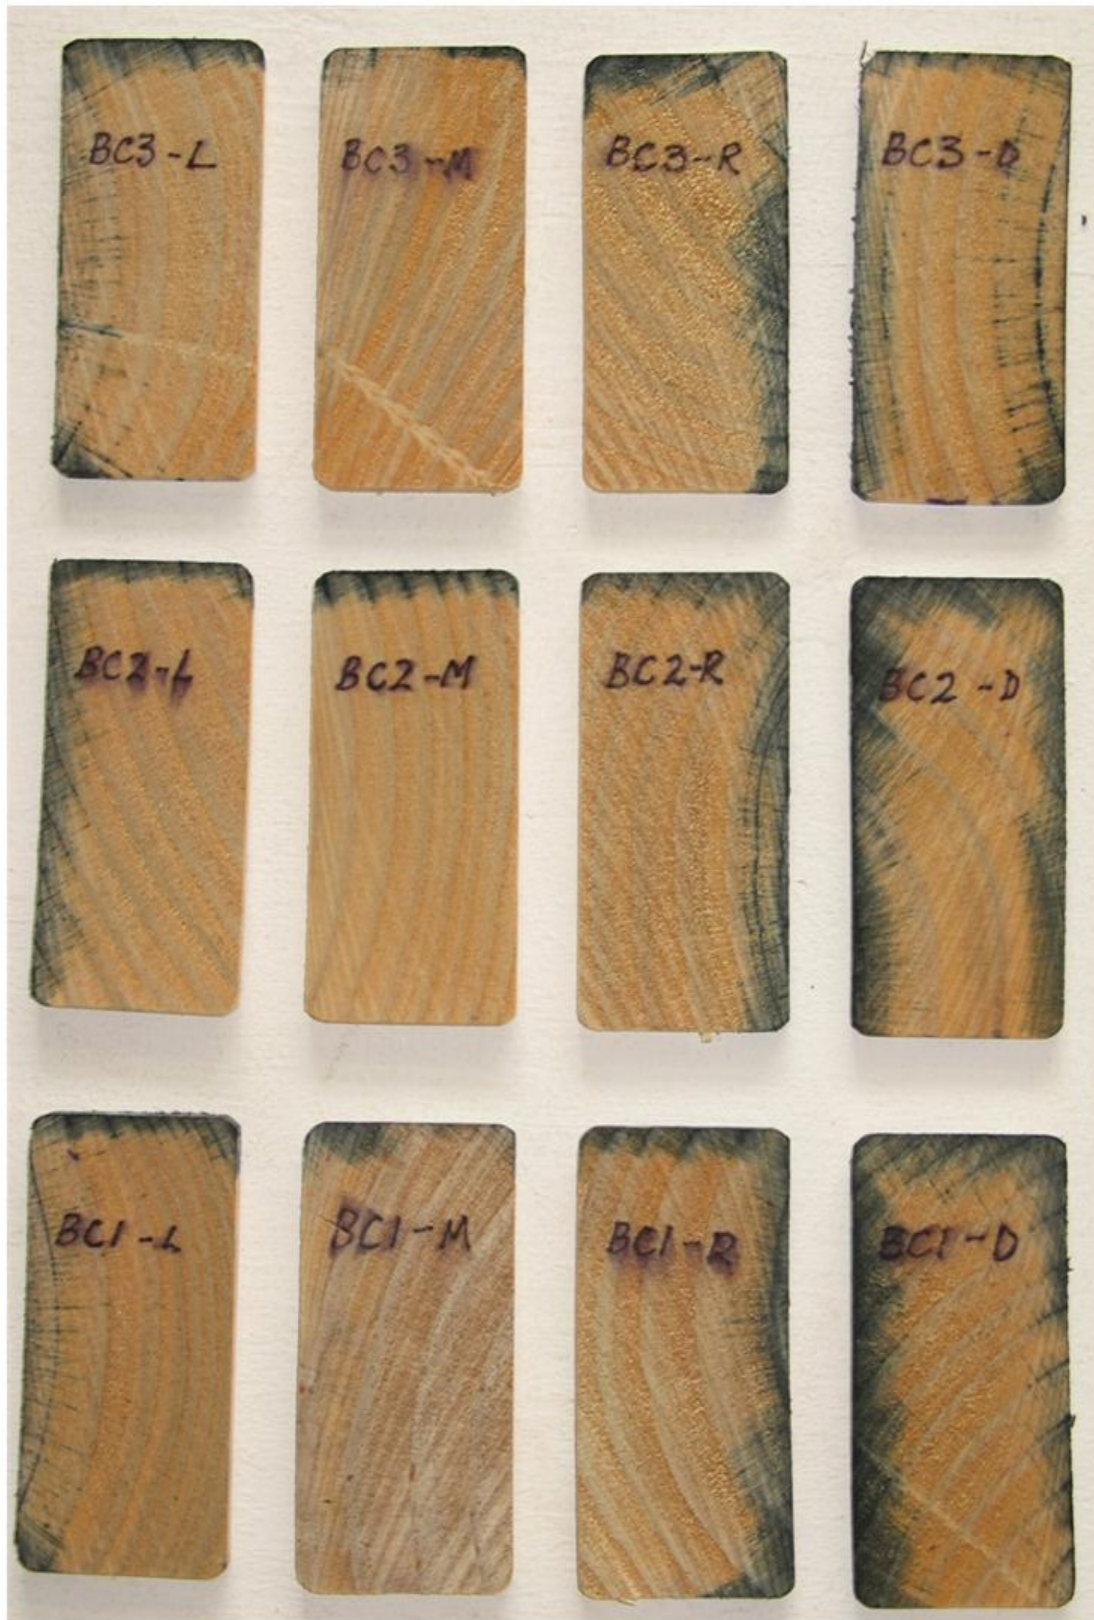
Figure 14 – Penetration of copper in ‘double coat brush-on’ treated units, BC1 at the bottom, through to unit BC3 at the top. Samples, from the left side, are left stud, middle stud, right stud and nog. Penetration was variable from the exposed surfaces and was largely via the medullary rays i.e., at right angles to the growth

In the copper naphthenate 'double coat brush-on' treated units penetration was again almost solely from the exposed component surfaces (Figure 14). Although the penetration envelop was not deep, evidence of deeper penetration was observed via ray cells. And this could be the reason why penetration was more variable than boron treated units. With the 'double coat brush-on plus injection treatment between studs' units there was preservative penetration from most surfaces, but somewhat patchy from concealed surfaces (Figure 16).
