FORSYTH BARR

FORSYTH BARR BUILDING STAIRS
SITE EXAMINATION AND MATERIALS TESTS
FOR DEPARTMENT OF BUILDING AND HOUSING
17TH SEPTEMBER 2011

REPORT PREPARED FOR:
DEPARTMENT OF BUILDING AND HOUSING

DR CLARK HYLAND

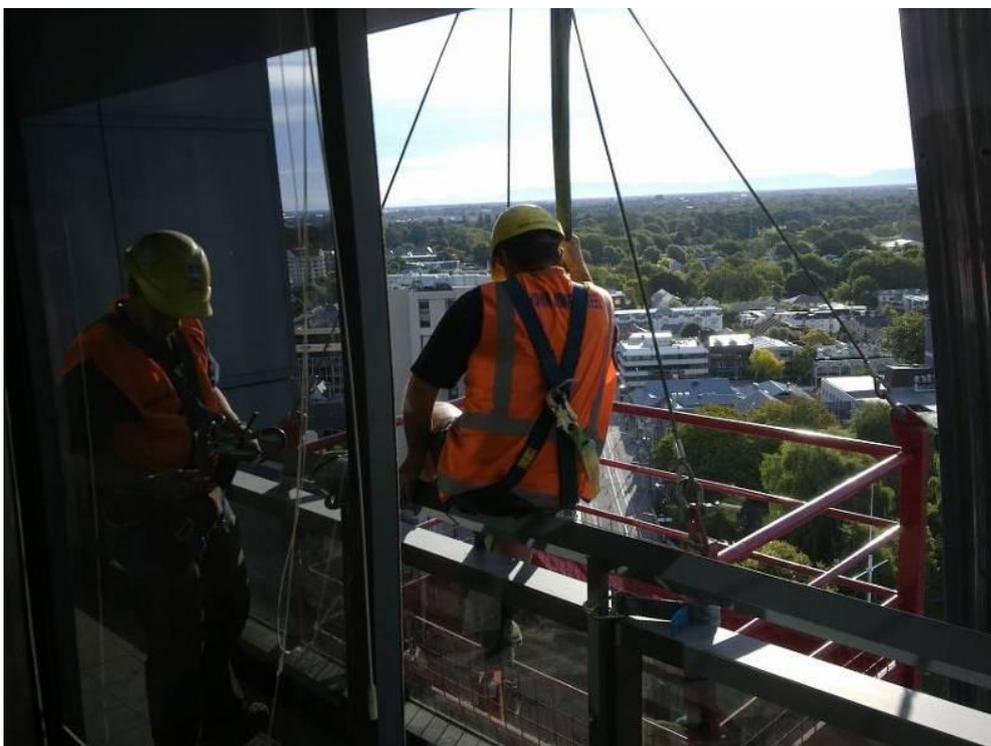
Figure 5 –Crane access into building

Access was gained externally by crane (Figure 5) consecutively into Levels 15, 16, and 17, then up to the roof internally using the remaining stairs.

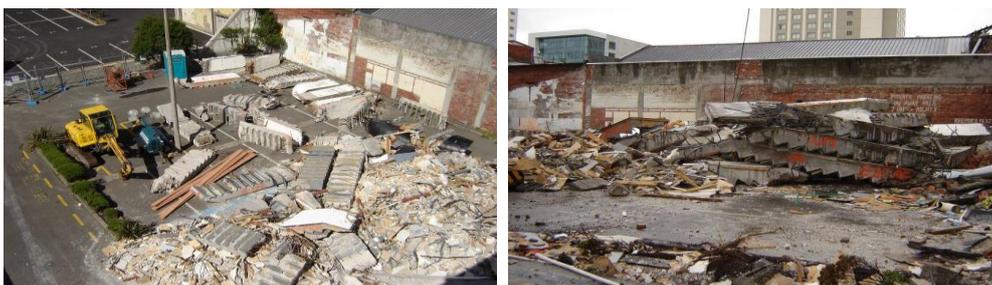
The collapsed stair remnants had been removed from the stairwell at Level 1 and 2 (Figure 13) by other parties and placed in the car park behind the Forsyth Barr building prior to the Stair Remnants Examination (Figure 12).

Figure 12 - Stair remnant debris in car park behind Forsyth Barr building after their removal from the stairwell.

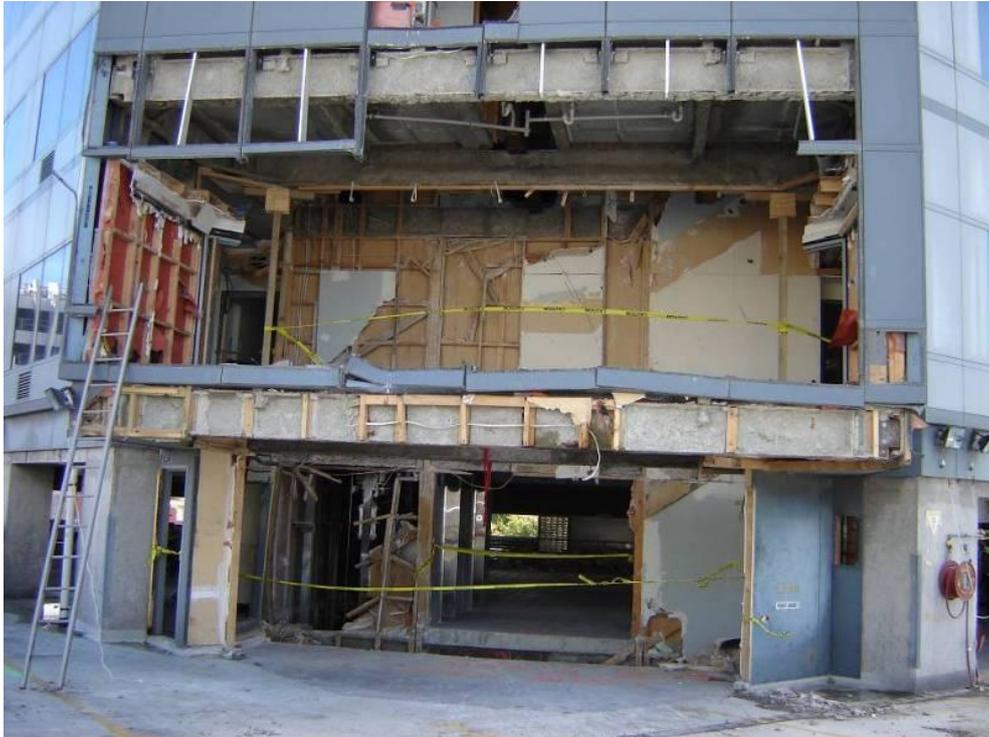
Figure 13 - Access into stairwell from Level 1 and 2 used for removal of stair remnants

The stair remnants had been retrieved by other parties from Level 1 and 2 of the stair well (Figure 13 and Figure 14).

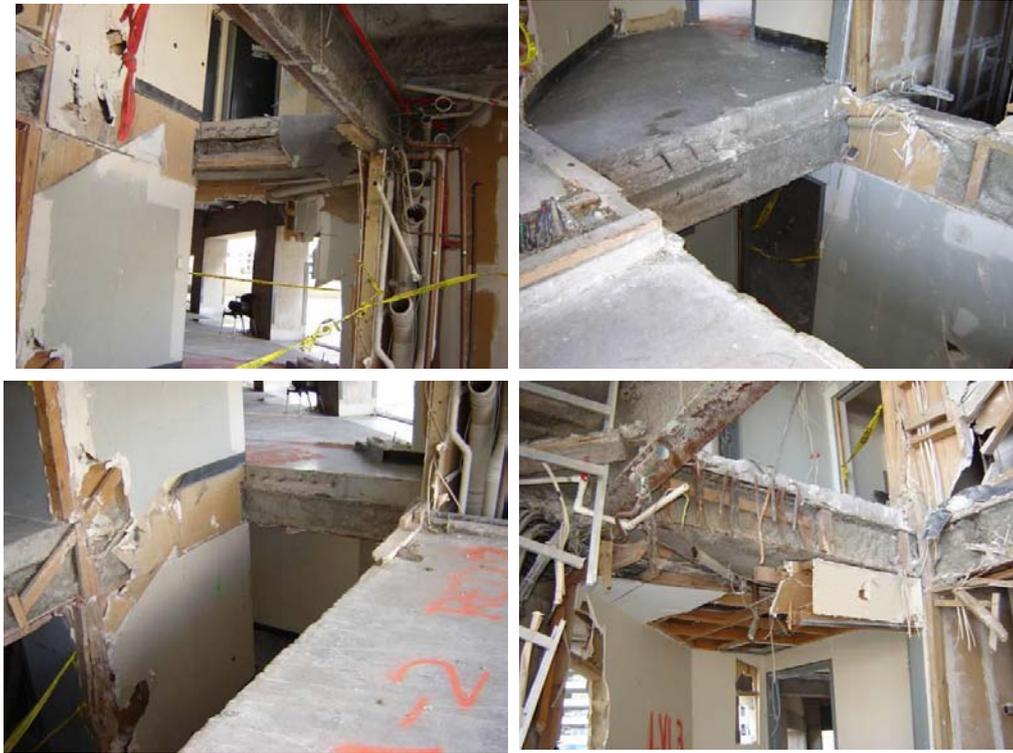
Figure 14 – Level 2 to 3 Stairwell in the access area used for remnant retrieval

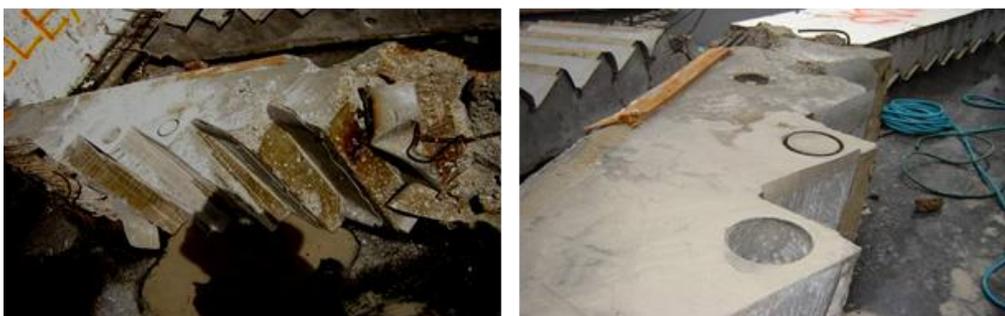
Figure 17 - Unit 2 showing concrete core test locations on the sides of treads

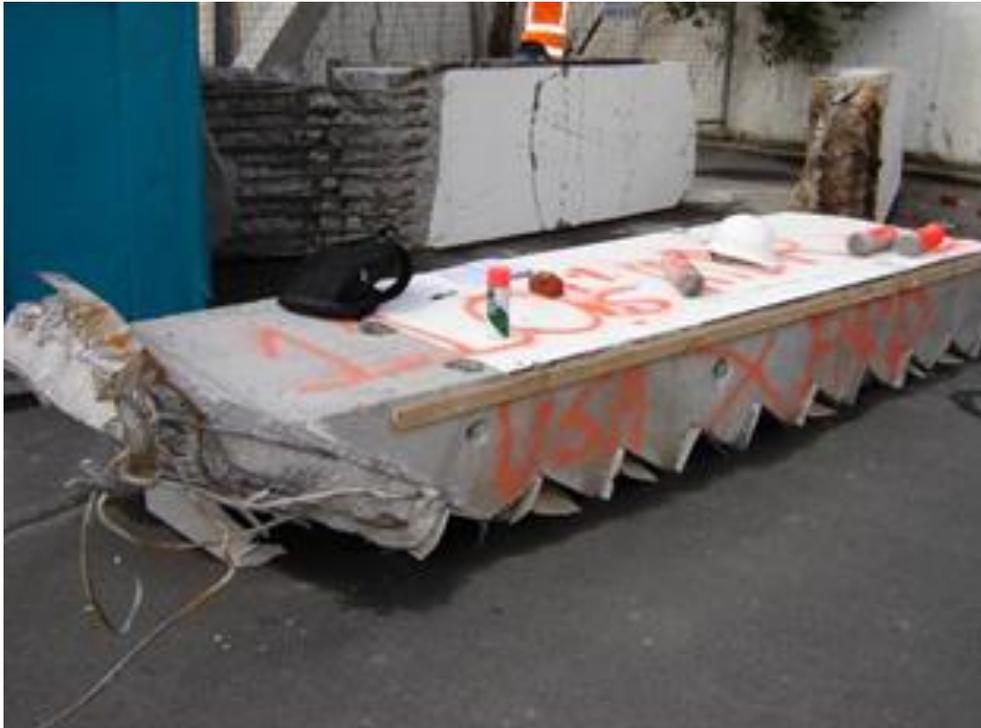
Figure 18 - Unit 3 with upper landing; Unit 1 to left behind; Unit 2 to right behind

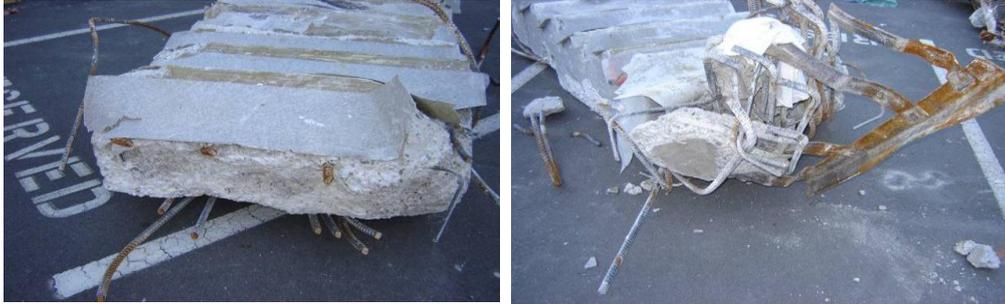
Figure 27 - Unit 12 (left to right): (a) Mid-height landing; (b) Lower landing.

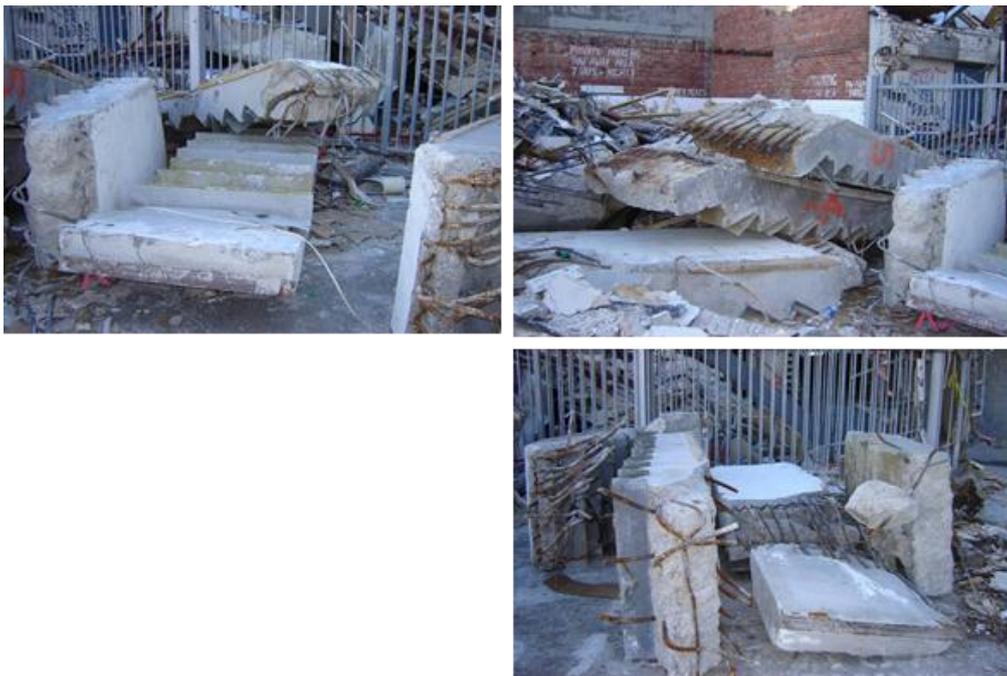
Figure 34 – Other stair remnants.

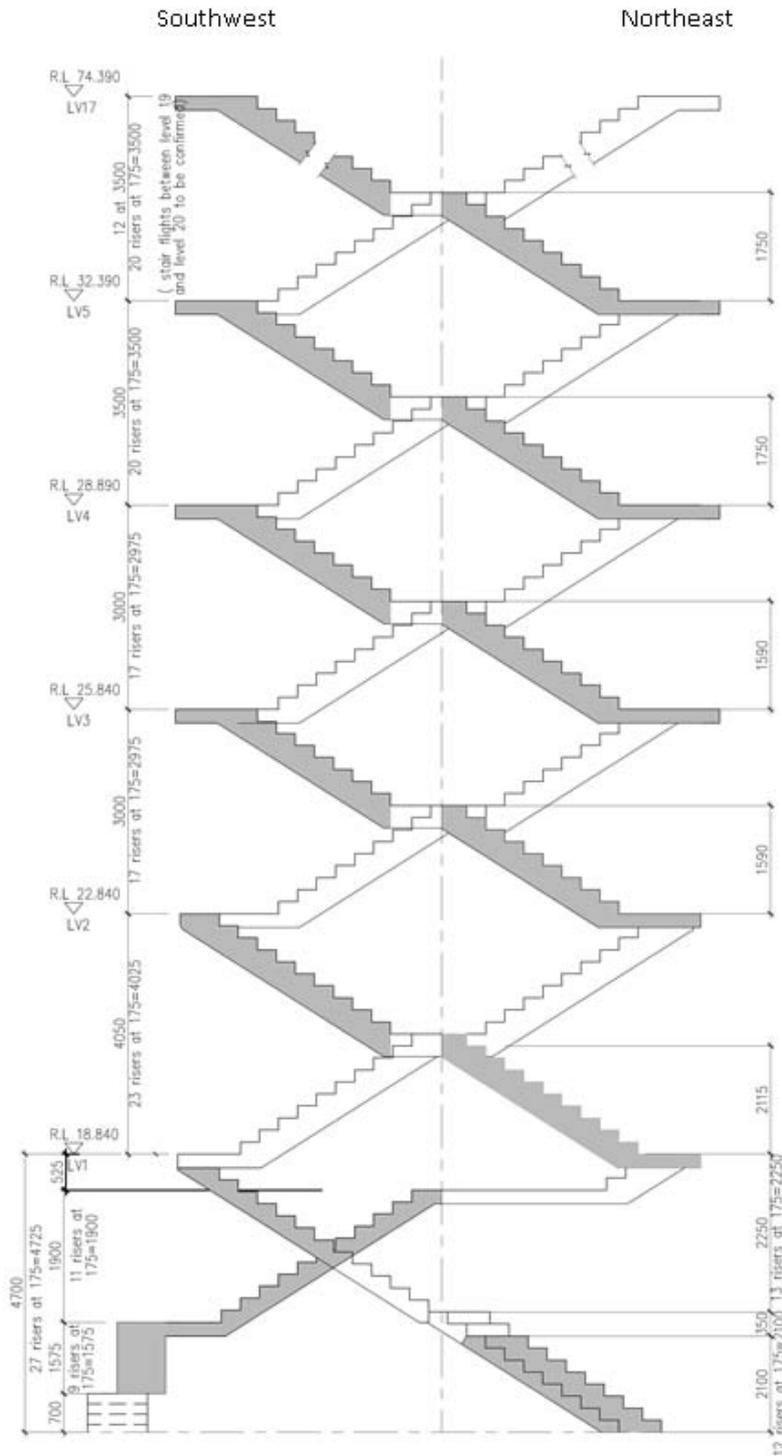
Figure 36 – Stair Elevation

- c. Each flight of stairs was shown on the Drawings as consisting of two precast half flights with a mid-height in-situ landing (Figure 36; Figure 37). However it appears that the stair flights were precast as one continuous unit as no construction joint could be seen in Units 8, 14 and 18 at the mid-height landing (Figure 23; Figure 29; Figure 33). The top end of the flight rested on a 381 mm x 102 mm RSC (rolled steel channel) and was cast into the building floor concrete (Figure 39). The bottom end of the precast flight sat on a 381 x 102 RSC steel channel with nominally 75 mm seating and detailed to allow 30 mm of horizontal compression movement between the stair and the lower floor (Figure 38). The typical design floor to floor height between Level 4 and 18 was documented as 3500 mm.

The stairwell is located at the rear of the lift shaft on the southeast corner of the building and consists of two sets of stairs arranged in scissor fashion aligned southwest to northeast, that were separated by light-weight fire rated walls (Figure 36).

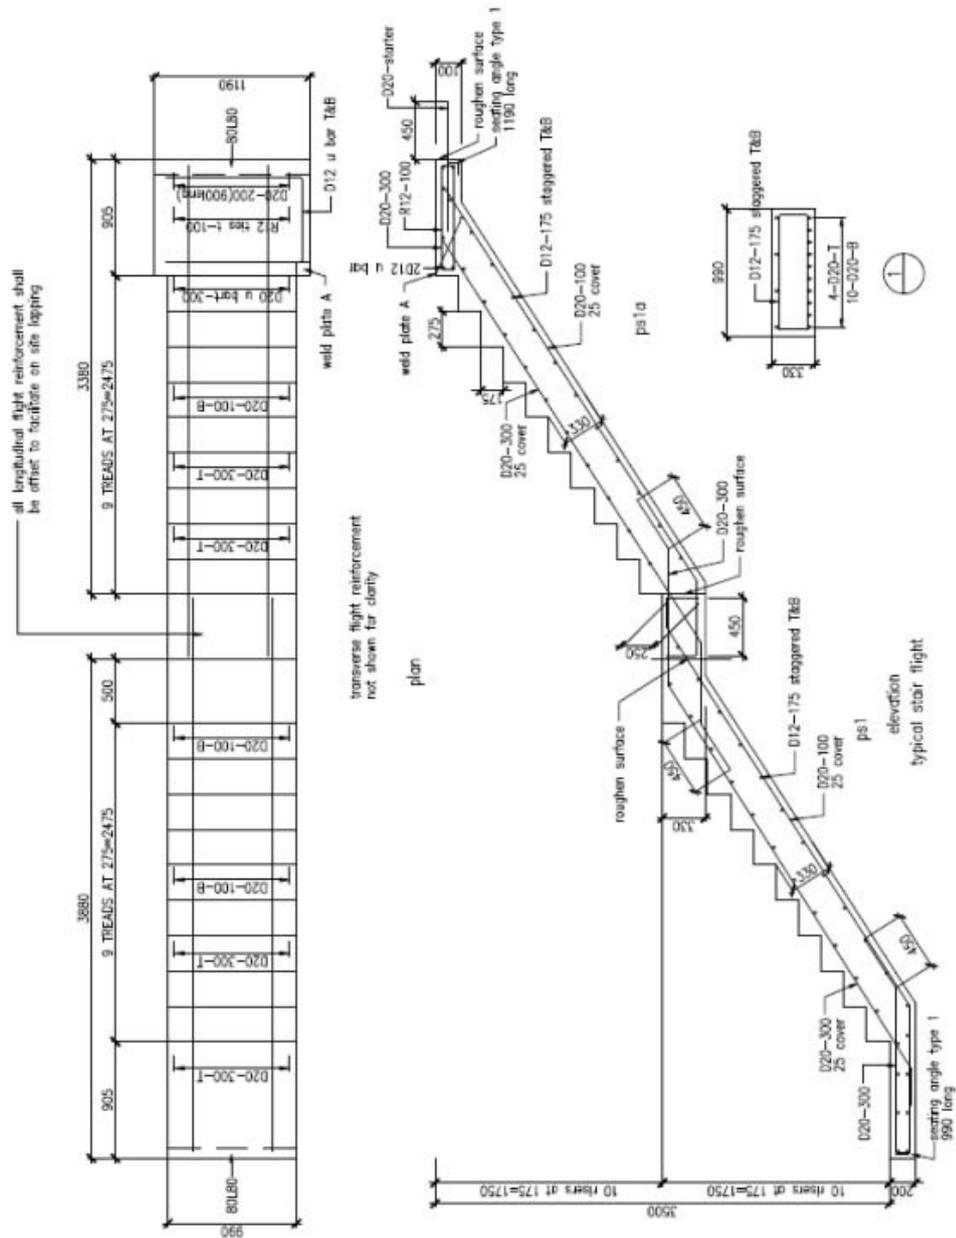
Figure 37 – Typical stair details

The Drawings show that the stairs flights were permitted to consist of two precast concrete units joined by in-situ concrete at a mid-height landing (Figure 37). The upper portion of each stair flight was seated on a 381x102 mm RSC steel channel section and had six D20 reinforcing bars cast into the upper concrete support beam (Figure 39). The lower portion of each stair flight sat on a 381x102 mm RSC steel channel section.

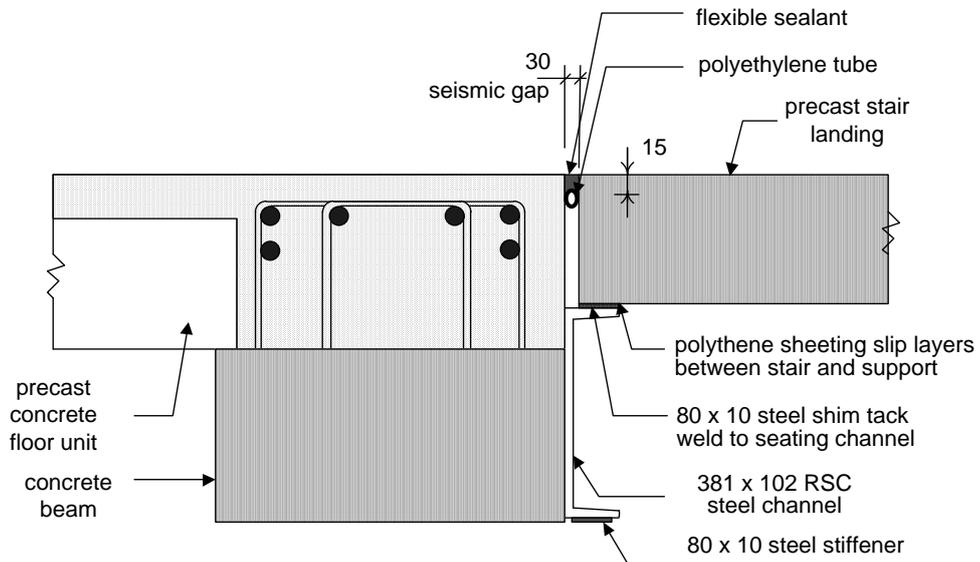
A 30 mm seismic gap was specified on the Drawings at the lower landings of the stair flights to allow the stair flights to slide freely back and forth and take up any inter-storey drift movements induced by an earthquake without damaging the stair or falling off the lower landings supports (Figure 38).

Figure 38 - Typical lower landing detail with seismic joint.
