CTV BUILDING

CTV BUILDING COLLAPSE INVESTIGATION
FOR DEPARTMENT OF BUILDING AND HOUSING
25TH JANUARY 2012

Report Issue Date: 27 January 2012

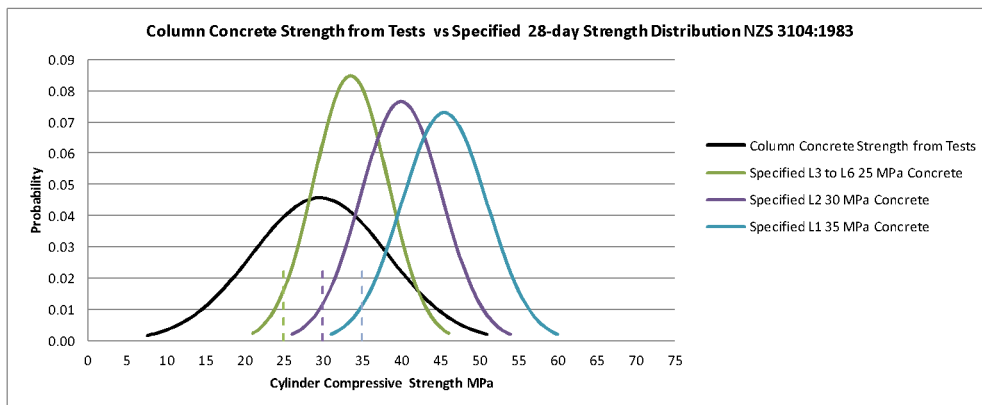
The position in relation to the column samples is summarised in Figure 4. The black line indicates the inferred distribution of concrete strengths from the tests. The other three distributions are the expected strength distributions at 28 days from pouring of concrete based on the specified concrete strengths (after 28 days) which were 35 MPa for Level 1 columns, 30 MPa for Level 2, and 25 MPa for Levels 3 to 6. Even

though it is not known which of the measurements applies to which strength distribution, it can be seen that a higher than expected proportion of the results is below the specified level in all cases.

Figure 4 - Column concrete test strengths compared to specified strength distributions.

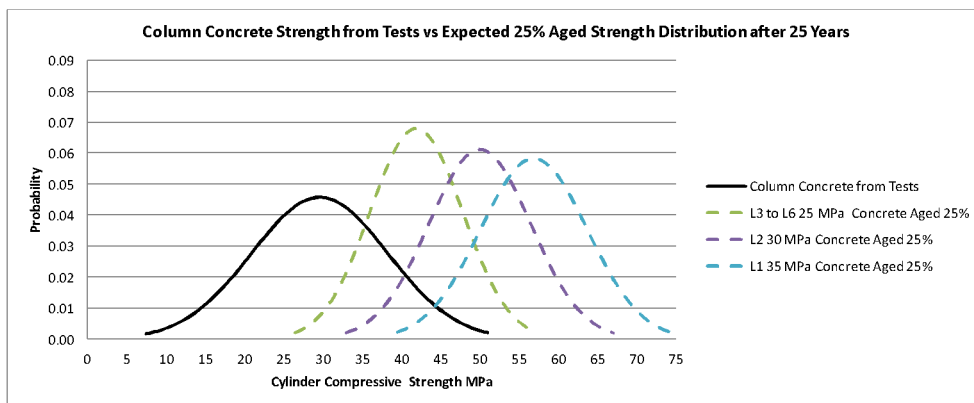
Figure 5 - Column strengths compared to expected strength distributions with 25% allowance for aging after 25 years.

While it is recognised that the tests were conducted on members that had been involved in the collapse, the results in Figure 5 indicate that column concrete strengths were significantly less than the expected strengths at the time of their testing. An expectation of 25% increase in strength during 25 years since construction is considered to be a general guide considering the specified strengths, the conservative approach to achieving specified strengths, and the expected strength gain with age.

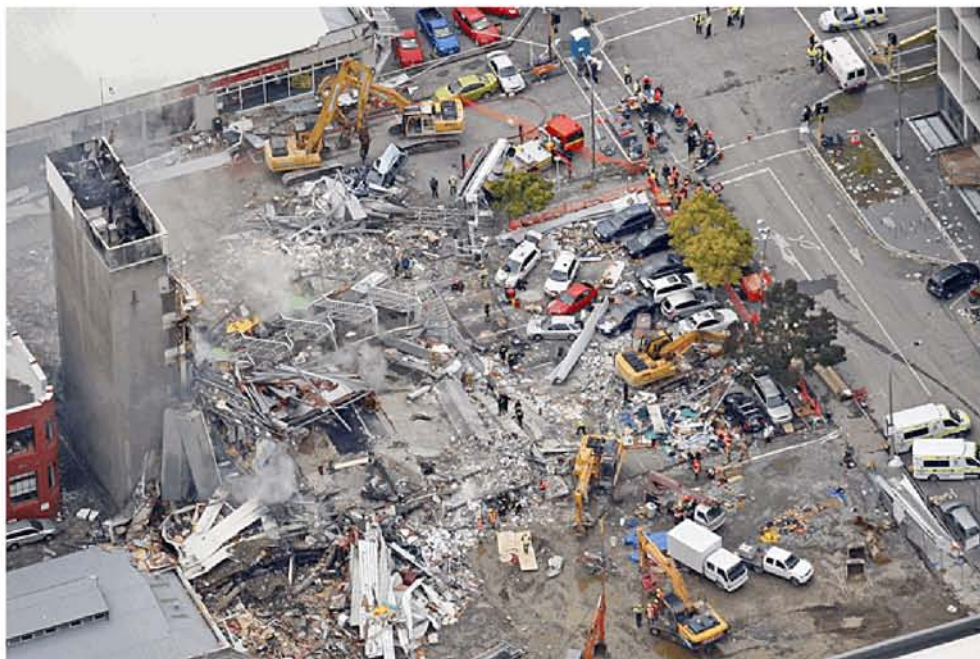
Figure 6 shows an aerial view of the collapse scene not long after the building collapsed. It is evident that the building collapsed straight down almost within its own footprint and that the South Wall (with stairs attached) fell on top of the floor slabs. The North Core remained standing after the collapse.

Figure 6 - The CTV Building collapse shortly after machinery began to remove debris. (NZ Herald)

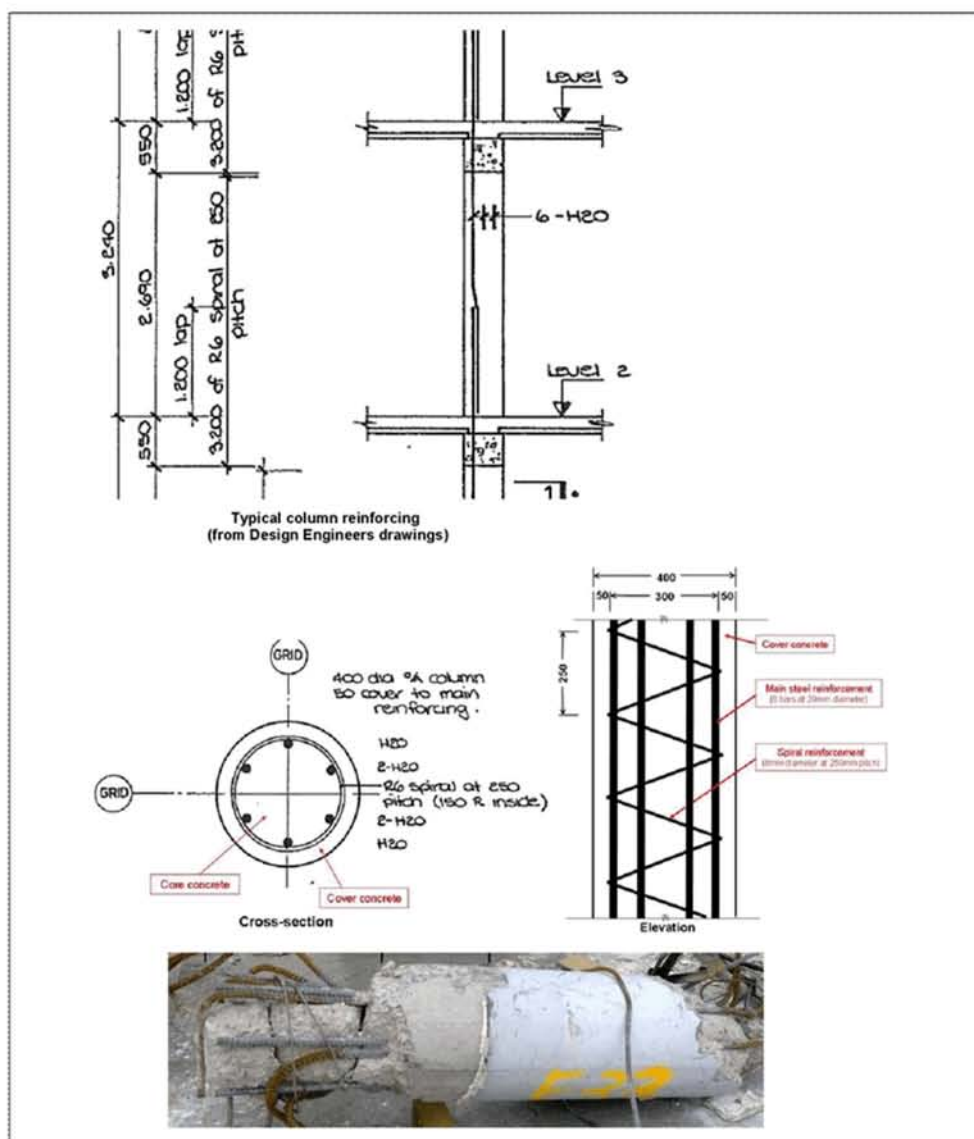
- Relatively large proportion of cover concrete in the columns.
- Possibility of significantly lower than specified concrete strength in critical columns.
- Lack of ductile detailing in beam-column connections.

The lack of ductility in the columns made them particularly vulnerable and they have been the focus of the analyses. The ability of a column to sustain inter-storey drift depends on its stiffness, strength and ductility. Established methods were used to estimate the capacity of critical columns to sustain the drift without collapse.

Figure 7 - Typical 400mm diameter column.

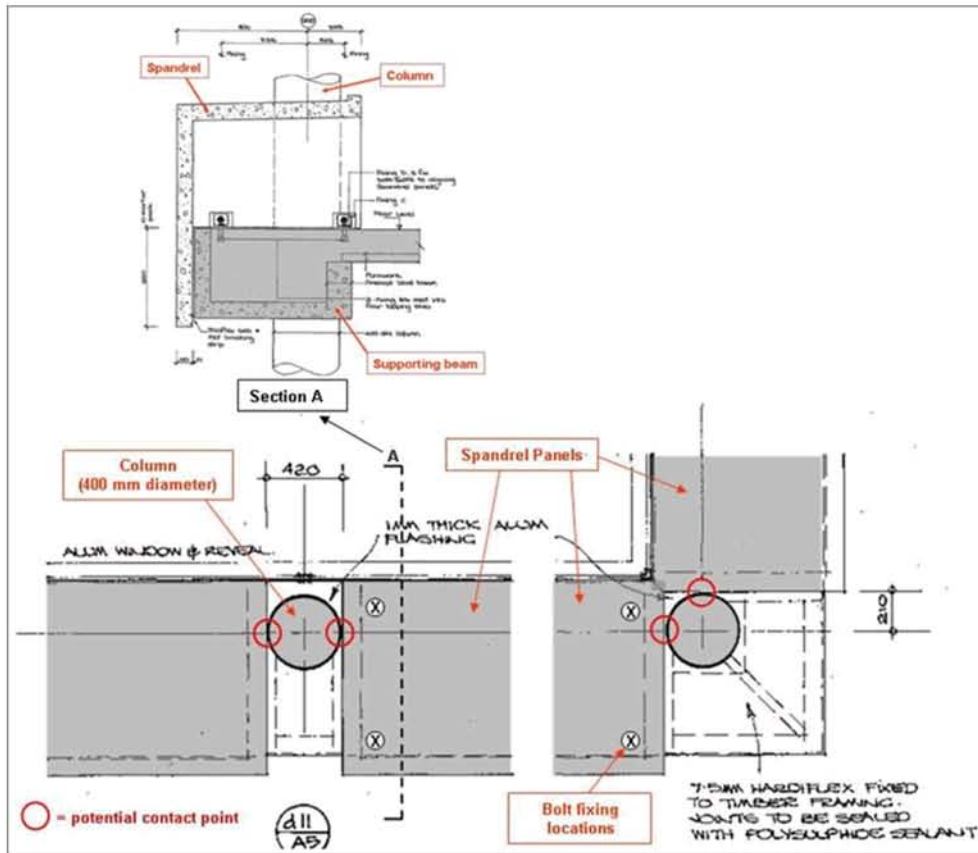
The pre-cast reinforced concrete Spandrel Panels were fixed to the floor slab and were placed between columns. The gap between the ends of adjacent spandrels was specified to be 420mm giving a nominal 10mm gap either side between the spandrel and the column. It is possible that these gaps varied from the nominal 10mm and it is estimated they may have ranged between 0 and 16mm. It is not known what the sizes of the gaps actually were, but analyses showed a significant reduction in column drift capacity for the case where no gap was achieved. Forensic evidence indicated that interaction may have occurred between some columns and adjacent Spandrel Panels in the 22 February 2011 event. There were also indications of cracking reported in some of the upper level columns after the September earthquake that may have indicated some interaction with the Spandrel Panels.

Figure 8 - Spandrel Panel detail.

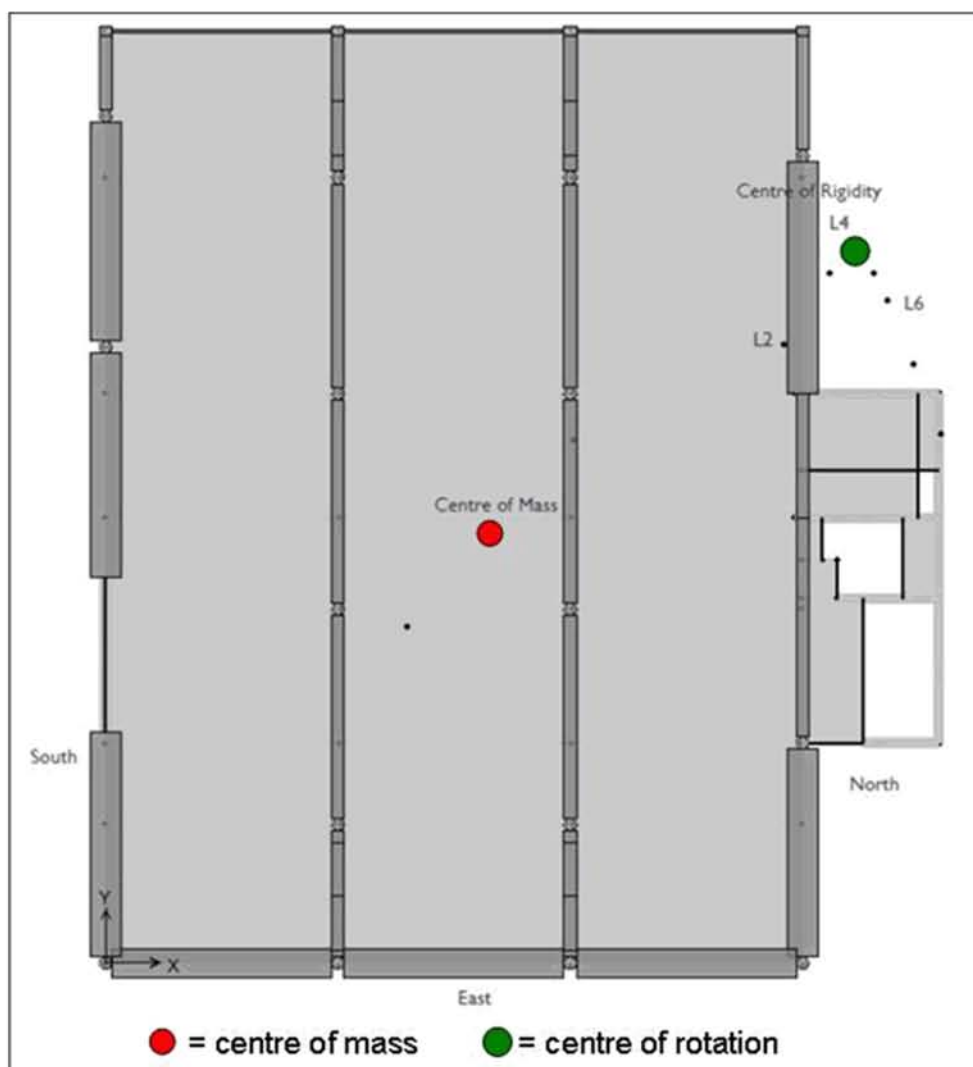
It was considered that the lack of symmetry in plan could cause displacements on the south and east faces to increase as the building rotated in plan. Figure 9 illustrates the results of one examination of this effect. The centre of mass indicates where the lateral forces would act. The centre of rigidity indicates where lateral forces, at Level 4, would be resisted. The horizontal distance between these points is a measure of the tendency of the building to twist when subject to horizontal ground motions.

Figure 9 - Plan irregularity.

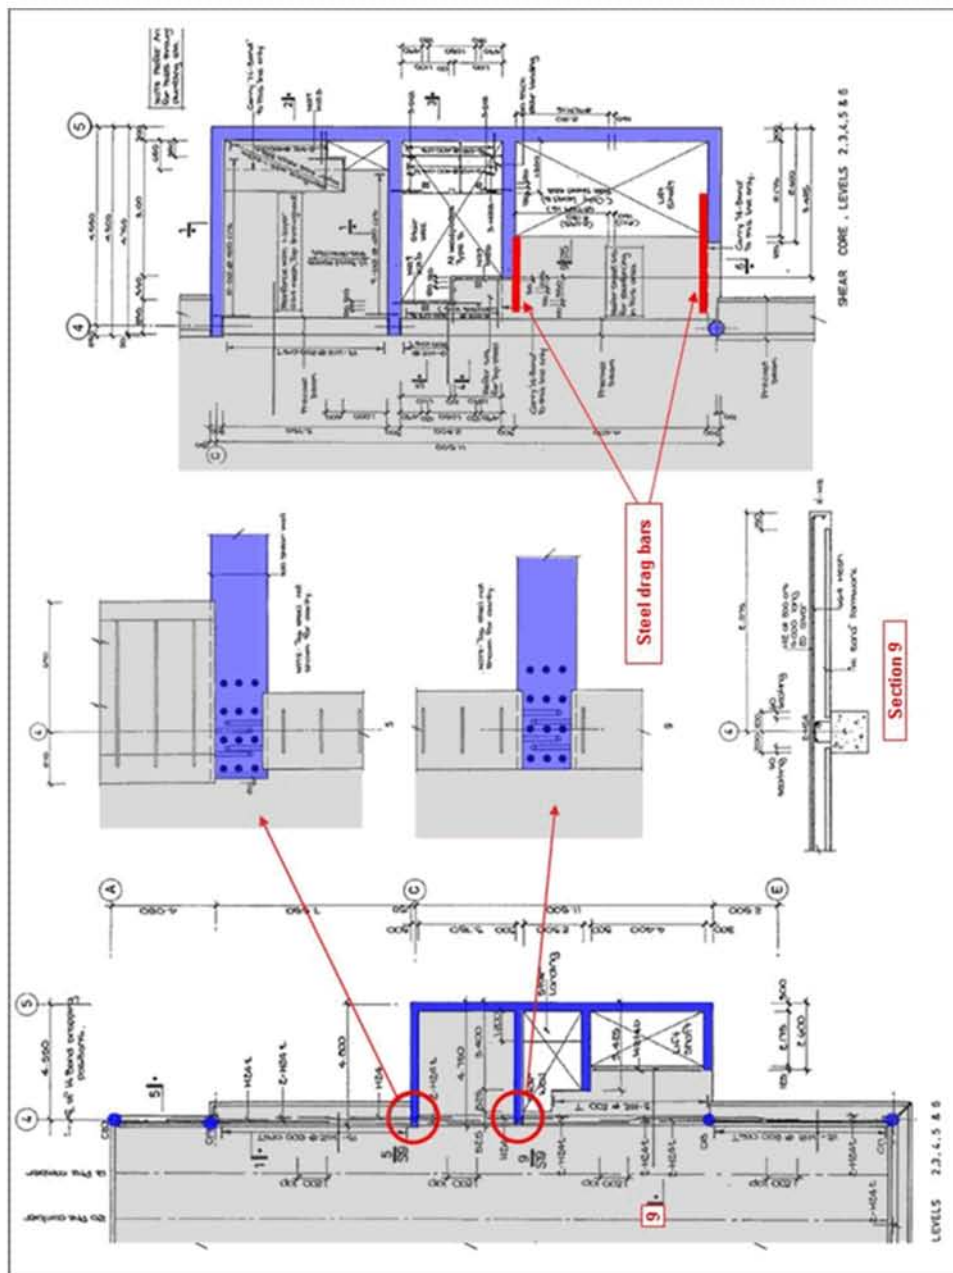
Figure 10 shows plans of the area where a typical floor slab (shaded grey) meets the stabilising walls of the north core (shaded blue). The large lateral forces from the floor slab must be transferred to the walls at the (limited) places where slab and wall elements meet and through the drag bars (shaded red) which were designed in October 1991 and subsequently installed at Levels 4, 5 and 6. These connections were seen as vulnerable and there was a possibility that the diaphragm slab would separate from the walls, resulting in increased lateral displacements and higher demands on critical columns.

Figure 10 - Diaphragm connections at North Core.

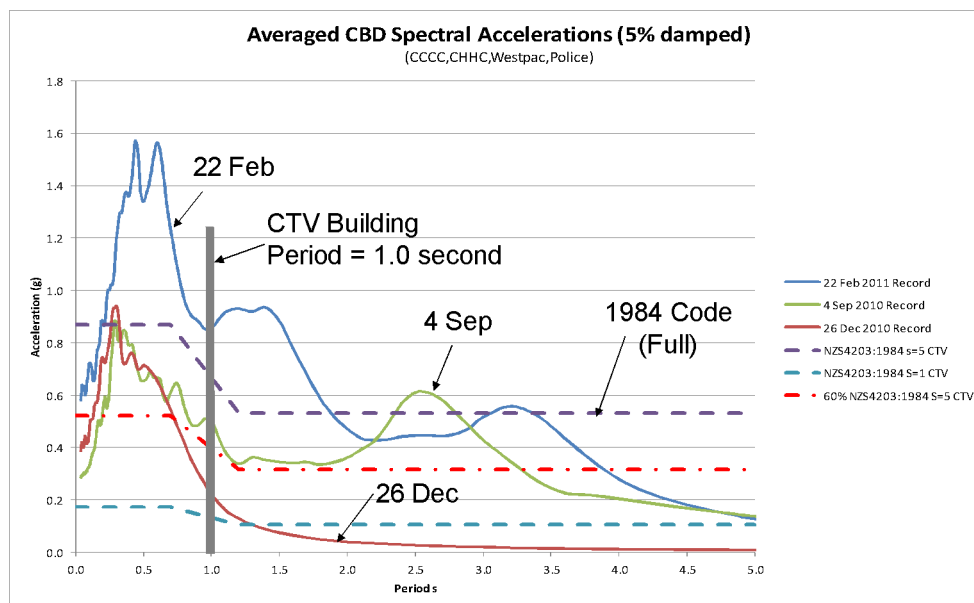
Figure 11 – Response spectra records for the September Earthquake, December Aftershock and the February Aftershock. Also shown (dashed lines) are the design spectra for the CTV building according to NZS 4203:1984. The lower dashed line is the spectra for ductile design that the North Core and South Wall were required to have axial / flexural dependable strength in excess of. The upper most dashed line is the elastic response spectra that the structure was expected to be able to match in terms of ultimate displacement without collapsing.

Although direct comparison of such spectra can be misleading, it can be seen that at a period of 1.0 second, the acceleration shown for the February Aftershock significantly exceeded the full 1984 value required for the design of elastically responding structures. The CTV Building had been designed for ductile response using forces derived from the lowest design spectra shown in Figure 11.

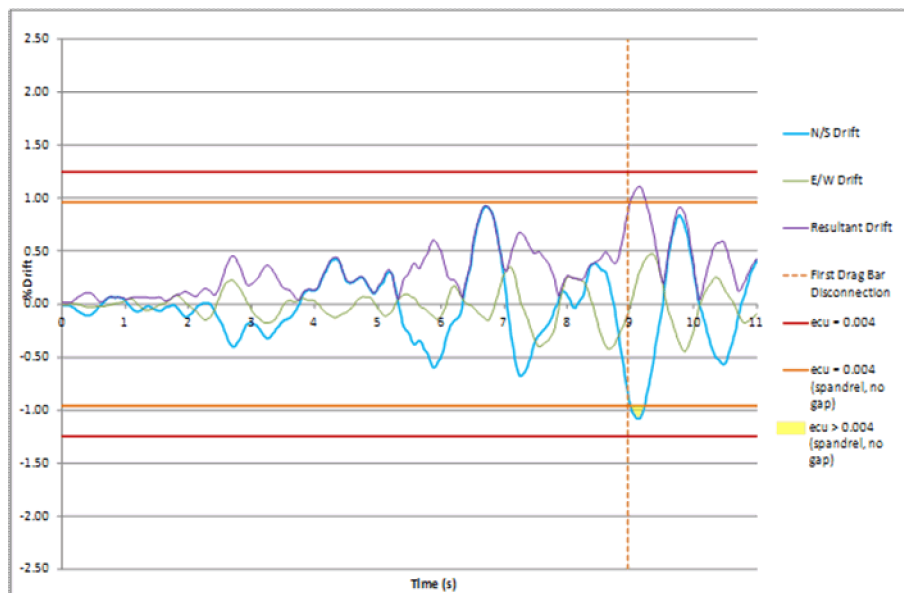
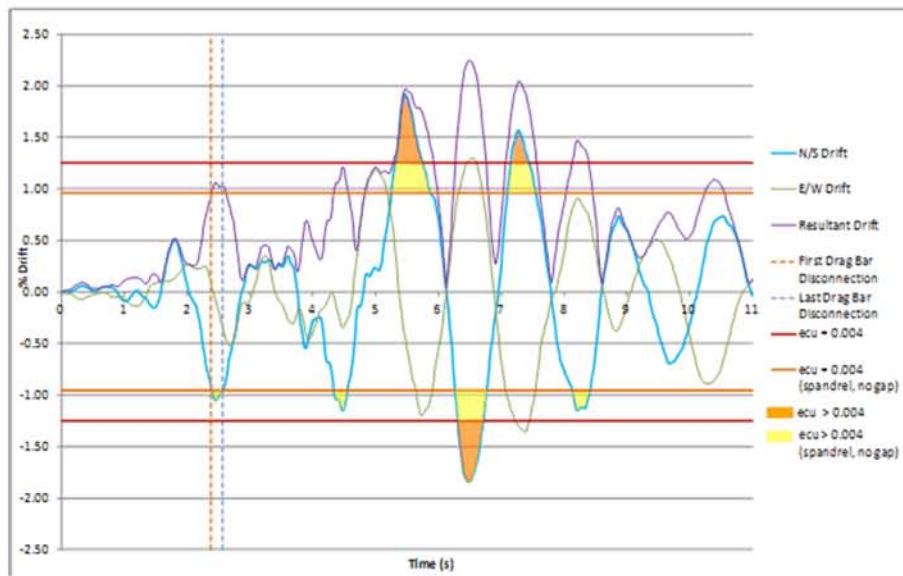
Figure 12 - Comparison of drift demand and capacity – column F2 Level 3 - CBGS, 4 September Darfield Earthquake, no masonry.

Figure 13 - Comparison of drift demand and capacity – column F2 Level 3 - CDBGs, February Aftershock, no masonry.

The horizontal lines represent the estimated capacity of this column to sustain the drift without failing according to various criteria (assuming expected concrete strength and without vertical earthquake effects). The band between the horizontal lines in Figure 12 and Figure 13 reflects the difference between “no interaction with the spandrels” (higher value) and “full interaction with the spandrels”. The areas where the drift had exceeded the estimated capacity are shown shaded. The band showing the range of capacities would be wider if allowance was made for the effect of variable concrete strength and vertical earthquake forces in the column.

These comparisons give some indication of the challenges of determining which column or mechanism initiated failure. However, the plots indicate clearly that there is a strong likelihood that the demands of the February Aftershock were enough to cause column failure, whereas the demands of the September Earthquake were much less.

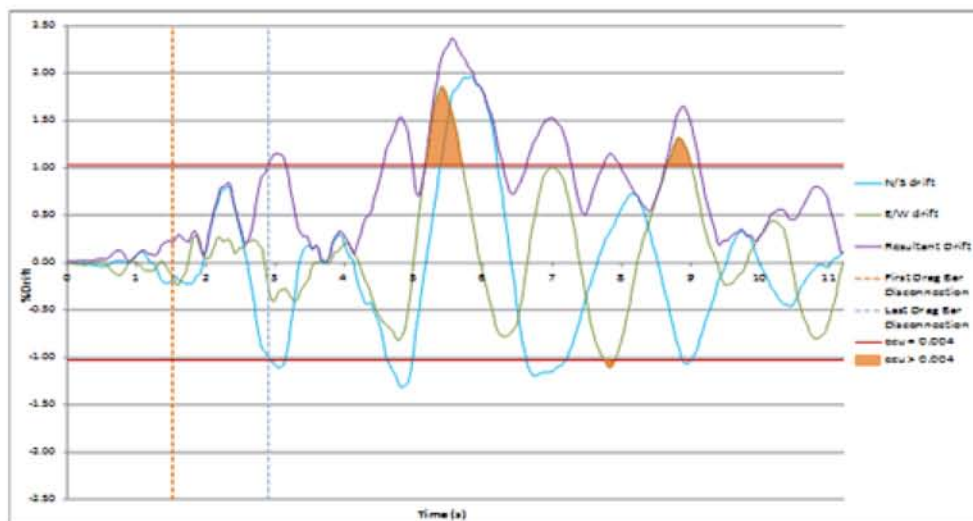
Figure 14 - Comparison of drift demand and capacity – column D2 Level 3 - CHHC, 22 February Lyttelton Aftershock, no masonry.

Similar plots were made for column D2 at Level 3, shown in Figure 14, with similar conclusions being reached regarding the likely performance of this column in the February Aftershock.

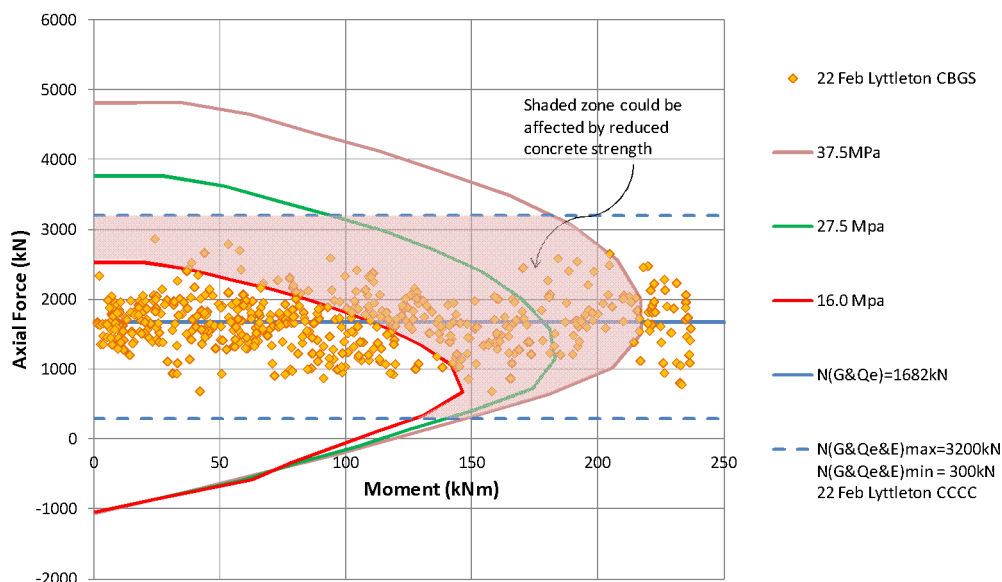
Figure 15 - Column interaction chart showing effect of varying concrete strength and vertical acceleration on column performance.

The axial forces in column D2, from the NTHA with vertical accelerations, were found to fluctuate at much higher frequency than the lateral modes of vibration. There was therefore significant variation in the axial force for any given cycle of lateral drift, with an increase in axial force being detrimental and a reduction in axial force being beneficial to the column drift capacity at any particular time step (Figure 15).

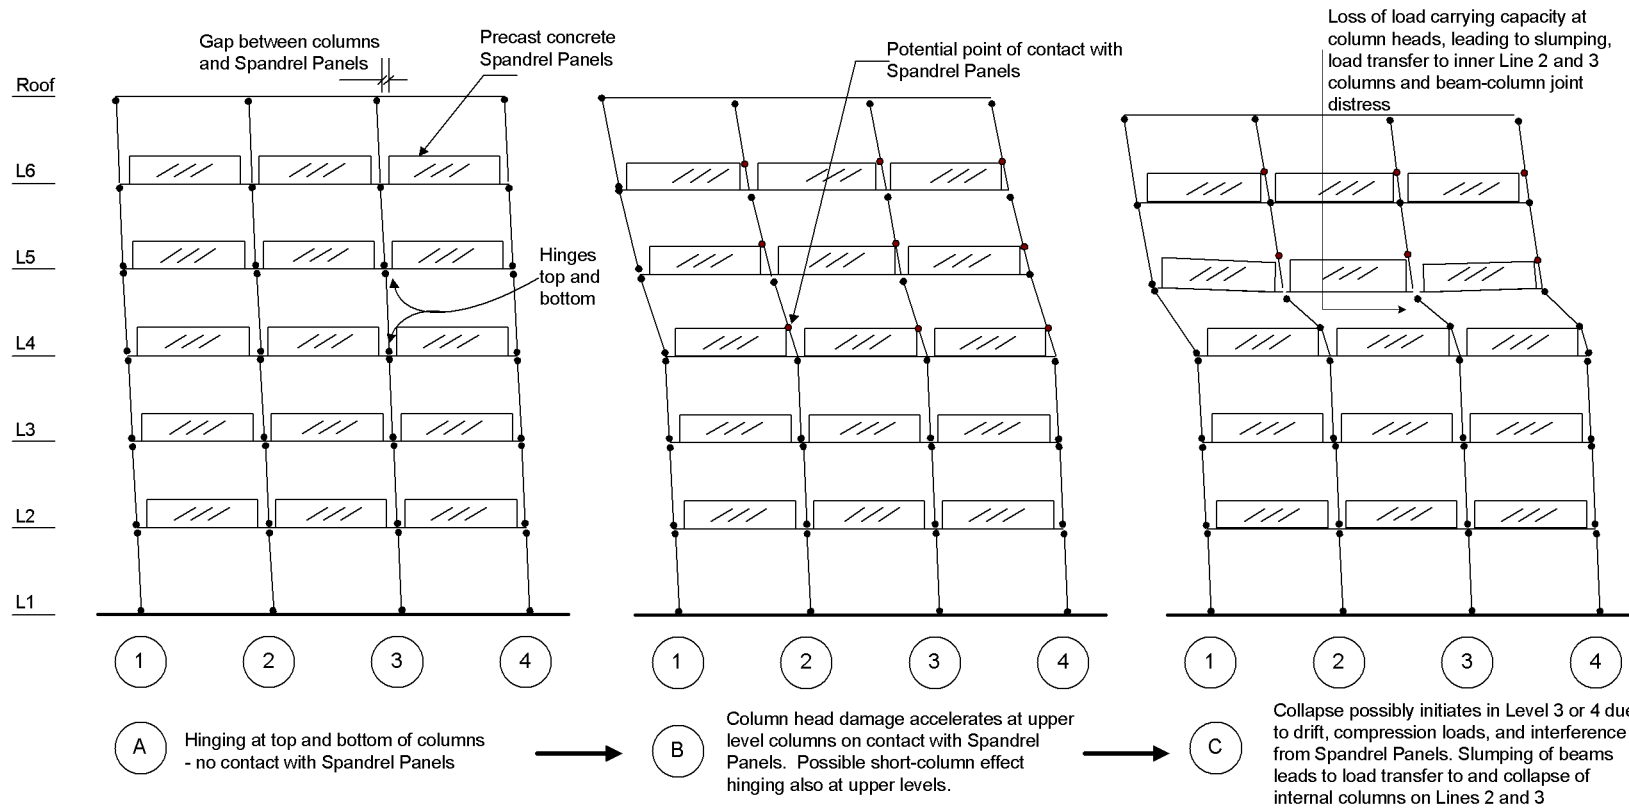
Figure 17 - Possible collapse sequence along Line F as Inter-storey drifts reach critical levels and columns begin to fail from lack of displacement capability or from additional damage caused through contact with precast concrete Spandrel Panels. Displacements and damage are greatest in the upper levels, but inelastic drift capacity less in the lower levels. Also change in torsional stiffness at Level 4 due to the Line A masonry infill wall stopping at that level may have contributed to collapse appearing to initiate above Level 4.

The slight eastwards throw of the debris along Madras Street was consistent with the report of Eyewitness 6 of a slight tilt to the east of the upper levels before they fell straight down. The column head fractures are consistent with flexural/compressive failure scenario shown in Figure 17 and Figure 18.

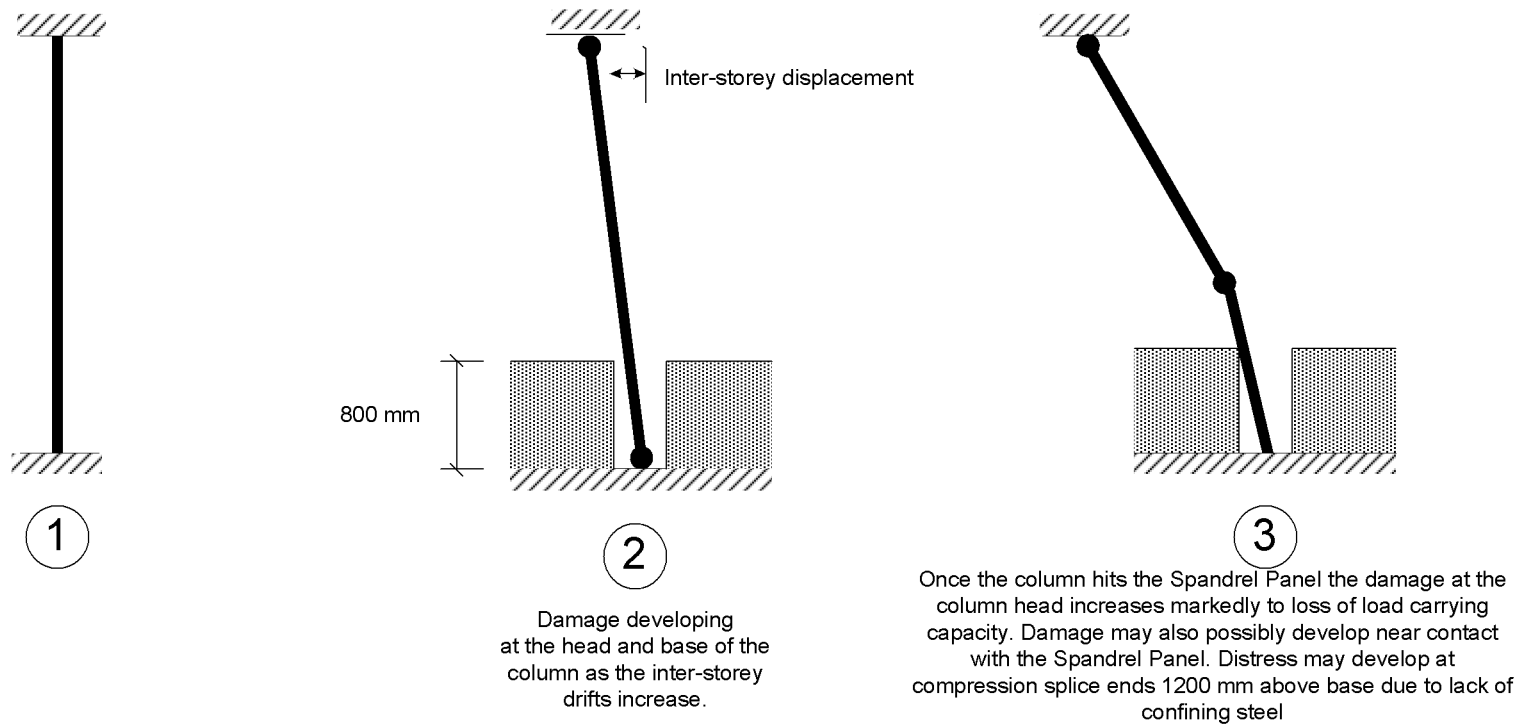
Figure 18 - Development of flexural/compressive column head damage in Line F columns and the damage acceleration effects from interference by the Spandrel Panels.

- Column fractures were evident on Line F columns. The column fractures were consistent with the flexural/compressive failure scenario shown in Figure 18.

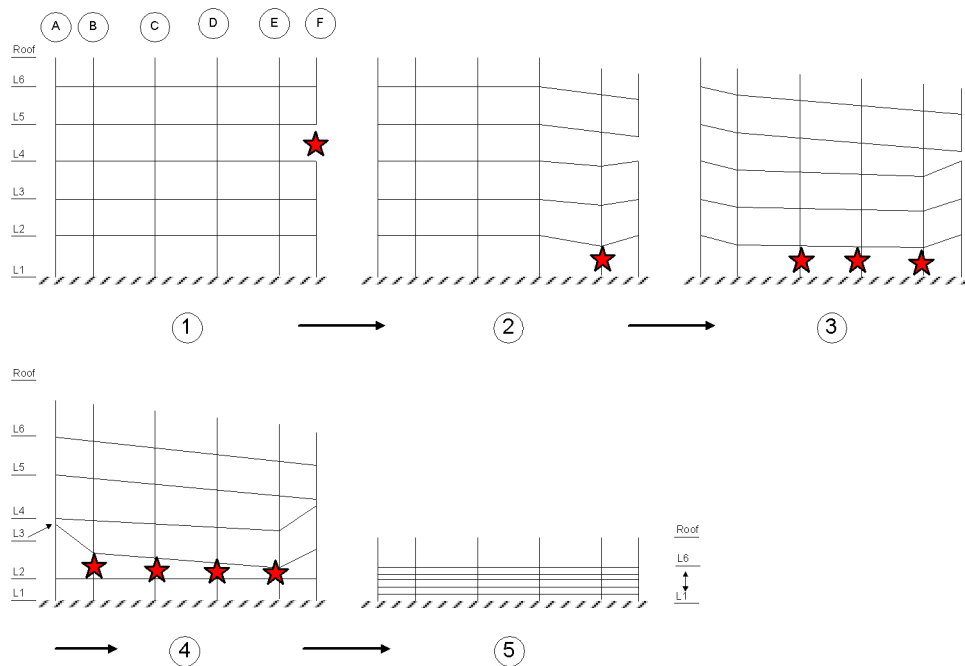
Figure 19 - Possible progression of collapse from loss of column capacity on Line F is shown sequentially as follows: (1) Collapse of Line F columns above Level 4 leads to extra floor area being supported off columns on Line E; (2) The Line E columns begin to collapse under the extra load; (3) As the Line E columns sink additional floor area becomes supported on the Line D columns which in turn begin to collapse, causing an eastward tilt in the upper levels; (4) The upper levels then hit the Level 4 Line F; (5) The collapse completes with all floors laying on top of each other. Note that collapse is also spreading in the north-south direction simultaneously to this as shown in Figure 19.

- No liquefaction appeared to have occurred on the site.
- The collapse had been confined within the building footprint on the south face.
- The slight eastwards throw of the debris along Madras Street was consistent with the report of Eyewitness 6 of a slight tilt to the east of the upper levels before they fell almost straight down. The eastwards throw was also consistent with column failure initiating along Line F leading to a slumping and eastward tilt of the levels above as shown in Figure 19.

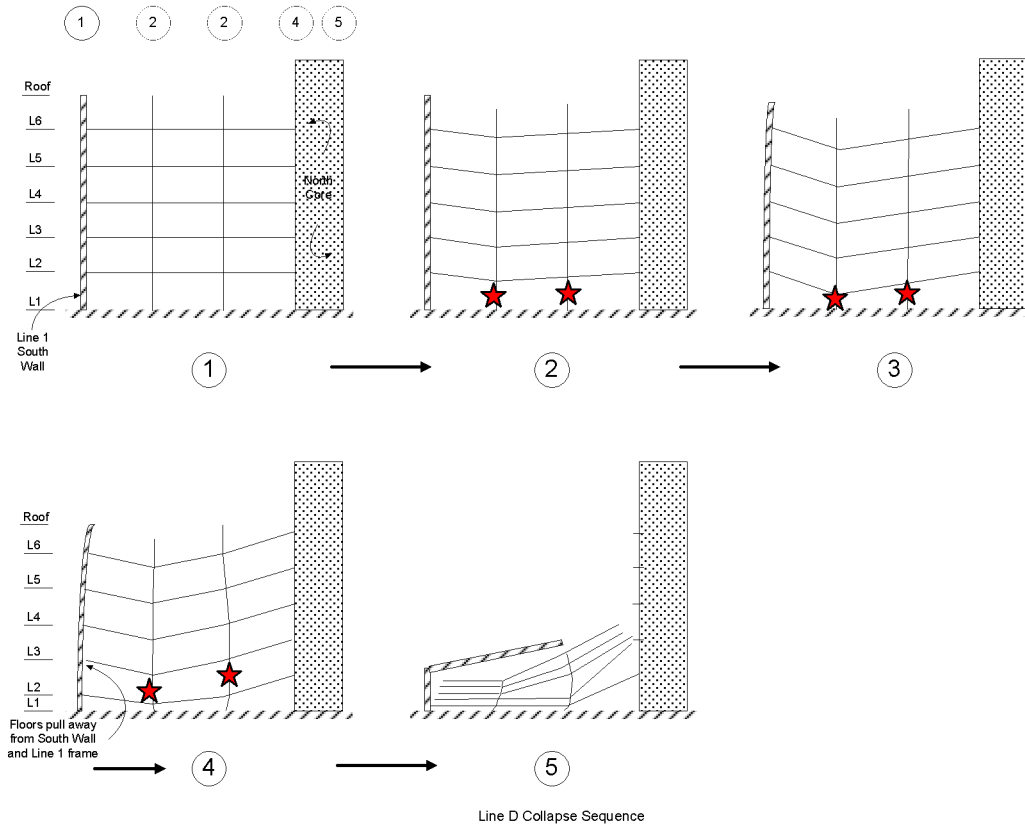
Figure 20 - Possible progression of the collapse on a north-south section through the building simultaneous with that shown progressing westwards in Figure 19 (1) Initial condition ; (2) Line 2 begins to subside; (3) As Line 2 subsides further the stiffer and stronger North Core pulls the collapsing floors towards it; (4) The South Wall is pulled northwards; (5) The slabs pull away from the North Core eventually lying diagonally against it and the South Wall is pulled down onto the collapsed building.

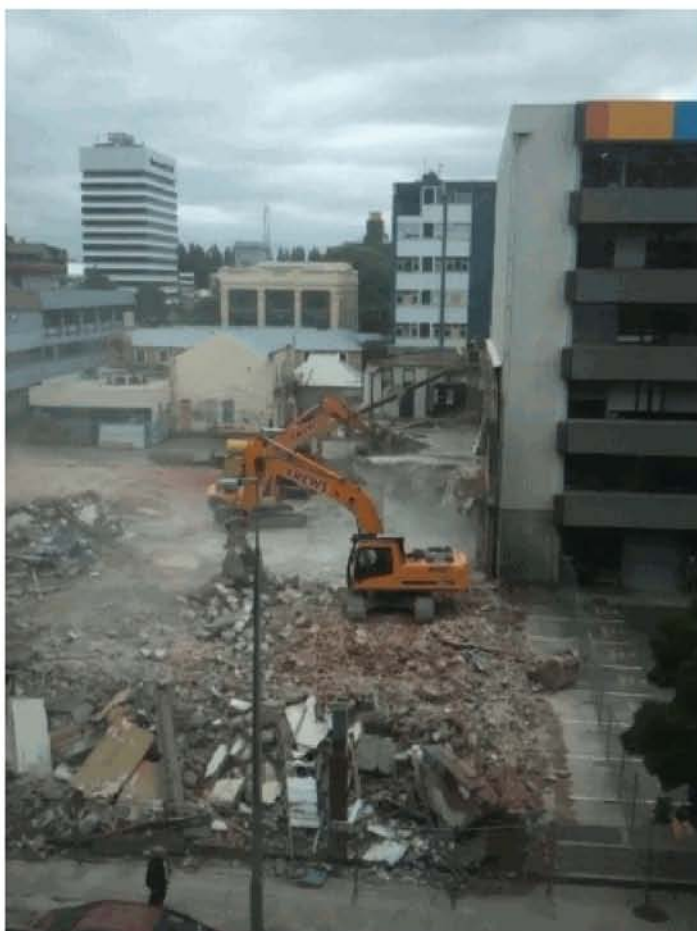
Heavy machinery with pneumatic pokers and pincers, and drop hammers, were used to break it up (Figure 29). This caused on-going and disturbing vibrations to occupants in the CTV Building.

The authors consider it unlikely that structural damage was caused by the demolition sufficient to affect the earthquake resistance of the CTV Building. This is because it is common practice to use such equipment for demolition work like that seen in Figure 29 and not to cause any significant structural damage to adjacent buildings.

Figure 29 - Heavy machinery demolishing the building adjacent to the CTV Building after the 4 September Earthquake. The boundary wall is still in place covering the Line A infill masonry wall of the CTV Building.

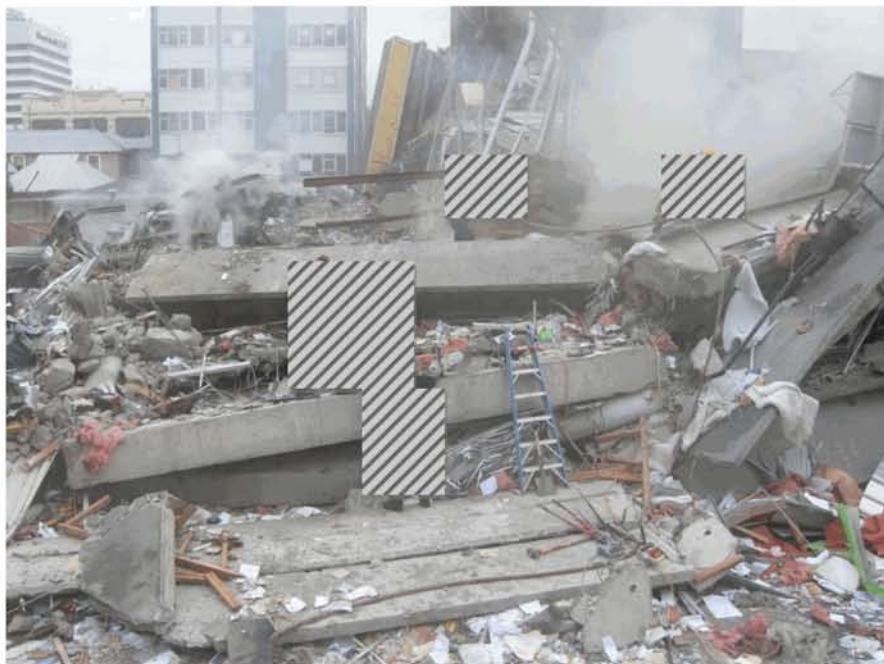
Figure 35 - Concrete Spandrel Panels, perimeter beams and columns on Cashel Street face (Line 1 / B-D).

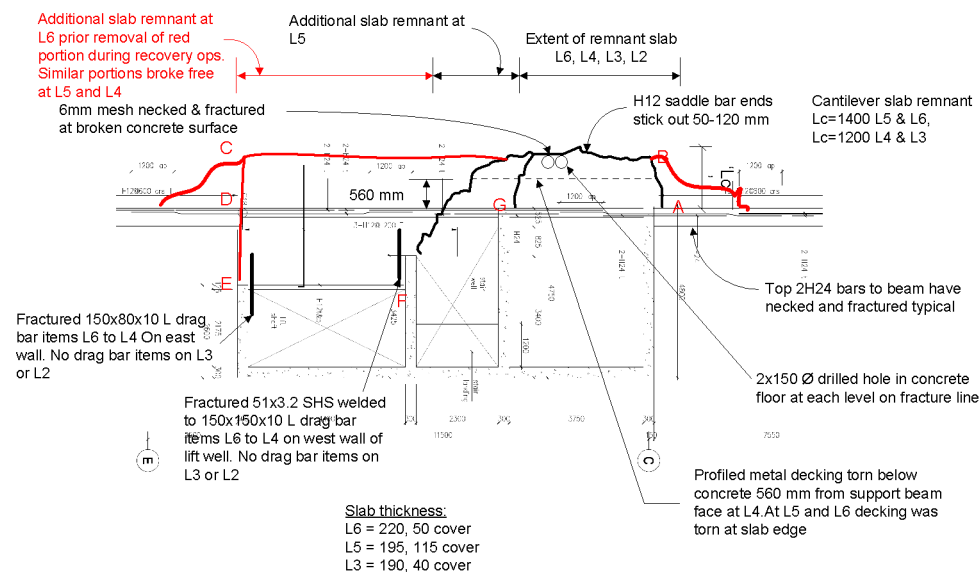
The slab failure surfaces diagram in the Site Examination and Materials Tests report therefore has been modified in this report (Figure 43) to account for observations from the photos of the condition of the structure immediately after the collapse and as found during the debris removal.

This indicated that the slabs at Levels 4 and 5 may not have broken away from the North Core walls due to in-plane diaphragm actions as this would have caused all the threaded anchors to have sheared off or bent over. It could be that the portion of slab immediately outside the lift well (refer Figure 43) had rotated downwards after the slab beyond that had broken away as Line 3 collapsed. For the slab failure to occur before the remnant rotated down, vertical support would still have been required from column 4-D/E. As it rotated downwards the slab appears to have pivoted about the tip of the walls, prying itself off the epoxied threaded anchors fitted into the portion of the Drag Bar adjacent to the walls (Figure 37 and Figure 115).

Figure 43 - North Core slab remnant profile based on the Site Examination and review of collapse photos.

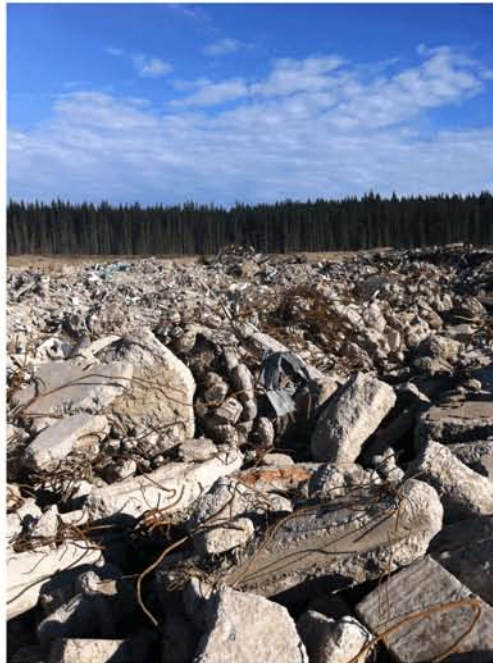
Figure 45 - A portion of the CTV Building debris field at the Burwood Eco Landfill from which columns were extracted for examination and testing.

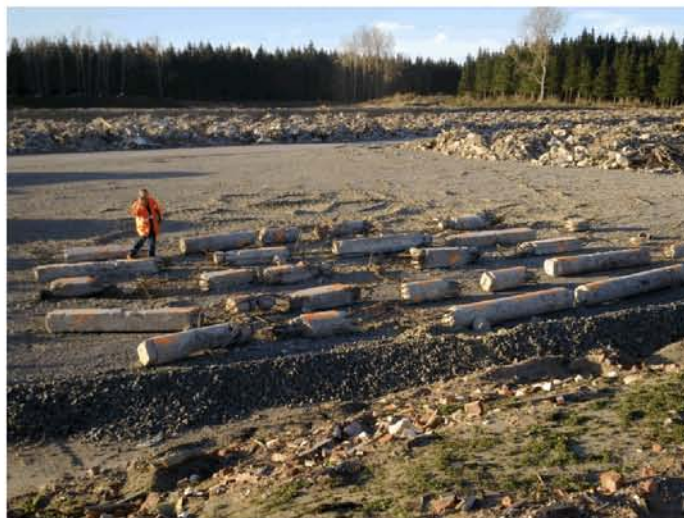
A number of circular columns examined showed axial/flexural hinging failures near mid-height as well as hinging at the base or head. Other circular columns were found full height with hinging damage at their heads and bases.

Rectangular columns which had all been located on Line A in the structure, typically exhibited beam-column joint failure as well as other damage.

Figure 46 - CTV Building columns extracted for examination and testing from the Burwood debris field.

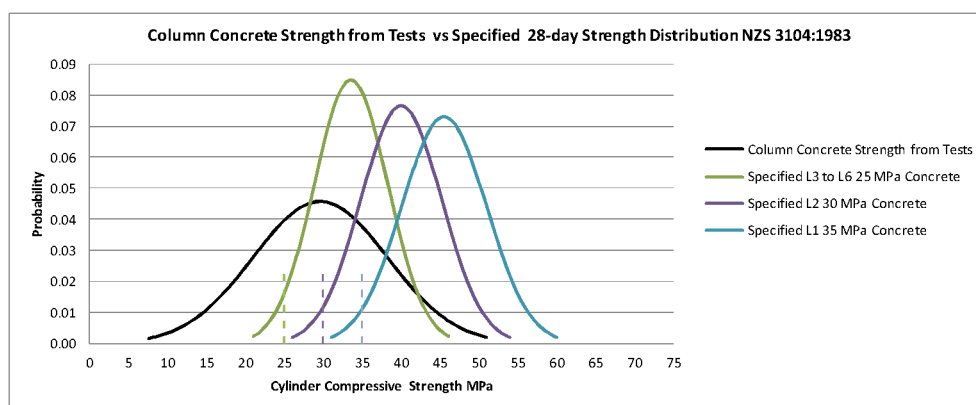
Figure 47 – Column concrete test strengths adjusted for test orientation vs 28-day concrete strength distribution according to NZS3104:1983. This indicates that the concrete in a significant proportion of the columns may have had strengths less than the minimum specified.

Based on the testing undertaken, it appeared that at the time of the collapse the columns in Levels 1 to 6 had mean concrete strength equivalent to that of concrete with 28-day strength of 20 MPa. This was less than the minimum specified concrete 28-day strength of 35 MPa for columns at Level 1; 30 MPa for columns at Level 2; and 25 MPa for columns from Level 3 to Level 6. This is shown graphically in Figure 47.

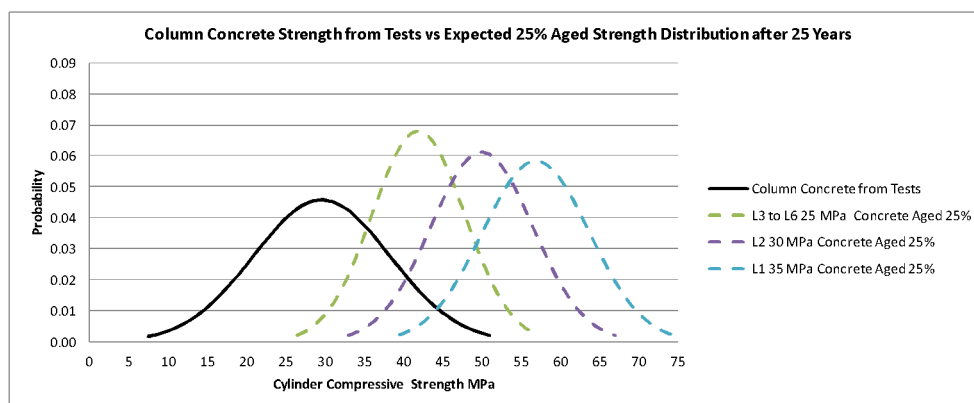
Figure 48 - Column strengths compared to expected strength distributions with 25% allowance for aging after 25 years.

The expected distribution of strength is shown compared to the tested distribution of strength in Figure 48.
